Technical Service Bulletin

GROUP CAMPAIGN	NUMBER 25-01-061H-1
DATE NOVEMBER 2025	MODEL(S) TUCSON (NX4A)

SUBJECT: DCU SOFTWARE UPDATE
(SERVICE CAMPAIGN TDFC)

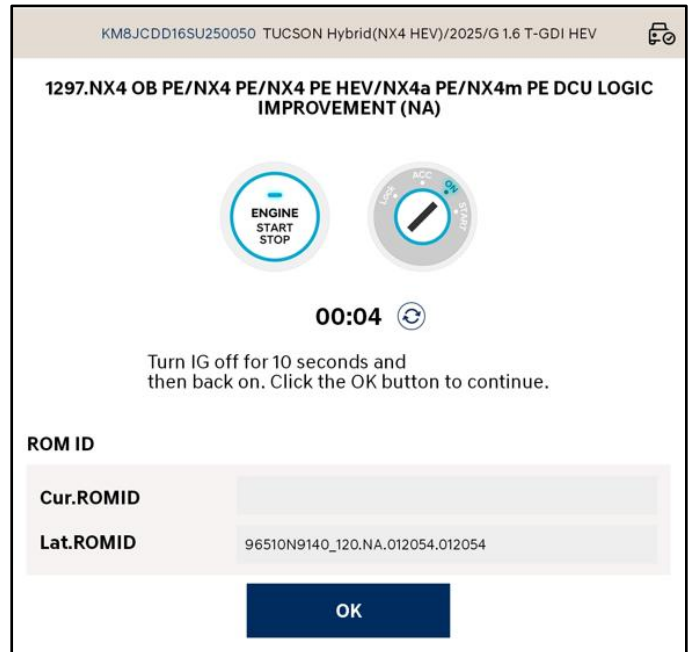
5. OTA initialization (A) should perform automatically:
 - If OTA initialization performs automatically, then proceed with the service procedure.
 - If the OTA initialization process fails, complete it manually under:
 - S/W Management > CCU_CCNF - Central Communication Unit (CCNF)**
 - > OTA Initialization (B).**

Follow the instructions on the screen.
