Service Bulletin

Bulletin No.: 24-NA-227

Subject: Vibration, Rattle or Boom at 1800 to 2000 RPM

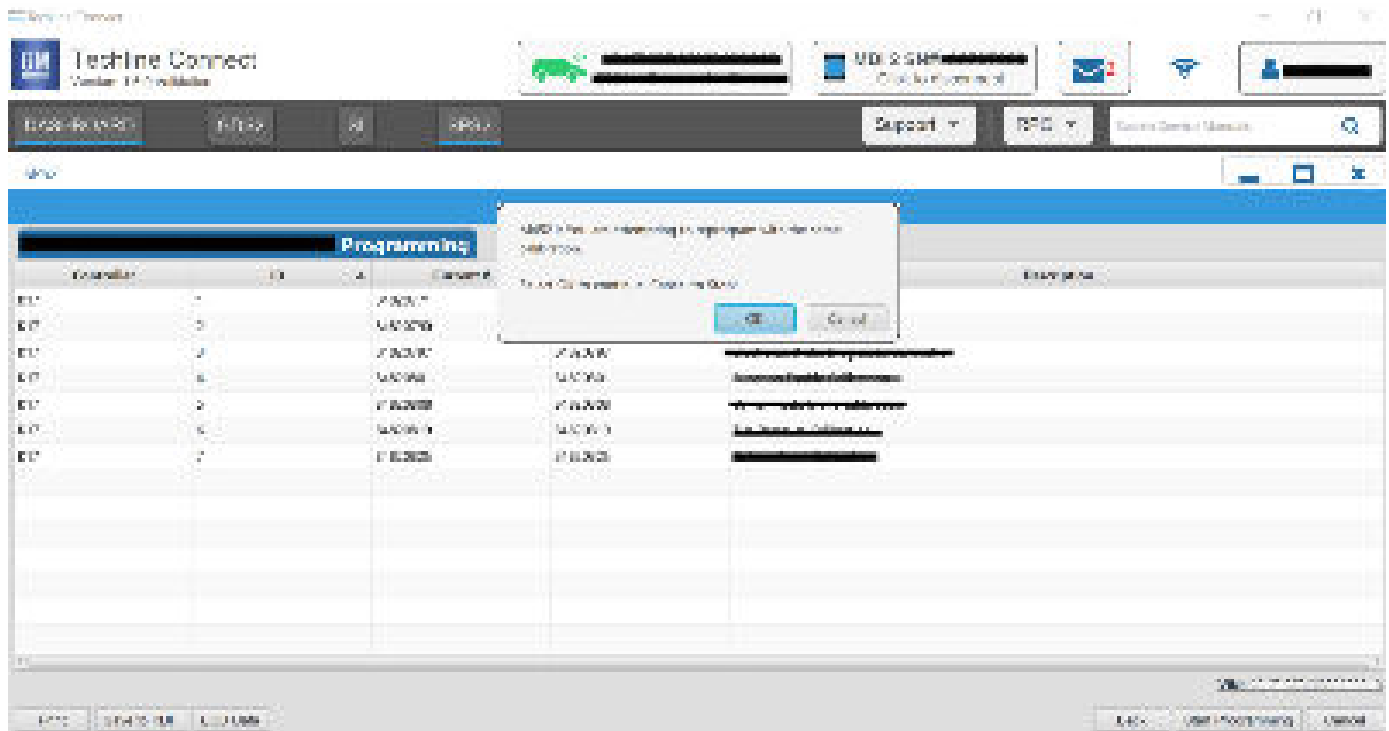
5644477

Important: If the vehicle VIN DOES NOT match, the message below will be shown.

Important: Techline Connect screen shown above.

Important: If the same calibration/software warning is noted on the TLC Summary screen, select OK and follow screen instructions. After a successful programming event, the WCC is located in the Service Programming System dialogue box of the SPS Summary screen. Record the WCC on the job card. No further action is required. Refer to the Warranty Information section of this bulletin.

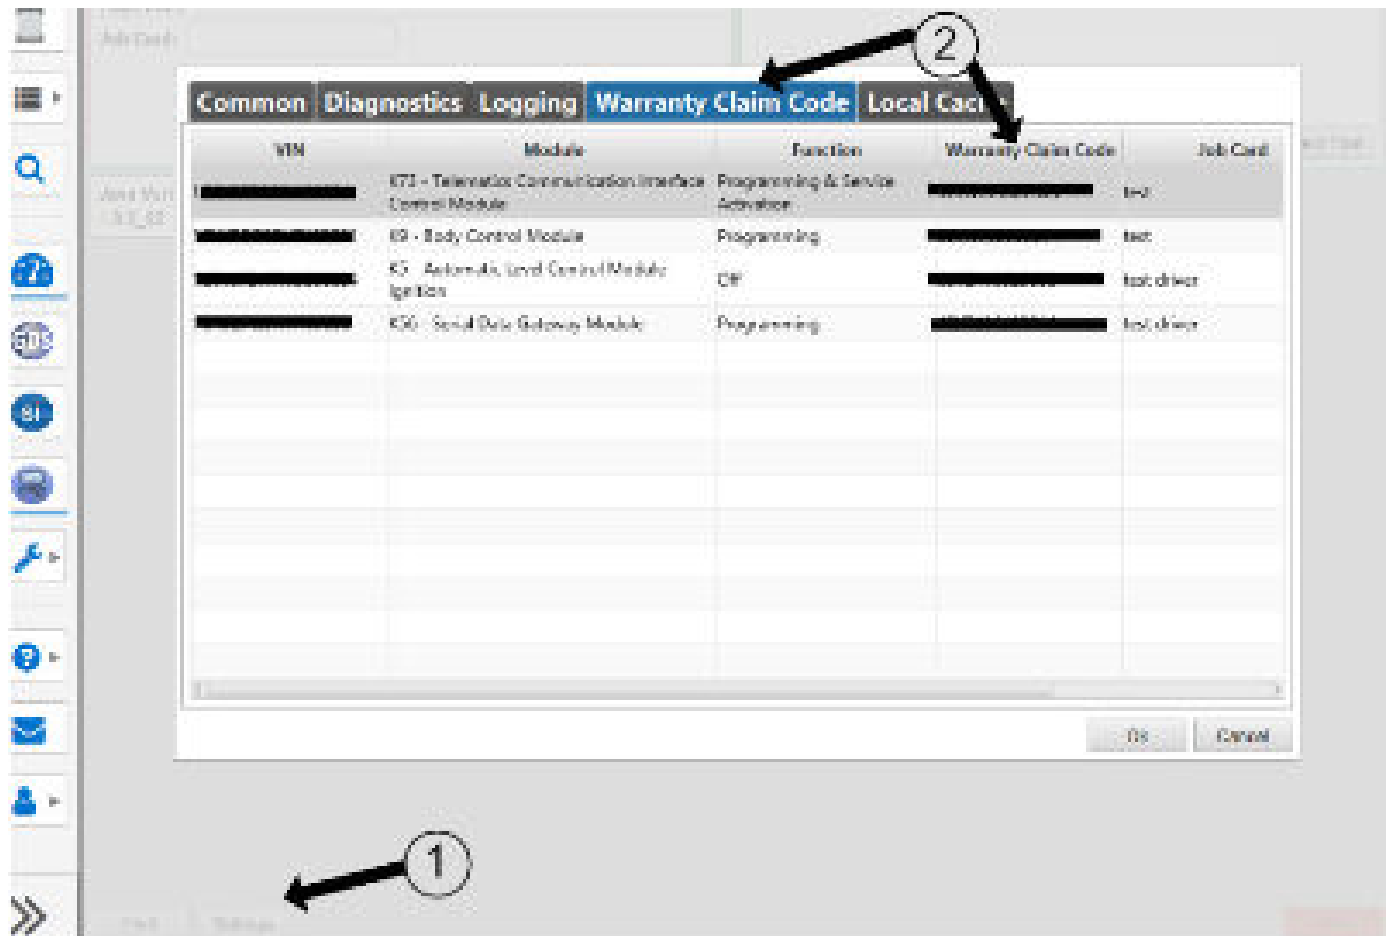
6125774

Warranty Claim Code Information Retrieval

If the Warranty Claim Code was not recorded on the Job Card, the code can be retrieved in the SPS2 system as follows:

The VIN, Warranty Claim Code and Date/Time will be listed on a roster of recent programming events. If the code is retrievable, dealers should resubmit the transaction making sure to include the code in the SPS Warranty Claim Code field.
