GROUP	MODEL
ENG	2021-2023MY Sorento (MQ4a)
NUMBER	DATE
257	December 2025

## TECHNICAL SERVICE BULLETIN

# ITM REPLACEMENT AND ECM & TCM LOGIC IMPROVEMENT (CA2508)

This bulletin provides information to replace the Integrated Thermal Management Module (ITM) and then upgrade the Engine Control Module 'ECM' and (if applicable) the Transmission Control Module 'TCM' system software on certain 2021-2023MY Sorento (MQ4a) vehicles produced from September 09, 2020 through December 19, 2023. The affected vehicles may experience an illuminated Multifunction Indicator Lamp (MIL) 'ON' with DTC(s) P218100, P2181F0, and/or P2181F1 stored. This condition may occur due to degradation of the diaphragm inside the ITM. There are no drivability or other symptoms associated with this condition. Follow the procedure outlined in this publication to replace the ITM and then upgrade the ECM and TCM systems (as applicable). Refer to [SST081](#) for software upgrade instructions using Kia Diagnostic System (KDS) tablet and VCI-II and confirm the Upgrade Event Number/Name, ROM ID Information, and Manual Mode passwords (if applicable) on the applicable vehicle.

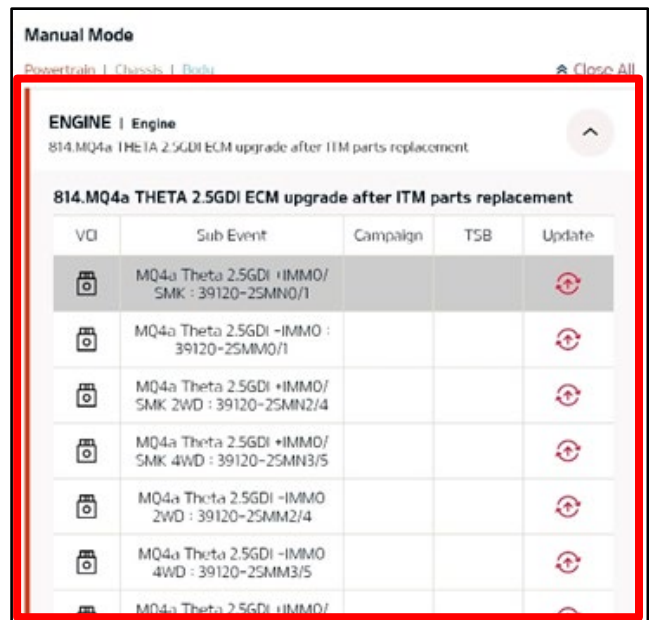
- **814. MQ4a THETA 2.5GDI ECM Upgrade After ITM Parts Replacement**

Select the applicable 'ECM' system module and the Event Group.

Verify the affected vehicle Calibration Identification of the applicable ECU ROM ID and reference the Information Table on pages 5 - 10 as necessary.

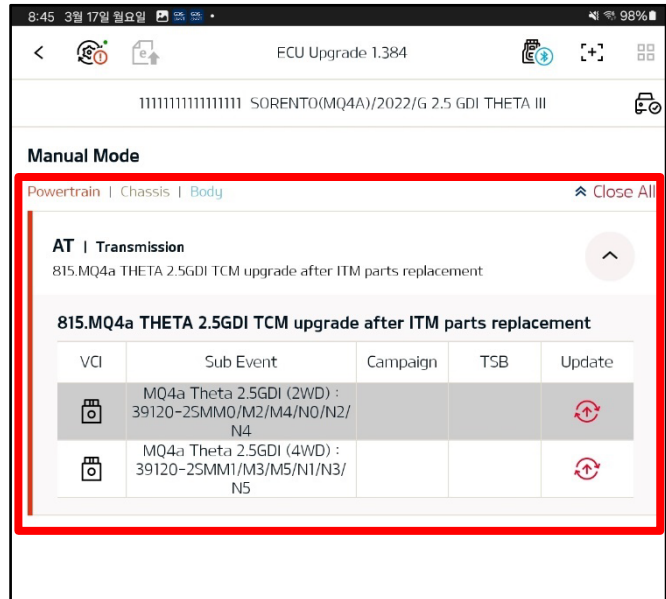
- **815. MQ4a THETA 2.5GDI TCM Upgrade After ITM Parts Replacement**

Select the applicable **'TCM'** system module and the Event Group.

Verify the affected vehicle Calibration Identification of the applicable ECU ROM ID and reference the Information Table on pages 5 - 10 as necessary.

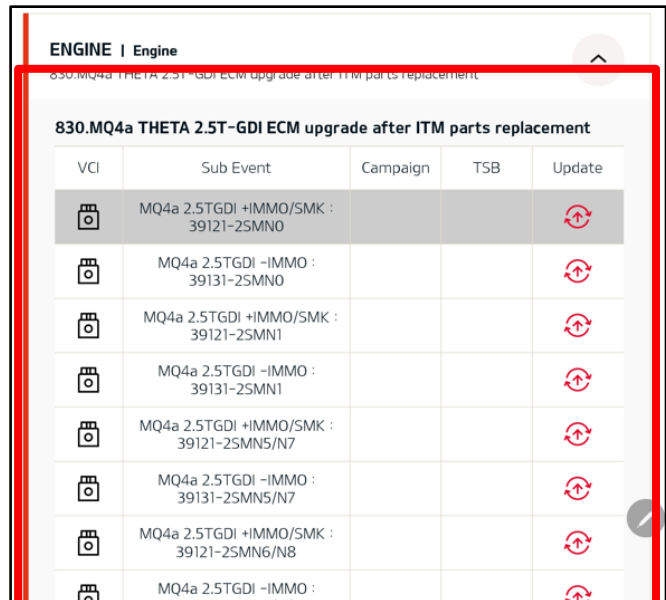
- **830. MQ4a THETA 2.5T-GDI ECM Upgrade After ITM Parts Replacement**

Select the applicable **'ECM'** system module and the Event Group.

Verify the affected vehicle Calibration Identification of the applicable ECU ROM ID and reference the Information Table on pages 5 - 10 as necessary.

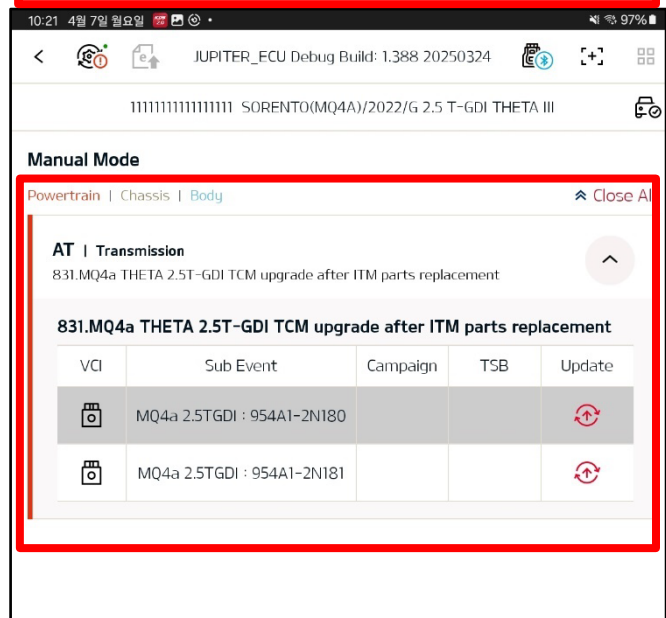
- **831. MQ4a THETA 2.5T-GDI TCM Upgrade After ITM Parts Replacement**

Select the applicable **'TCM'** system module and the Event Group.

Verify the affected vehicle Calibration Identification of the applicable ECU ROM ID and reference the Information Table on pages 5 - 10 as necessary.

**After SW #831 Upgrade is Completed:**  
**Perform Air Bleeding and Transmission Learning procedure using KDS.**
