Technical Service Bulletin

| GROUP SUSPENSION | NUMBER 25-SS-004H |
| DATE DECEMBER 2025 | MODEL(S) PALISADE (LX2) |

SUBJECT: SELF-LEVELING REAR SHOCK ABSORBER CLUNKING/THUMPING NOISE ON ROUGH ROADS (WARRANTY EXTENSION Z12)

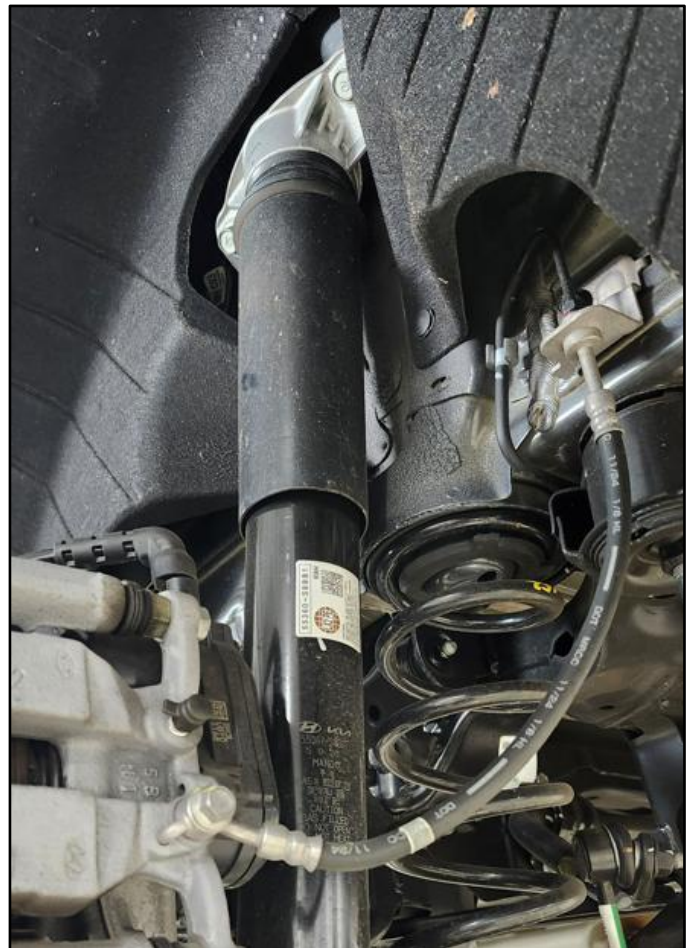
3. Visually inspect the rear suspension components listed below for visible damage.

- **NO DAMAGE:** Proceed to [Shock Absorber Replacement](#).
- **DAMAGE:** Follow the normal diagnostic process and repair as necessary. Test drive and verify if a clunk or thump noise is present from the rear of the vehicle.
 - **NO NOISE:** If the noise is resolved, then the service procedure is complete.
 - **NOISE:** If the noise is still present, proceed to [Shock Absorber Replacement](#).
