Service Bulletin

Bulletin No.: PIP6033A

Subject: CVT Transmission Noise - Slip or Loss of Motion

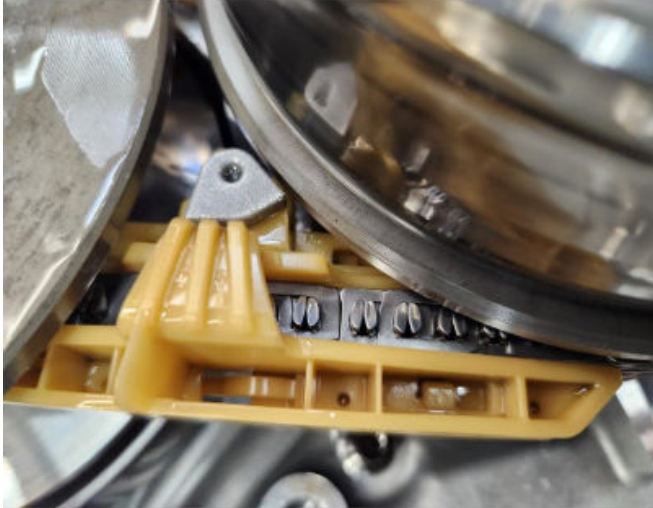
6750282

The Pictures below show examples of a good drive chain.

Take note of how the chain ends (deer hooves) have a polished appearance.
