**HYUNDAI**  
**Technical Service Bulletin**

GROUP <b>BODY</b>	NUMBER <b>25-BD-011H-1</b>
DATE <b>DECEMBER 2025</b>	MODEL(S) <b>SANTA CRUZ (NXT)</b>

**SUBJECT:** TONNEAU COVER INSPECTION & REPAIR GUIDE

**Description:** Some Santa Cruz (NXT) vehicles may have a tonneau cover that does not latch or unlatch, retract properly, and/or have a v-gap is present when closed. This may be due to a broken or missing clip on the underside of the tonneau cover. This bulletin provides instructions to inspect and, if necessary, repair the tonneau cover function using the Tonneau Cover Repair Kit or replacing the tonneau handle & latch assembly.

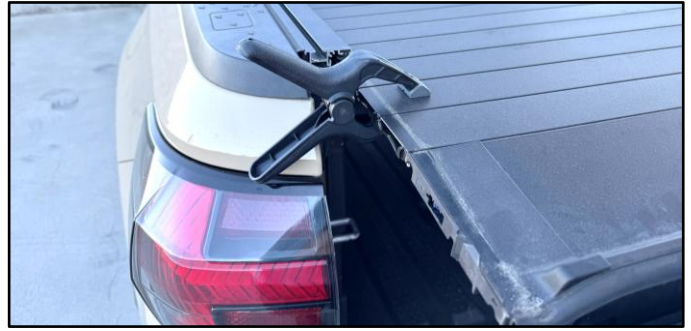
4. Visually inspect the plastic guide rails (E) under the tonneau cover for displacement.

Reinsert the plastic guide rail(s) into the track(s) if needed.

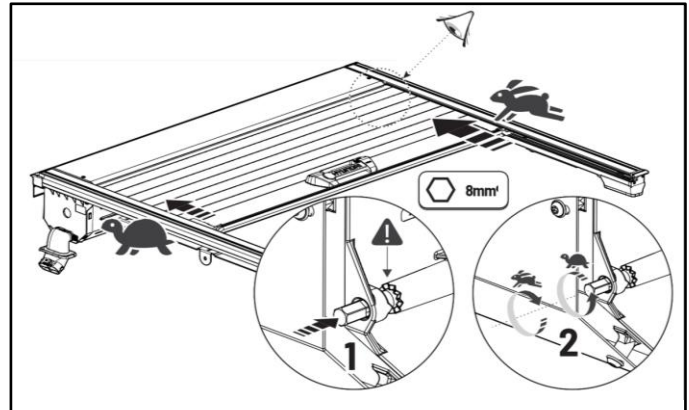
Ensure the cover does **NOT** retract too fast and slam into the canister.

24. If necessary, adjust the tension of the spring by pressing and turning the knob, **right** to tighten (increase speed), and **left** to loosen (decrease speed).
