Field campaign

Topic	Software Update Window Short Drop Deletion Continental GT/GTC 26MY (SC25 /31)
Market area	Bentley: worldwide (2WBE),China 796 VW Import Comp. Ltd (Vico), Beijing (6796)
Brand	Bentley
Transaction No.	2078277/22
Campaign number	ED59
Note	
Type	
US code

Software Update | Window Short Drop Deletion | Continental GT/GTC | 26MY
(SC25/31)

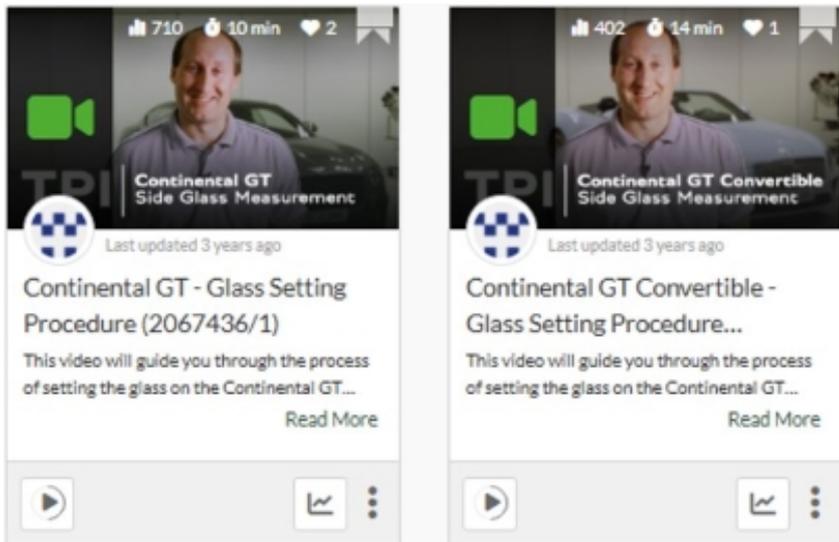
Figure 8

Further explanation can be found in the videos shown in Figure 8, which can be found on eAcademy Digital Learning Hub.
