# ABS Wheel Speed Sensor Faults

**Reference Documentation** Service Bulletin [TSB 42-080](#) publication date 5/10/24.

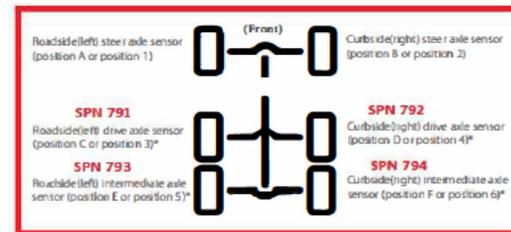
- Additional Information** Fault setting results in:
- Reduced ABS functionality, Loss of ESC
  - Reduced ATD regen functionality
  - Reduced optimized idle (OI) functionality
  - Occurs while driving or low speed or idling
