GROUP	MODEL
BOD	2025-2026MY EV9 (MV1a)
NUMBER	DATE
348	January 2026

TECHNICAL SERVICE BULLETIN

SUBJECT: **SERVICE ACTION: FRONT PASSENGER WALK-IN SEAT SWITCH INSPECTION, REPAIR & REPLACEMENT (SA636)**

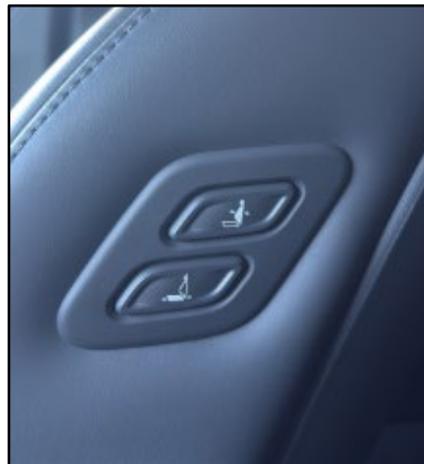
This bulletin provides information to inspect the front passenger walk-in seat switch on certain 2025 - 2026MY EV9 (MV1a) vehicles produced from May 16, 2024 through August 21, 2025. On some vehicles, the switch may not be mounted flush to the backrest cushion. **This condition does not affect the functionality of the switch and is a cosmetic issue only.** Follow the procedure outlined in this publication to inspect the front passenger walk-in seat switch for a non-flush condition and, if necessary, trim the backrest seat cushion excess foam around the walk-in switch mounting area and replace the switch with a new part. Before conducting the procedure, verify that the vehicle is included in the list of affected VINs.
