SIB 52 19 23

SECOND ROW 60/40 SEAT RAIL FLEX CABLE REPLACEMENT

2026-01-14

G07 (X7) SECOND ROW 60/40 SEAT RAIL

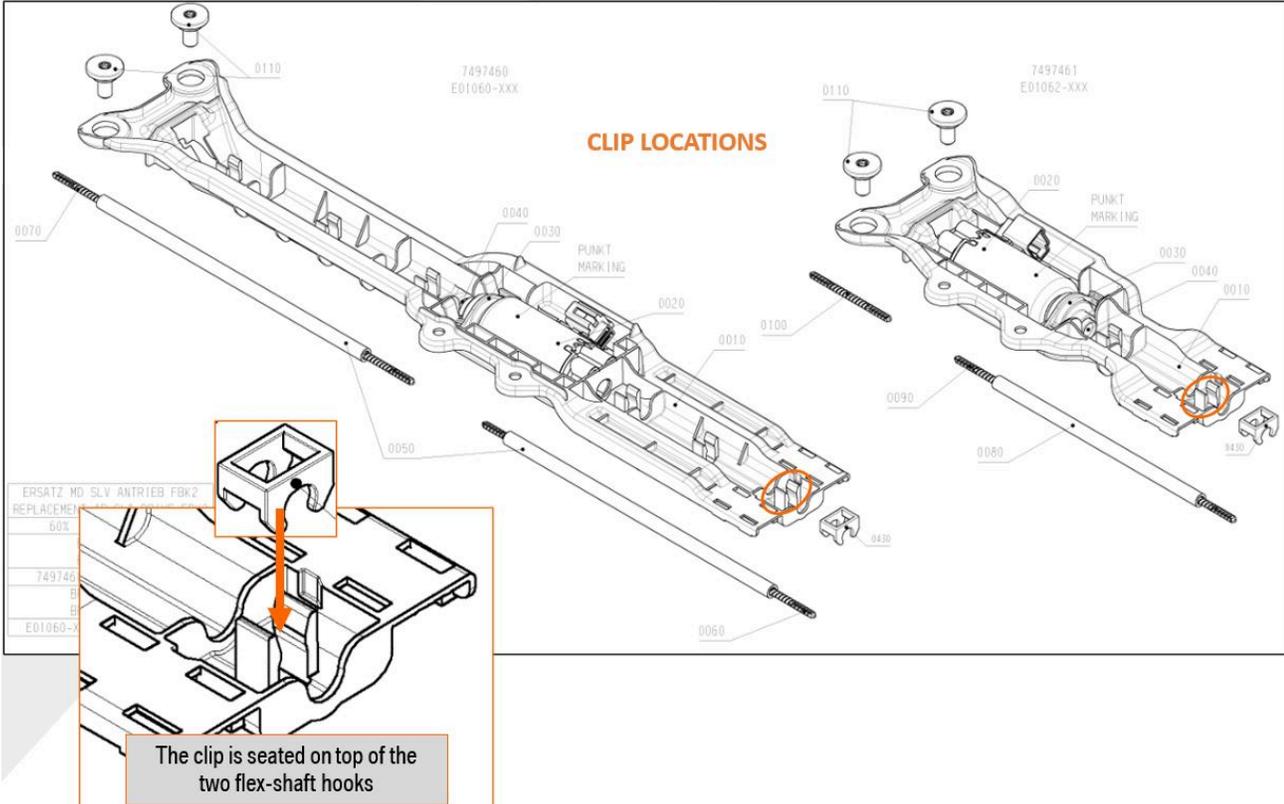
The locking clip is shown in ETK to be used in conjunction with flex cable repairs.

The clip is seated on top of the two flex-shaft hooks

NOTE: If this locking clip has come loose due to the cable popping free, it should be replaced.
