SIB 51 02 26

CENTER CONSOLE ARMREST BUTTON FALLS OUT

2026-01-21

E-Series	Model Description
G45	X3 Sports Activity Vehicle

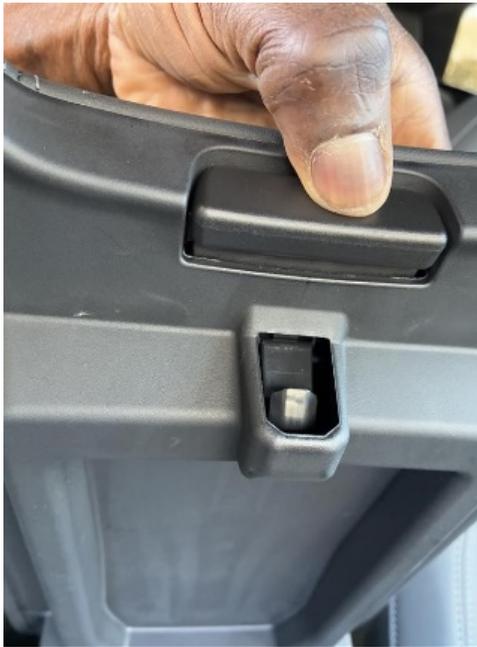
5. When installing the new button, you should hear an audible click once it is fully seated.

6. Once the repair is complete, check the latch and button operation before closing the armrest.
