SERVICE PROGRAM BULLETIN

APPLICABILITY: 2026MY Forester **NUMBER:** WRH-25
SUBJECT: Rear Door Latch & Actuator Assy Replacement **DATE:** 01/15/26

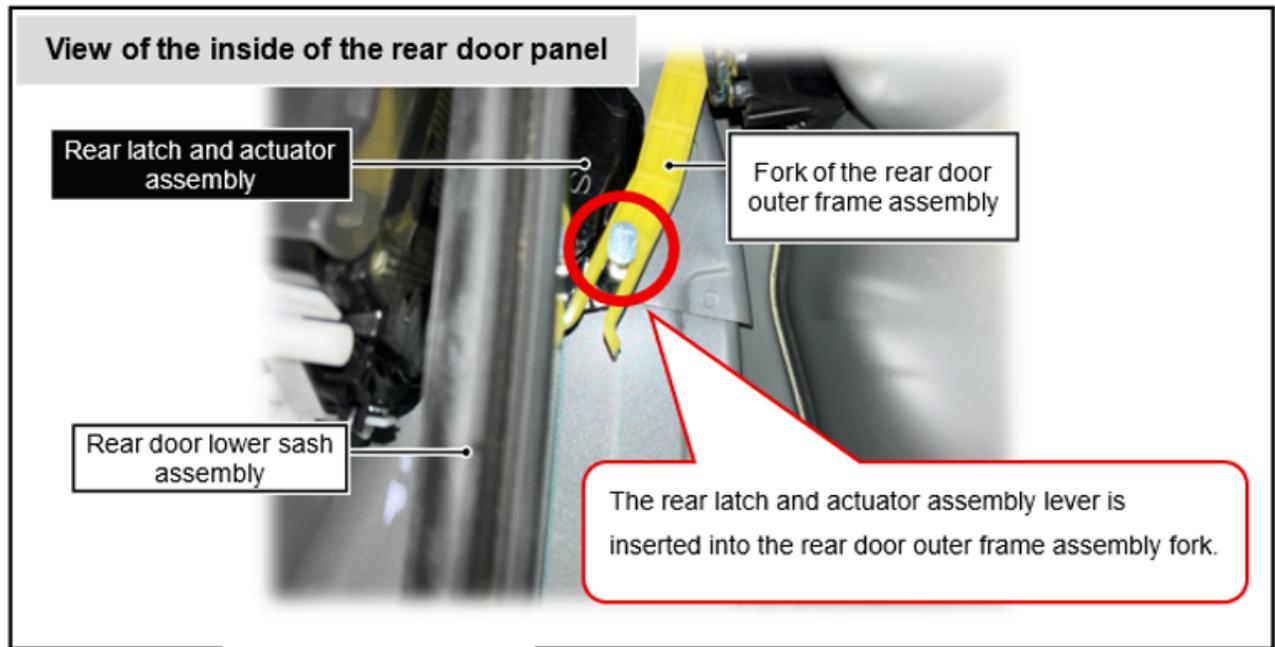
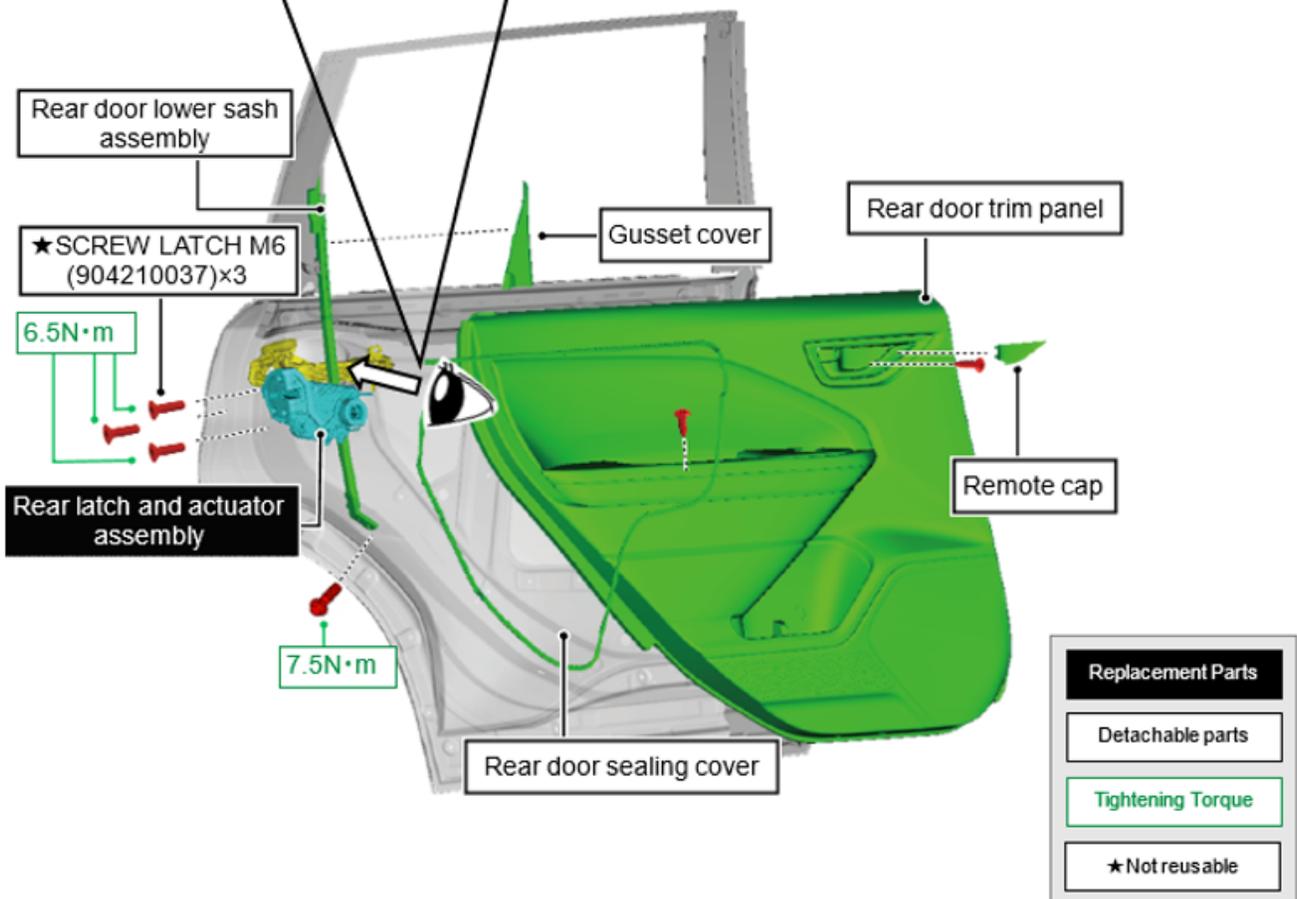
COMPONENT CONFIGURATION:

Damage to the micro switch in the door latch used for detecting the rear door lock status may lead to incorrect detection of the rear door lock status. In this condition, the Key lock-in prevention function, the PIN Code Access registration, and the welcome lighting function may not operate correctly.

Subaru retailers will replace the right-hand and left-hand rear door latch and actuator assemblies at no cost to the customer.
