**SERVICE BULLETIN**

**APPLICABILITY:** 23-25MY Outback/Legacy Models (including Wilderness models)  
 23-25MY Ascent Models  
 24-26MY Impreza  
 24-26MY Crosstrek (including Wilderness models)  
 24-25MY WRX  
 25-26MY Forester  
 26MY Forester Wilderness

**NUMBER:** 15-305-22R  
**DATE:** 11/15/22  
**REVISED:** 01/20/26

**SUBJECT:** Reprogramming File Availability for Optimization of Gen 4.5 Denso CP1.5 Infotainment Systems

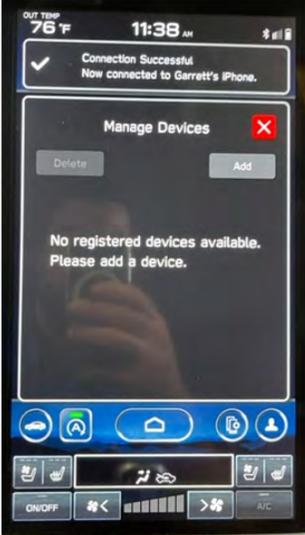
Number	Category	Symptoms to be Improved:
6	Display	<p>The registered mobile device information is not displayed on the Manage Devices screen.            (This occurs when the name or device ID of a mobile device contains a character code that cannot be displayed.)            (only applicable to HIGH and MID trim)</p>

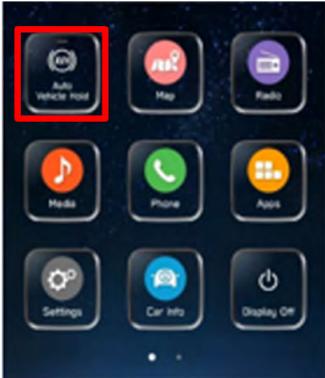
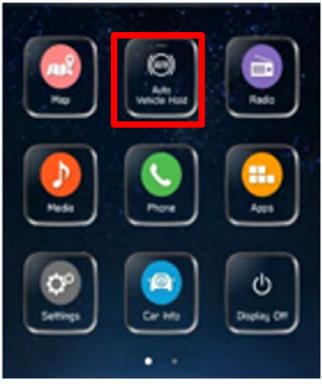
Number	Category	Symptoms to be Improved:
6	Display	<p>The AVH icons on the HOME screen are initially lined up next to the Valet-Mode icon. However, in some cases they are placed at the top (upper left corner of the first page) or next to the MAP icon. (only applicable to HIGH and MID trim)</p> <div style="display: flex; justify-content: space-around; align-items: center;">

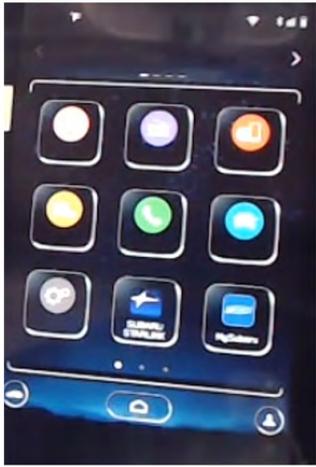
</div> <p>After switching the clock function to AUTO, the CID screen display may become distorted. (only applicable to HIGH and MID trim)</p> <div style="text-align: center;">

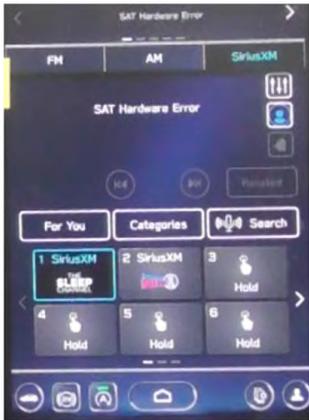
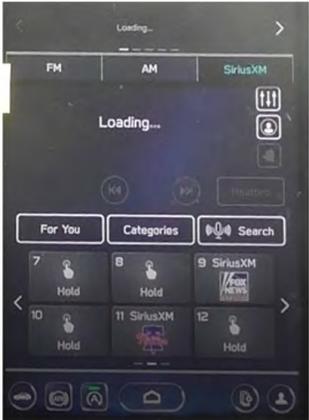
</div> <p>It may take excessive time to start the CID screen after ignition on.</p>
7	SXM	<p>The first time ignition on after the CCU software update added the SXM360 functionality, the SXM playback screen may remain at “Loading...” after the CCU software update.</p> <div style="display: flex; align-items: center; justify-content: center;"> <div style="text-align: center;">

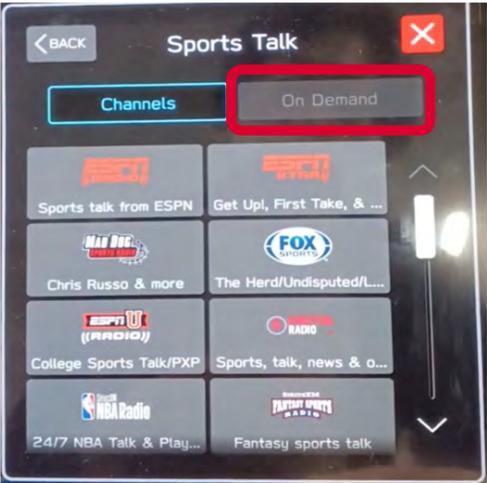
Number	Category	Symptoms to be Improved:
7	SXM	<p>In the SXM screen, the On Demand button in the upper right corner is grayed out and cannot be operated in the Sports→ Sports Talk screen. (only applicable to HIGH and MID trim)</p>

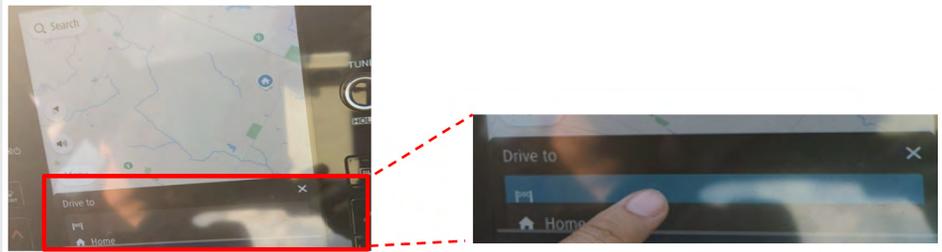
8	Navi	<p>After booting, the Map screen may not appear even if the Map icon on the Home screen is pressed. (only applicable to HIGH trim)</p> <p>Three destination suggestion displays in the navigation system are sometimes displayed overlapping each other. Originally, up to three destination suggestions are displayed at the bottom of the screen when the navigation system is started. (only applicable to HIGH trim)</p>

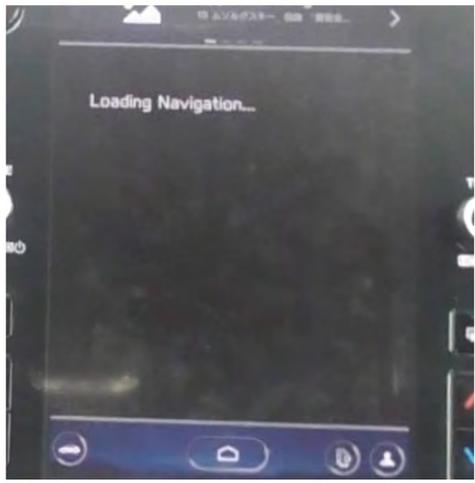
Number	Category	Symptoms to be Improved:
8	Navi	<p>When turning ignition off and on while the Map screen is displayed, the message ""Loading Navigation..."" may remain on the screen, and the Map screen may not be displayed. (only applicable to HIGH trim)</p>

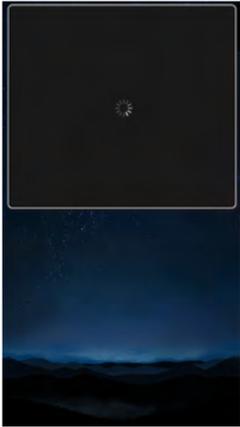
<p>After engine starts, only the black frame of the Caution screen display may remain on the CID screen. The rear view camera can be displayed by shifting to shift R.</p>

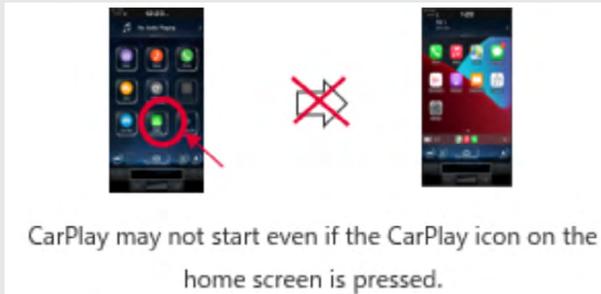
<ul style="list-style-type: none"> <li>- When starting the engine with the iPhone connected via USB, CarPlay may not start even if the CarPlay icon on the home screen is pressed. (This can be resolved by reinserting the USB cable.)</li> </ul> <div data-bbox="696 1482 1297 1776" style="text-align: center;">

<p>CarPlay may not start even if the CarPlay icon on the home screen is pressed.</p> </div>		
<ul style="list-style-type: none"> <li>- When WirelessCarPlay is disconnected due to radio interference, we have incorporated improvements to avoid radio interference and make it easier to reconnect (not applicable to BASE trim)</li> </ul>

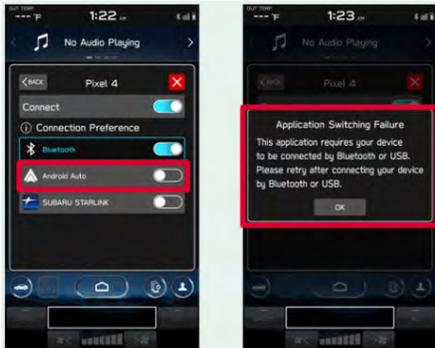
<p>- When you toggle on Android Auto from the Manage Device screen in CID while the Android device is not connected via USB, there may be a failure to start Wireless Android Auto (not applicable to BASE trim)</p>

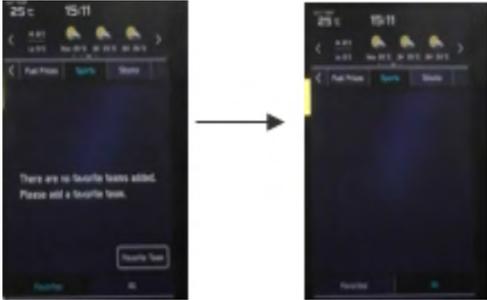
Number	Category	Symptoms to be Improved:
9	SXM	<p>- When performing the operation to delete SXM viewing history under a certain 'Driver Profile' state, it may result in the deletion of SXM viewing history recorded under a different 'Driver Profile' (not applicable to WRX)</p> <p>- When repeatedly switching radio preset channels using the steering wheel switch, the previous preset channel may play back and the highlight on the radio preset button disappears. Alternatively, preset channel switching via the steering wheel switch might become temporarily unavailable after a certain period (not applicable to WRX).</p> <p>- Immediately after starting the engine and navigating to the SXM screen, various SXM functions are not working. Playback channel information is not displayed on the screen. Button operations are unresponsive. SXM audio is not playing (not applicable to WRX).</p> <p>- When pressing the ""All"" tab on the TravelLink Sports screen, a blank tab screen is displayed. To navigate to the ""LPGA"" within the ""Sport""/ ""Golf"" category, you need to press it twice (not applicable to WRX).</p>

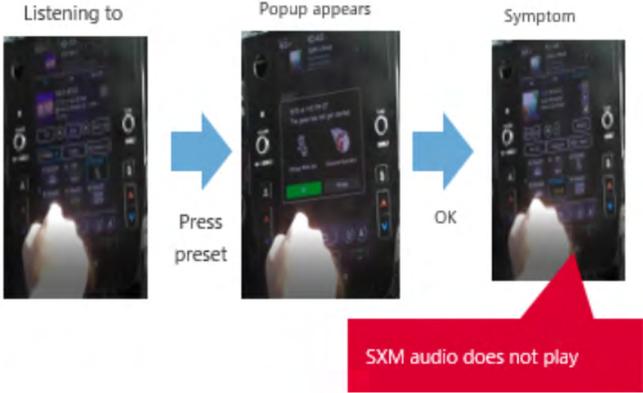
<p>- While listening to the radio (FM/AM) and attempting to select a sports team channel (SXM channel) from the presets, if the chosen team has a scheduled game on that day but it hasn't started yet a popup screen displaying the game schedule appears. However, after the popup screen appears, the system returns to the previously played channel, and the SXM audio does not play (not applicable to WRX).</p>

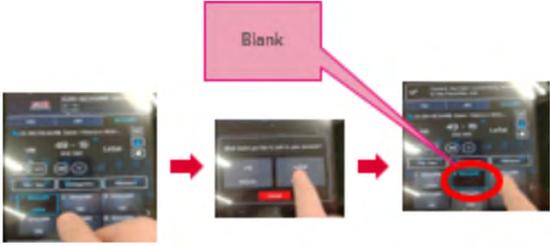
<p>- When registering SXM sports team channels to the radio preset buttons if a team for which logo image cannot be captured is registered, the channel short name will not be displayed on the registered button and the button will be blank (not applicable to BASE trim)</p>

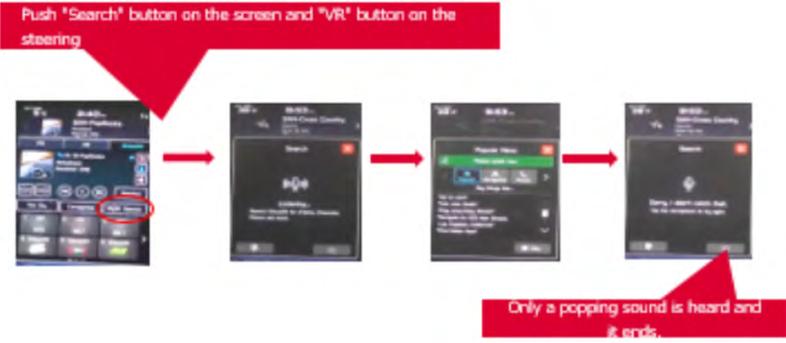
<p>- The voice recognition function encounters an error and ends, when initiating the SXM Search feature simultaneously with the activation of the CCU unit's voice recognition</p>

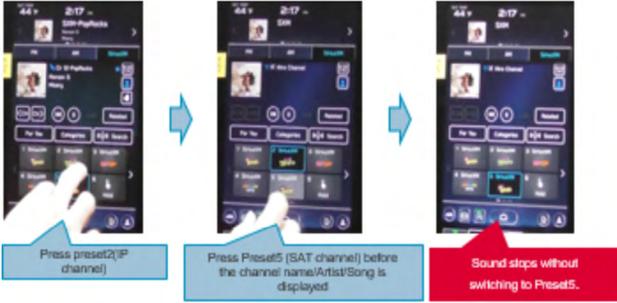
Number	Category	Symptoms to be Improved:
9	SXM	<p data-bbox="500 157 1490 262">- When switching to the SAT channel (satellite channel) immediately after selecting the IP channel (Internet channel) on the SXM360, song information is not displayed and audio playback stops (not applicable to BASE trim)</p> <div data-bbox="690 268 1307 571" style="text-align: center;">

<p data-bbox="690 514 852 556">Press preset2(IP channel)</p> <p data-bbox="868 514 1112 556">Press Preset5 (SAT channel) before the channel name/Artist/Song is displayed</p> <p data-bbox="1128 514 1307 556">Sound stops without switching to Preset5.</p> </div> <p data-bbox="500 588 1490 735">- If the ignition-off/on operation is performed quickly immediately after ignition-on, the previously viewed channel in SXM may not start playing automatically (It will play by switching the audio source) (not applicable to BASE trim)</p> <p data-bbox="500 745 1490 850">- When the contract status is Demo, "Your Trial Expires in 0 Days" is displayed on the SXM Setting screen. The display will be removed when the contract status is Demo (not applicable to BASE trim)</p> <div data-bbox="885 861 1112 1123" style="text-align: center;">

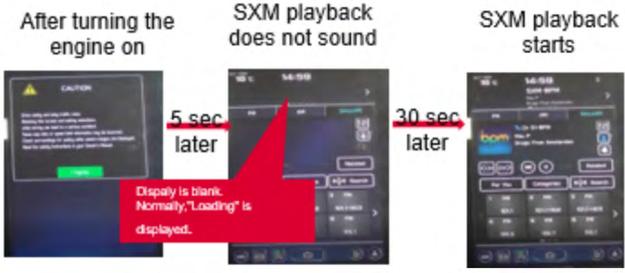
<p data-bbox="852 1249 982 1291">Wrong</p> <p data-bbox="1209 1260 1339 1302">Correct</p> </div> <p data-bbox="500 1396 1490 1543">- Registering a channel with blank information in presets results in a preset button with a blank label, and the channel logo is not displayed. Additionally, pressing the preset button with the blank label does not initiate playback of the channel.</p> <p data-bbox="500 1554 1490 1669">- After turning the engine on, "Loading" should appear on the channel information screen until SXM playback starts, but it does not appear and remains blank</p> <div data-bbox="690 1669 1315 1942" style="text-align: center;">

<p data-bbox="706 1669 868 1732">After turning the engine on</p> <p data-bbox="917 1669 1079 1732">SXM playback does not sound</p> <p data-bbox="1161 1669 1323 1732">SXM playback starts</p> <p data-bbox="852 1774 917 1816">5 sec later</p> <p data-bbox="1096 1774 1161 1816">30 sec later</p> <p data-bbox="820 1848 998 1911">Display is blank. Normally, "Loading" is displayed.</p> </div>

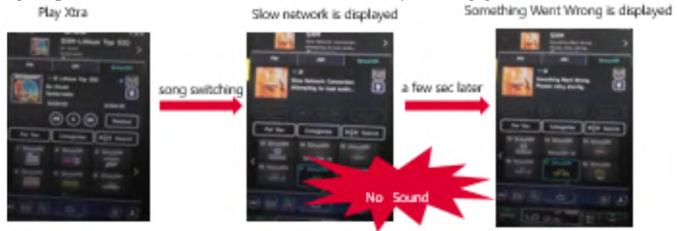
Number	Category	Symptoms to be Improved:
9	SXM	<p>- SXM sound stops sounding after conditions listed below:</p> <ol style="list-style-type: none"> <li>1. Register FM station A, an SXM sports channel that is not in the middle of a game, and FM station B in the order in which they are listed in the radio presets.</li> <li>2. Use the steering wheel switch to switch from FM station A to FM station B, skipping the SXM sports channel that is not in the middle of a game.</li> <li>3. Just before the playback of FM station B starts, operate the steering switch seek to return to the previous channel.</li> </ol> <p>- While playing SXM's Xtra channel, "Slow Network" --&gt; "Something Went Wrong" is displayed and no sound is heard (not applicable to BASE trim)</p>

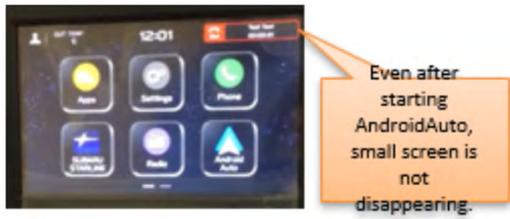
Number	Category	Symptoms to be Improved:
11	Display Appearance	<p>- The call screen reduction appears in the Status Bar while connected to Android Auto. Originally, when Android Auto is activated during a hands-free call, the call screen reduction should disappear (only applicable to BASE trim).</p>

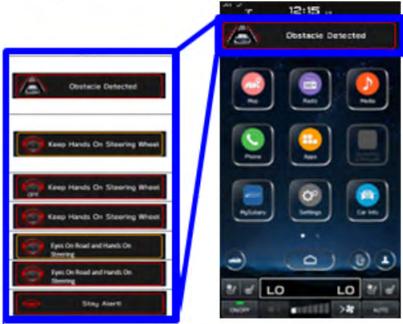
<p>- If the language setting of the CID is changed while an alarm message by the Driver Monitoring System(DMS) is displayed on the CID, the alarm will be hidden (not applicable to BASE trim)</p>

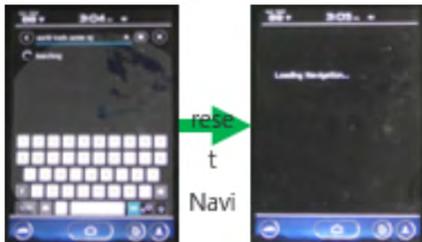
12	Touch Operation	<p>- Suddenly, the touch screen on the CID (Central Information Display) becomes unresponsive, even though the screen display remains normal. (not applicable to WRX)</p> <p>- CID doesn't respond to touch (The screen is displayed and sound is played, but only the operations are not available)</p>
13	Navi Operation	<p>- When repeatedly entering text on the destination search screen, the screen may freeze, and the navigation application restarts (only applicable to HIGH trim)</p> <div style="text-align: center;">

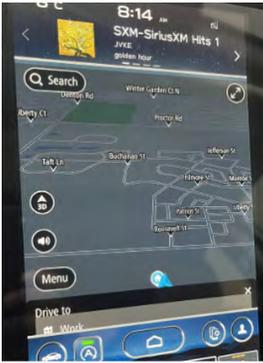
<p>- In the navigation screen, the bottom of the destination suggestion list's popup screen is cut off and not fully displayed (only applicable to HIGH trim)</p>

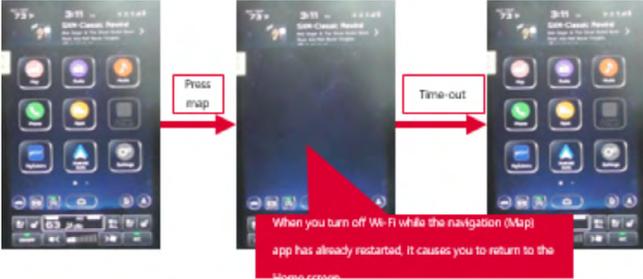
Number	Category	Symptoms to be Improved:
13	<b>Navi Operation</b>	<p>- During map data updates, if you switch off the Wi-Fi function from the Settings screen pressing the Map icon on the Home screen doesn't display the Map screen for a while (only applicable to HIGH trim)</p> <div style="text-align: center;">

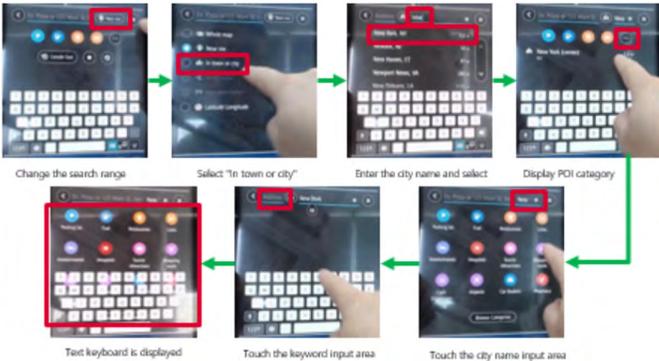
</div> <p>- Even when pressing the Map icon the map does not appear and it remains stuck on the 'Loading Navigation' message. This issue occurs due to a corrupted file that stores settings and destination history (only applicable to HIGH trim).</p> <p>- The text keyboard which should not be displayed appears on top of the list of POI categories (only applicable to HIGH trim) when performing the steps below:</p> <ol style="list-style-type: none"> <li>Narrowing down the search range within a specific city in the navigation destination search.</li> <li>Move to the POI category screen.</li> <li>Touch the city name input area, then the keyword input area, in that order.</li> </ol> <div style="text-align: center;">

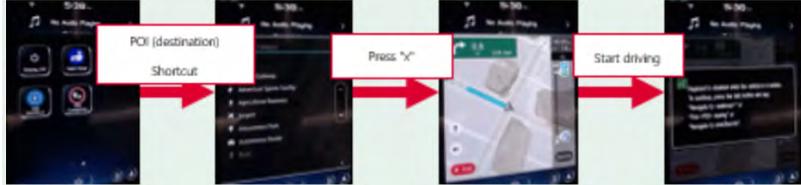
Number	Category	Symptoms to be Improved:
13	Navi Operation	<p>- "Keyboard is disable while the vehile is in motion"" is displayed on the screen when performing the steps below (only applicable to HIGH trim) :</p> <ol style="list-style-type: none"> <li>1. Press the POI (destination) Shortcut on the home screen to display the list of destinations.</li> <li>2. Press "x" to clear the list.</li> <li>3. Start driving with the Map screen displayed.</li> </ol>

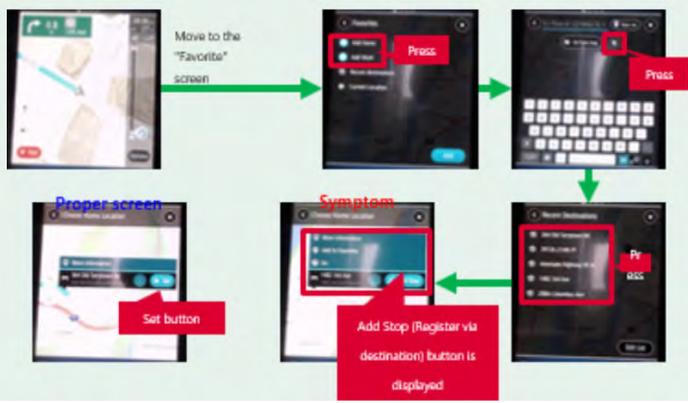
<p>- Add Stop (Register via destination) button is displayed instead of Set button and Favorite registration for Home/Work cannot be done after performing the steps below moving to the ""Favorite"" screen with the navigation destination set (only applicable to HIGH trim) :</p> <ol style="list-style-type: none"> <li>1. Press Add Home/Work</li> <li>2. Select a location from the Destination History screen</li> </ol>

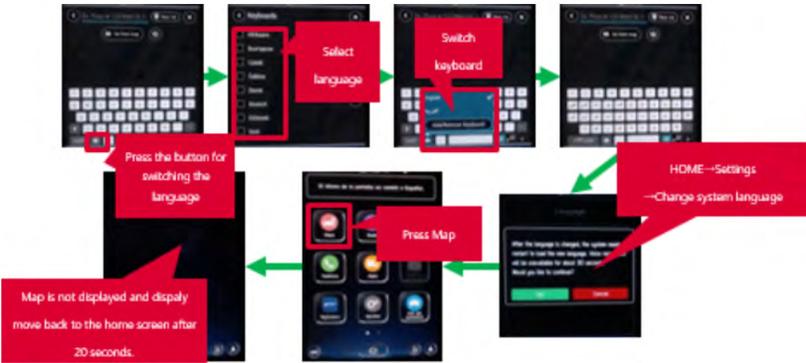
<p>- Map is not displayed when Map is pressed from the home screen if switching the language used for the text input keyboard on the search screen of the navigation application (only applicable to HIGH trim)</p>

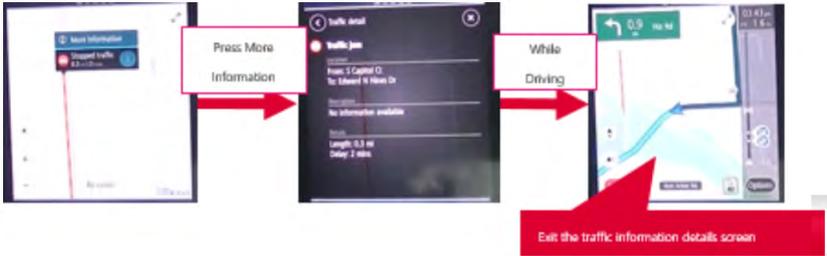
</div> </div> <p>- When using voice recognition to search for a destination based on a Point of Interest (POI) category name (such as "gas station"), the search results may display facilities that have names partially matching the POI category name in addition to the facilities within that specific category (only applicable to HIGH trim)</p> <p>- While parked or driving, touch the traffic information icon on the map or the traffic information icon on the route bar and display the traffic information details screen. If you start driving with this screen displayed, it will exit the traffic information details screen and transitions back to the map screen (only applicable to HIGH trim)</p> <div style="text-align: center;">

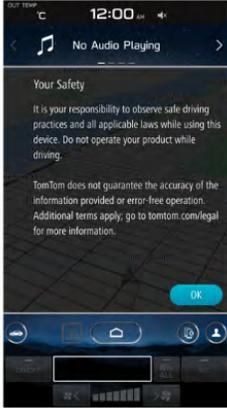
Number	Category	Symptoms to be Improved:
13	<b>Navi Operation</b>	<p>- The requirement to press ""OK"" on the Your Safety screen during the initial navigation launch sometimes wasn't displayed (only applicable to HIGH trim).</p> <p>Before the change: If the navigation app was launched for the first time from any icon other than the Map icon on the Home screen (e.g., through a rest suggestion feature) the Your Safety screen would not appear and navigation functionality could not be initiated.</p> <p>After the change: Even if the navigation app is launched for the first time from an icon other than the Map icon on the Home screen, the Your Safety screen will be displayed.</p>

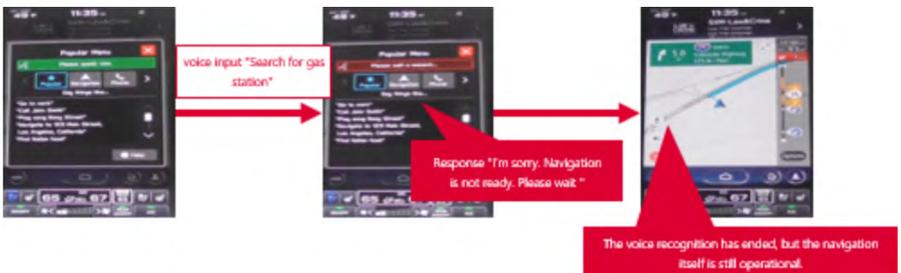
<p>- When searching for navigation POIs using voice recognition, the response is "Navigation is not ready" and POI search may not start (only applicable to HIGH trim)</p>

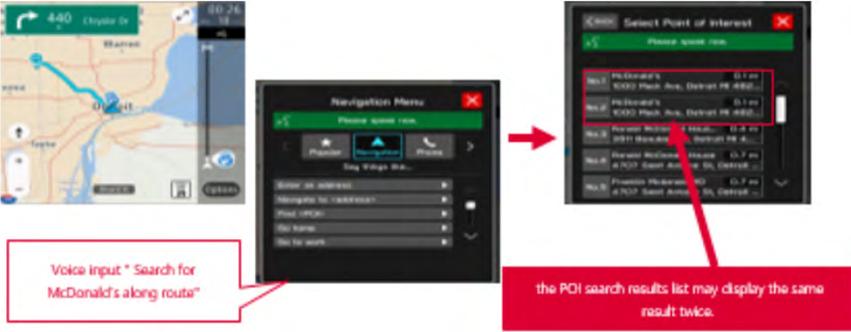
Number	Category	Symptoms to be Improved:
13	Navi Operation	<p>- When using voice recognition during navigation to say 'Search for **** along route,' the POI search results list may display the same result twice (only applicable to HIGH trim)</p>

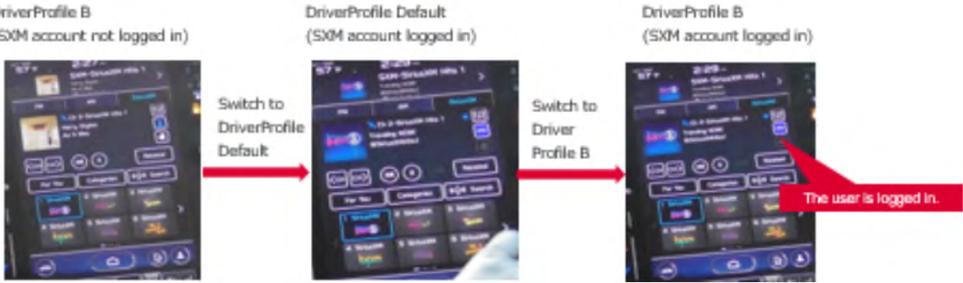
<ul style="list-style-type: none"> <li>- Switching the Driver Profile user causes the user to be logged into SXM even though he/she was not logged into the SXM account as the user after the switch</li> </ul>

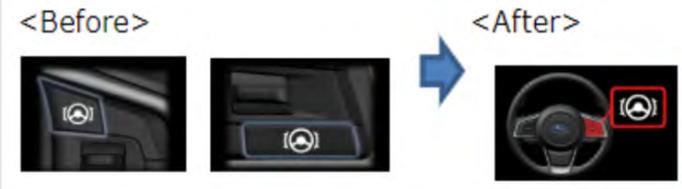
Number	Category	Symptoms to be Improved:
22	Meter Display	<p>- Change the image of steering switch in the meter interrupt screen from individual zoomed images to an image of the entire steering wheel and the symbol (not applicable to WRX)</p> <p>Previously: different switch images were used depending on the model line and equipment grade.</p> <p>After: a common image is used regardless of the model or the grade.</p>

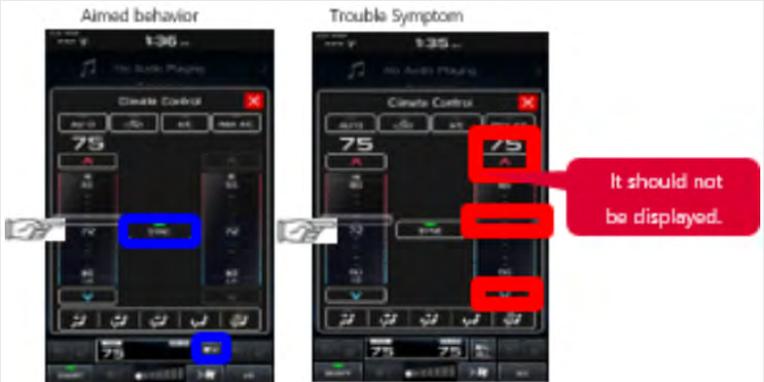
<p>- In the maintenance schedule settings screen despite setting a date the configured date is not displayed and is replaced with hyphens (not applicable to WRX)</p>
24	Air Conditioner	<p>- With the air conditioning SYNC enabled and the single-seat focus set to the driver's seat tapping the temperature adjustment bar on the driver's side unexpectedly displays the temperature adjustment bar for the passenger's side, which should not be displayed (only applicable to BASE trim)</p>

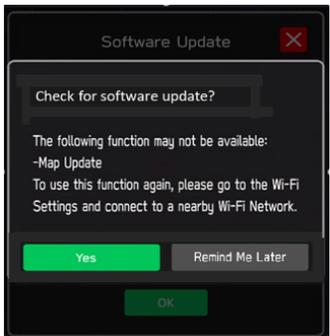
Number	Category	Symptoms to be Improved:
26	Software Update	<p>- To use FOTA (Firmware update Over The Air) for CCU software update via DCM (Data Communication Module) it is necessary to switch from the Wi-Fi communication settings for MapUpdate to the DCM communication settings. To notify the customer about this switching, the below message screen pops up a new CCU software becomes available from the server. (not applicable to BASE trim)</p>

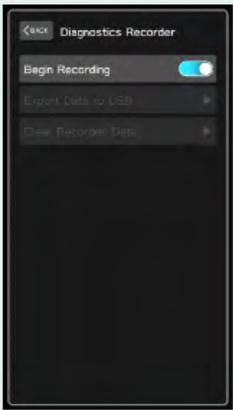
10	<p>Update against vulnerability in security of Bluetooth connection.</p>
11	<p>When getting CCU USB logs at the Diagnostics Recorder screen in the Dealership Mode, it was necessary to turn off "Begin Recording" to "Export Data to USB." And after the log acquisition, it was necessary to turn "Begin Recording" ON again. The system interface is improved so that "Begin Recording" is automatically switched ON after log acquisition has been accomplished.</p> <div data-bbox="786 1524 1019 1934" style="text-align: center;">

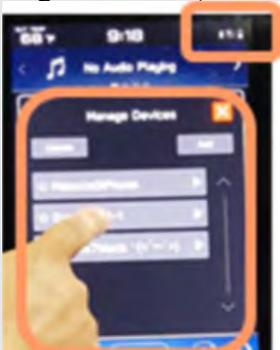
Number	Symptoms to be Improved:
1	CID goes black and does not accept any control.
2	Audio playing while CID shows black display
3	CID reboots.
4	“Manage Devices” is grayed out and cannot establish Bluetooth connection.
5	When the Bluetooth connection is cancelled manually on the mobile phone side during hands-free calling, the Bluetooth connection is disabled for that particular mobile phone. Even when it occurs, the connection can be reestablished by deleting the device in “Manage Devices” and register the device again by adding operation.
6	Bluetooth connection fails against the device that was paired before and “Manage Devices” is grayed out.
7	<p>Bluetooth connection is disabled with a discrepancy in the display of status bar (showing Bluetooth devices being connected) and the “Manage Devices” screen (showing no Bluetooth devices being connected.)</p>

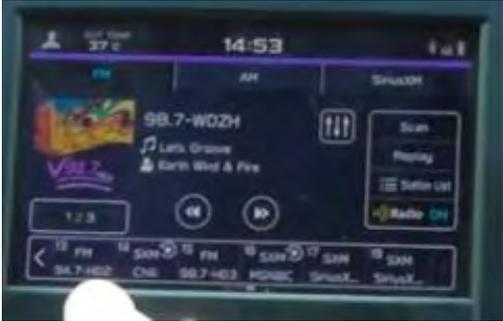
Number	Symptoms to be Improved:
8	Android Auto Wireless (AAW) cannot be connected.
9	Android Auto Wireless (AAW) cannot be started from “Manage Devices” Screen.
10	Sound volume control does not work while using Android Auto. It is caused by data communication error between Android device and CCU.
11	Cyclic short noise like a drilling or vibration is heard from speakers.
12	<p>Sound is lost when changed to Subchannel 2 right after a preset HD radio channel has been selected.</p>

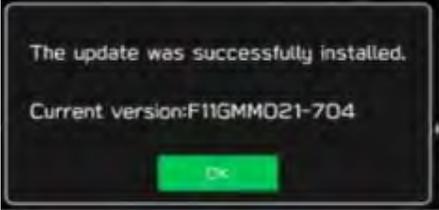
13	After the destination is set on Navi screen, voice recognition command of “Find <POI category> along route” is made, search results are not given in order of distance.
14	When “Call” button is pressed in “Confirm Destination” screen of Navigation system (to call the destination site,) the call can be made but the screen does not transit to phone call screen.
15	<p>Popup of “The update was successfully installed” is not displayed after reboot (IG-OFF and ON) operation of FOTA (Firmware Over The Air) update.</p>

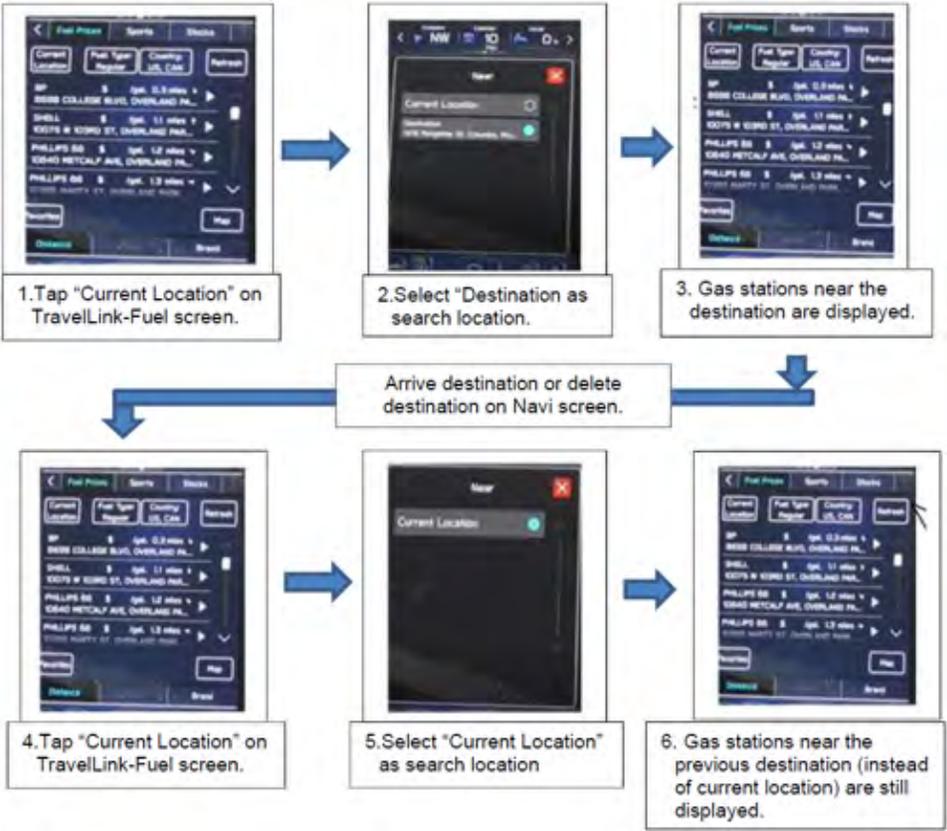
Number	Symptoms to be Improved:										
17	<p>A wrong search location is used on TravelLink function. Example of the symptom.</p>

<p>1. Tap "Current Location" on TravelLink-Fuel screen.</p> <p>2. Select "Destination as search location."</p> <p>3. Gas stations near the destination are displayed.</p> <p>Arrive destination or delete destination on Navi screen.</p> <p>4. Tap "Current Location" on TravelLink-Fuel screen.</p> <p>5. Select "Current Location" as search location</p> <p>6. Gas stations near the previous destination (instead of current location) are still displayed.</p>										
18	<p>Music cannot be played sequentially when they are stored in different folders in a USB memory. The specifications are improved to enable music in different folders to be played sequentially.</p>										
19	<p>"Repeat All" is added as one of the play modes.</p>

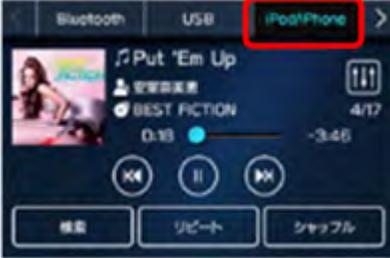
Number	Symptoms to be Improved:
1	<p>iPod/iPhone tab in Media screen cannot be selected, when connected by USB.</p> <p>The symptom occurs when the iPhone is connected to CP1.5 via Bluetooth in parallel to USB connection by error. (It is supposed to be connected either via Bluetooth or by USB.)</p>

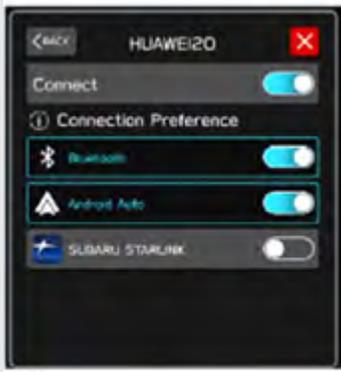
2	<p>On the “Manage Devices” screen Bluetooth cannot be selected as connection preference.</p>

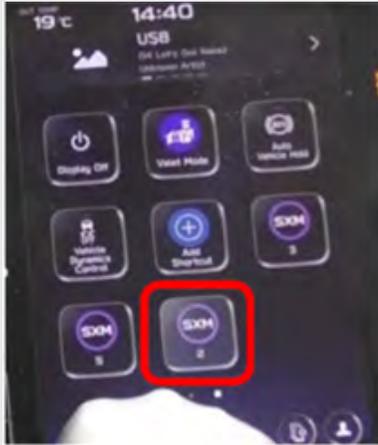
Number	Symptoms to be Improved:
6	<p>SXM station shortcut created by the customer does not work when the SXM has not been used as audio source after the Ignition Switch was turned on in the ignition cycle.</p>

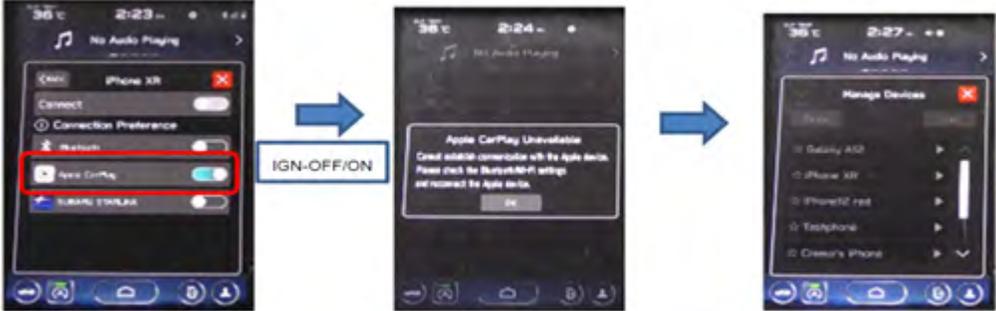
7	<p>Manage Device Screen becomes dark and inoperative when Ignition Switch is turned Off and On while starting CarPlay by CID operation.</p>

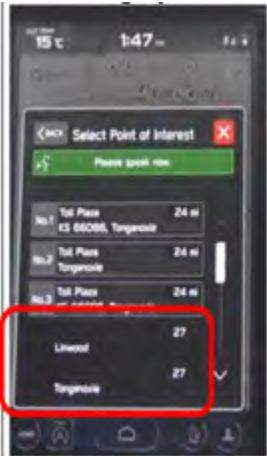
8	<p>Cannot connect to CarPlay via wireless connection. This symptom possibly occurs after the Ignition Switch was turned Off and On abruptly.</p>
9	<p>POI Search Result shows only city names and distances (without unit) when voice recognition POI search with Category name like “Find toll gate” is used.</p>

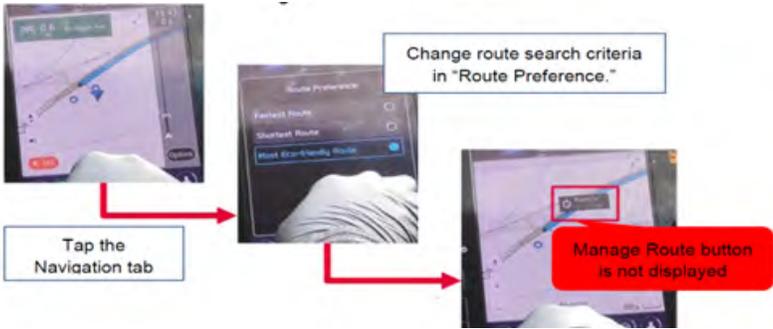
Number	Symptoms to be Improved:
10	Navigation restarts itself, when the letters are rashly entered or deleted using keyboard function to search destination.
11	<p>“Manage Route” button is not displayed when touching the route line on Navigation system, when the route search criteria got changed in the Route Preference Screen after a route had been searched.</p>

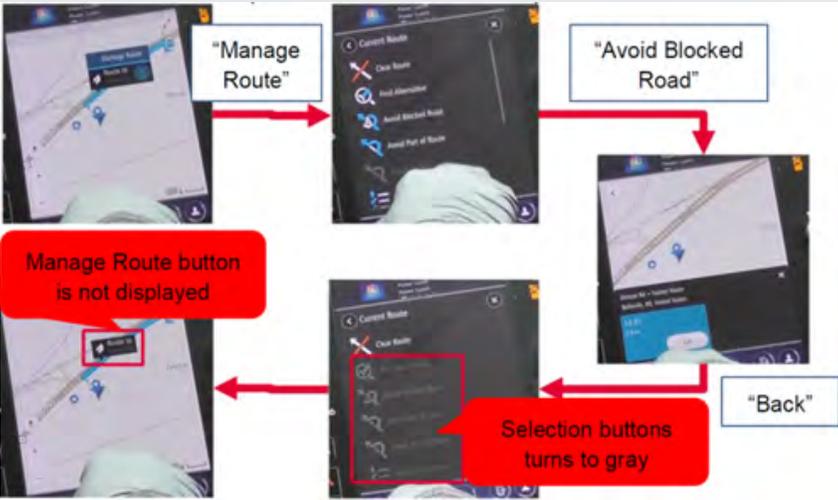
12	<p>“Manage Route” button is not displayed and buttons on the Current Route Screen become unselectable (turns to grayish fill) when the Navigation system is operated in the sequence of “Manage Route” &gt; “Avoid Blocked Road” (in the Current Route Screen) &gt; “Back.”</p>

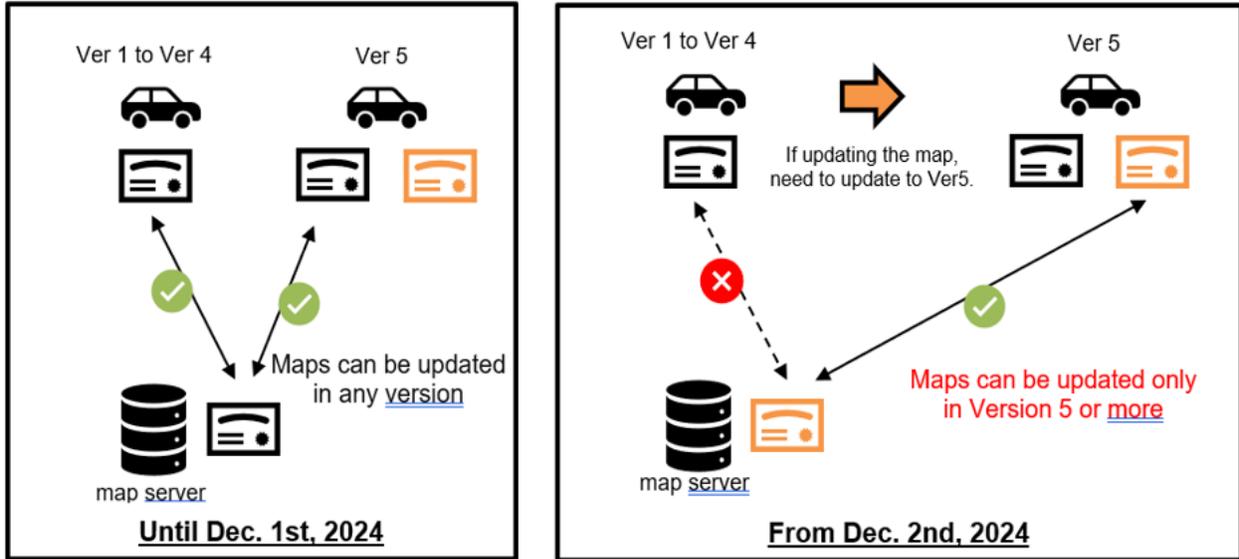
**IMPORTANT NOTE:** The certificate of the data distribution server for the map update service by Map OTA (MOTA) will be changed **from Dec 1<sup>st</sup>, 2024**, and the previous server certificate will no longer be eligible after **2<sup>nd</sup> December, 2024**. To get the MOTA service on and **after Dec 2<sup>nd</sup>, 2024, Ver. 5 software that includes new server certificate should be installed in advance.**
