Technical Service Bulletin

Subject: WRINKLES ON LEATHER SEAT SURFACE OF NEW (UNSOLD) VEHICLE OR ON NEW UPHOLSTERY UNDER WARRANTY REPAIR	Bulletin No.: 09-001/26
	Last Issued : 01/06/2026

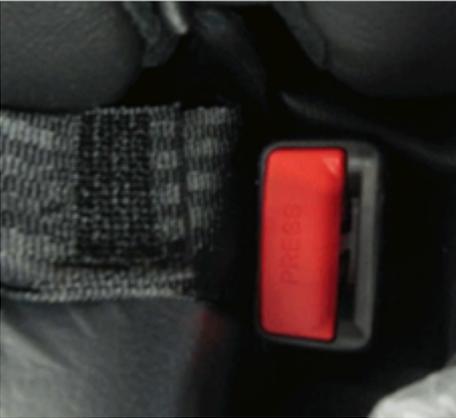
- **DO NOT** keep the iron in the same area for a long time. Doing so could damage the seat surface, as shown below.
- **DO NOT** run the iron without a water-soaked cloth, especially over the seat trim beading and seat side trim areas.

Damaged seat side trim

Damaged seat trim beading
