Check engine light active - Fault P3007F1, P3007F2, P300CA8, or P300CA9 present in CDI control unit

Topic number	LI14.30-N-075882
Version	7
Function group	14.30 - Secondary air injection
Date	1/23/26
Validity	Model 907 with engine 654
Reason for change	Complaint update

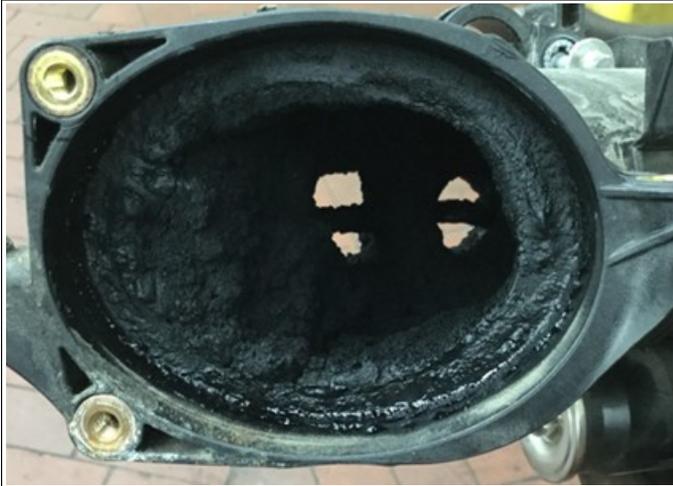
[Saugrohr_Intake_manifold_II.jpg](#)

- Inspect the charge air distribution line (intake manifold) for carbon buildup.
- Inspect the following (especially for P300CA9, but advisable for thoroughness):
- High-pressure EGR valve
- High-pressure EGR cooler (A6541409000)
- EGR pipe (A6541400702)
- Charge air mixing pipe (A6540902000) and intake manifold (charge air distribution line)
- Housing intermediate flange (A6541407000)
- Exhaust back pressure sensor area
- Check all for carbonization, consistency, and proper installation. If any significant issues are found, perform necessary cleaning or repair measures.
