Technical Service Bulletin

Topic	Window Drop Glass Operation Continental GT/GTC 25-26MY
Market area	Bentley: worldwide (2WBE),China 796 VW Import Comp. Ltd (Vico), Beijing (6796)
Brand	Bentley
Transaction No.	2080372/1
Level	EH
Status	Released for publishing
Release date	Jan 20, 2026

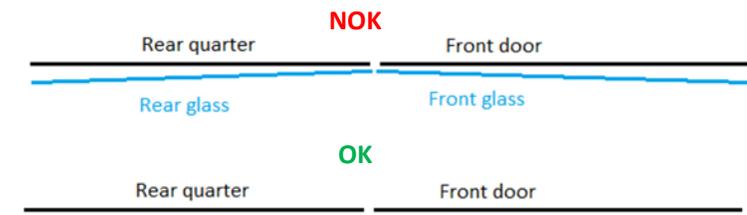
See image below, for OK and NOK after adjustment/checking

Repair Group 64 'Slide glass checking and adjusting'

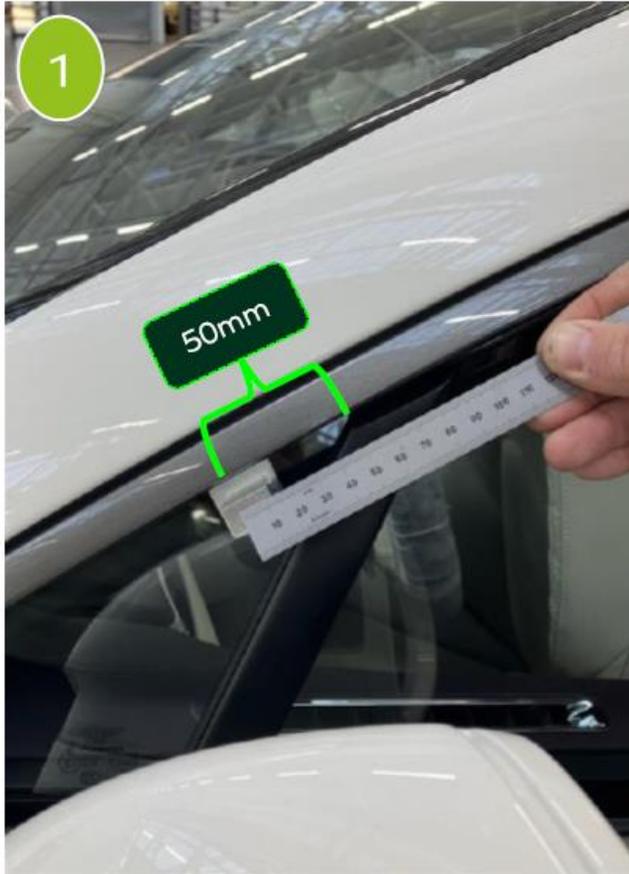
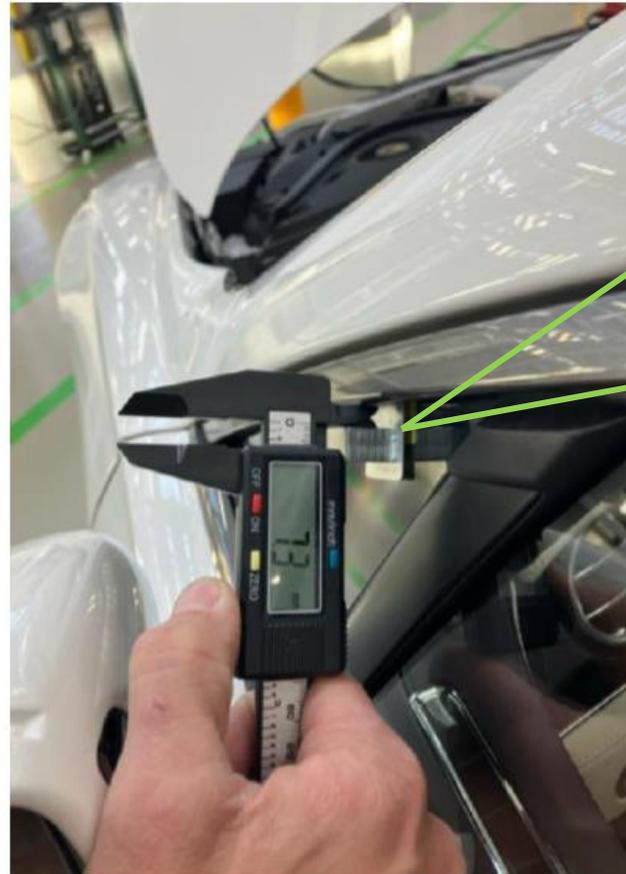
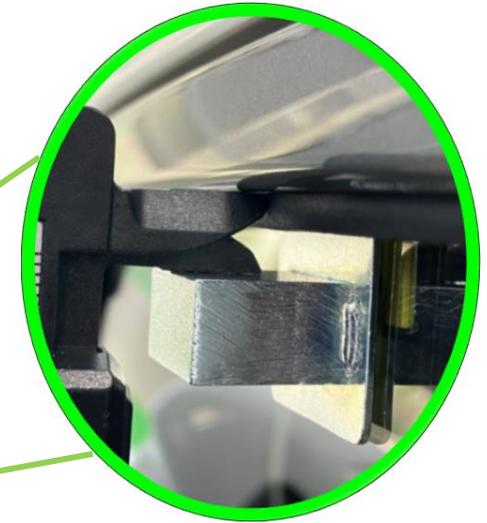
INTERLOCK POINT 1

Specification
7.5mm \pm 1mm
(Interlock Tool WT10549/1)
If the measurement is out of specification refer to ElsaPro Repair Group 64 'Front door quarter glass – To adjust'

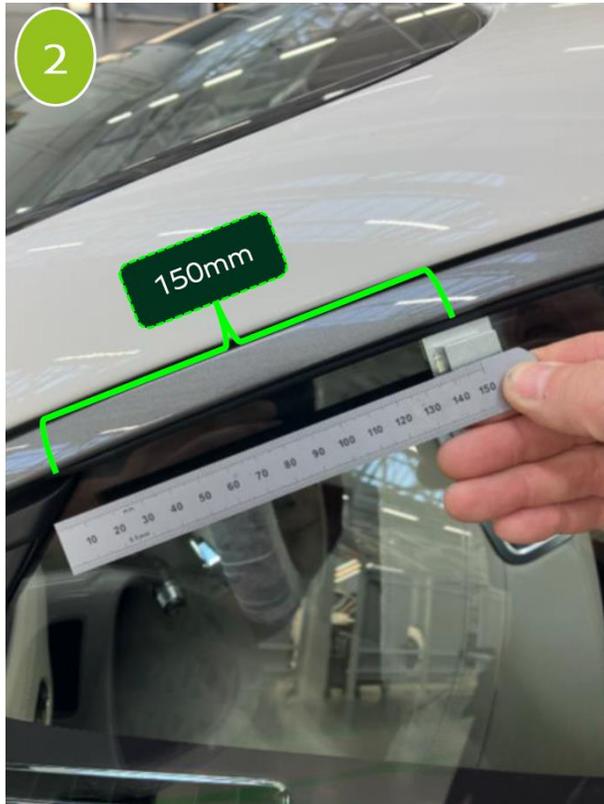
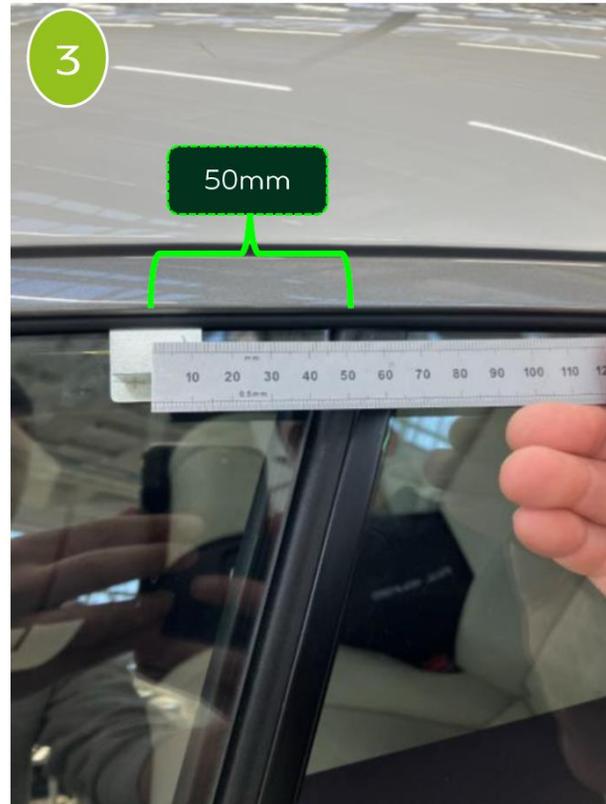
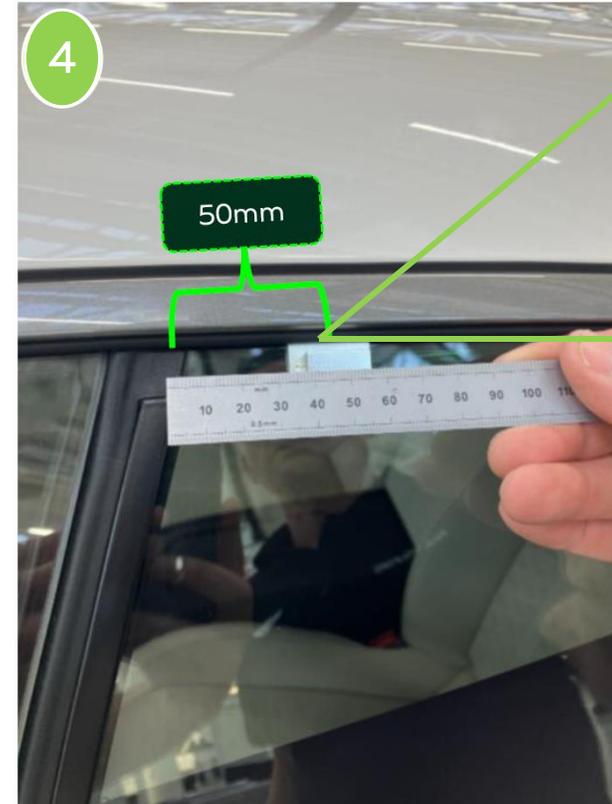
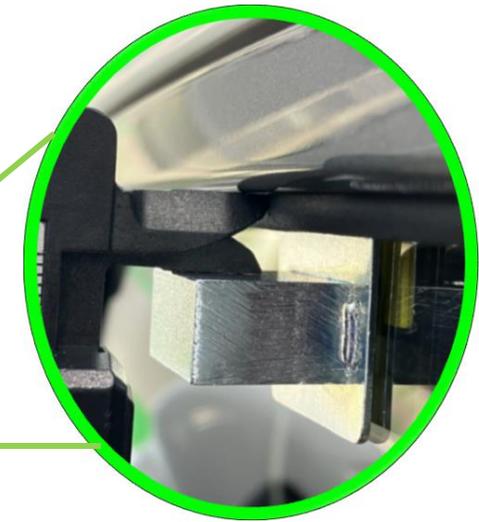
INTERLOCK POINTS 2, 3, 4

Specification
8mm ± 1mm
(Interlock Tool WT10549)

If the measurement is out of specification refer to ElsaPro

Repair Group 64 'Slide glass checking and adjusting'

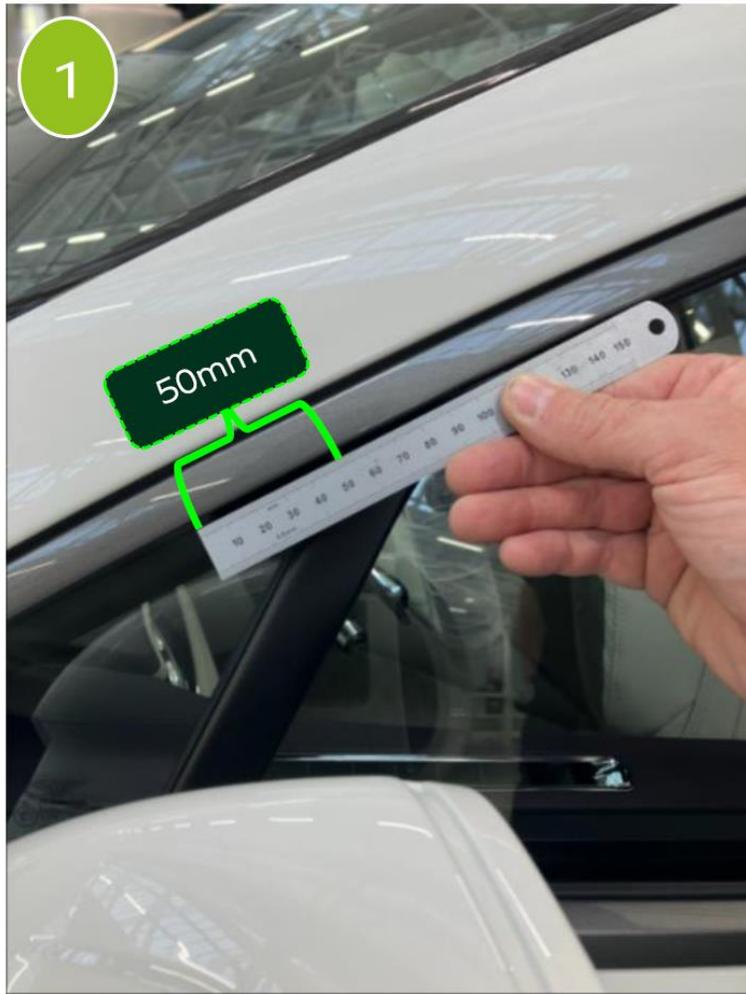
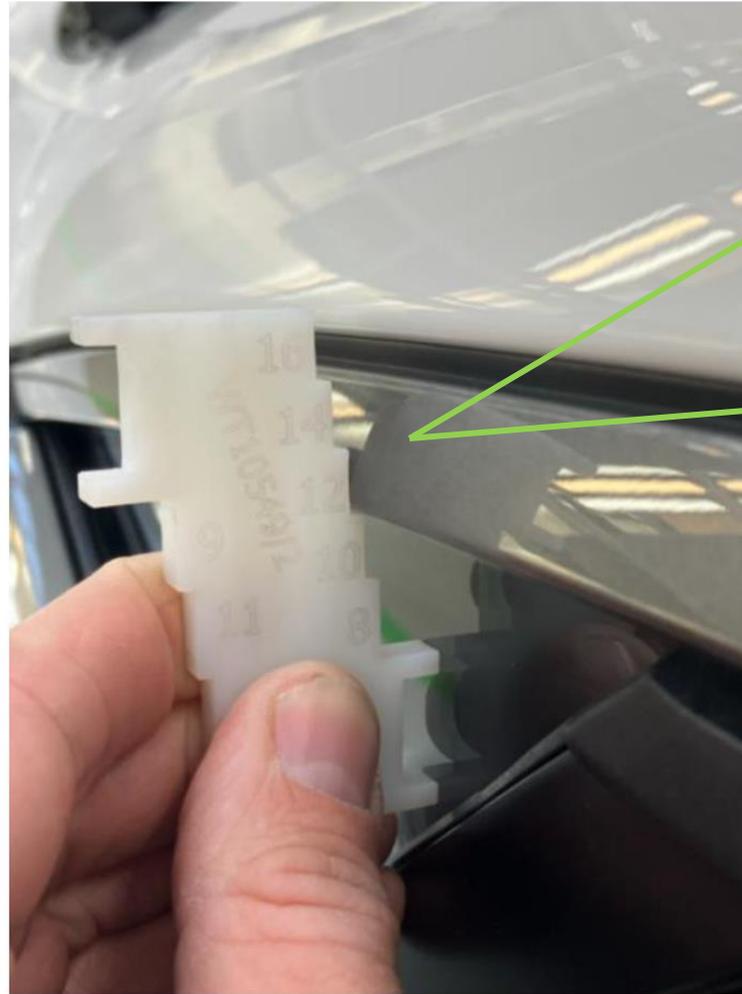
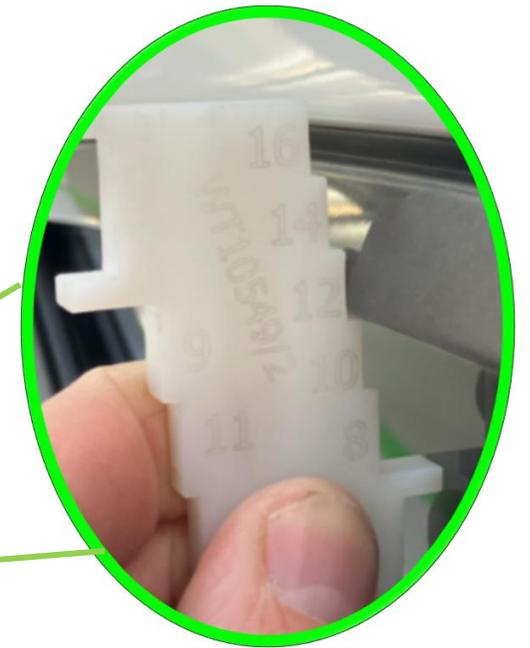
PROFILE POINT 1

Specification
10mm ± 1mm
(Profile Tool WT10549/2)

If the measurement is
out of specification refer
to ElsaPro

**Repair Group 64 'Slide
glass checking and
adjusting'**

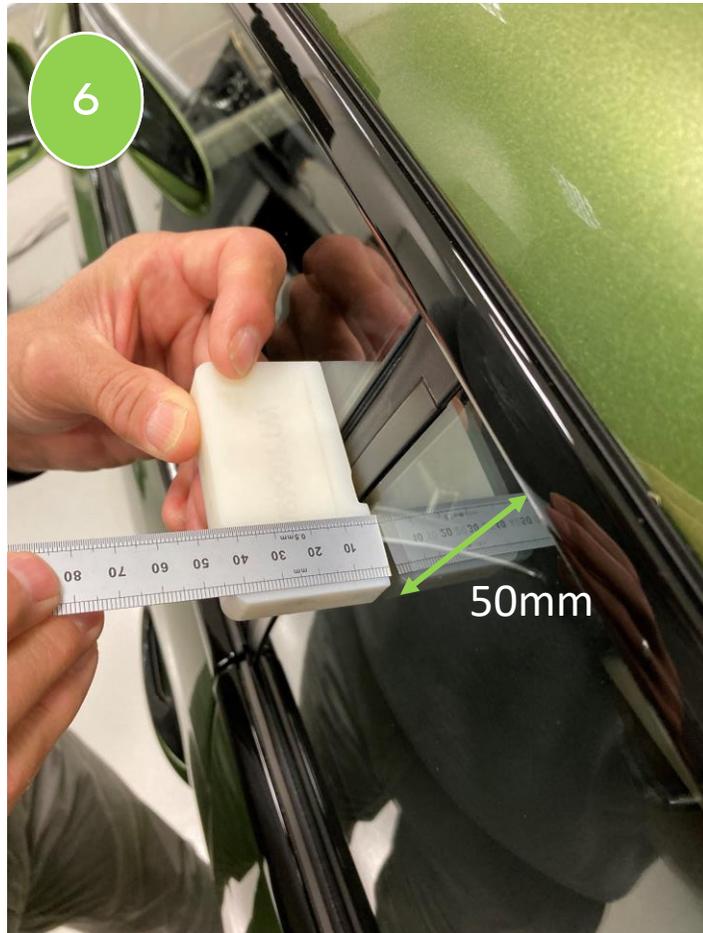
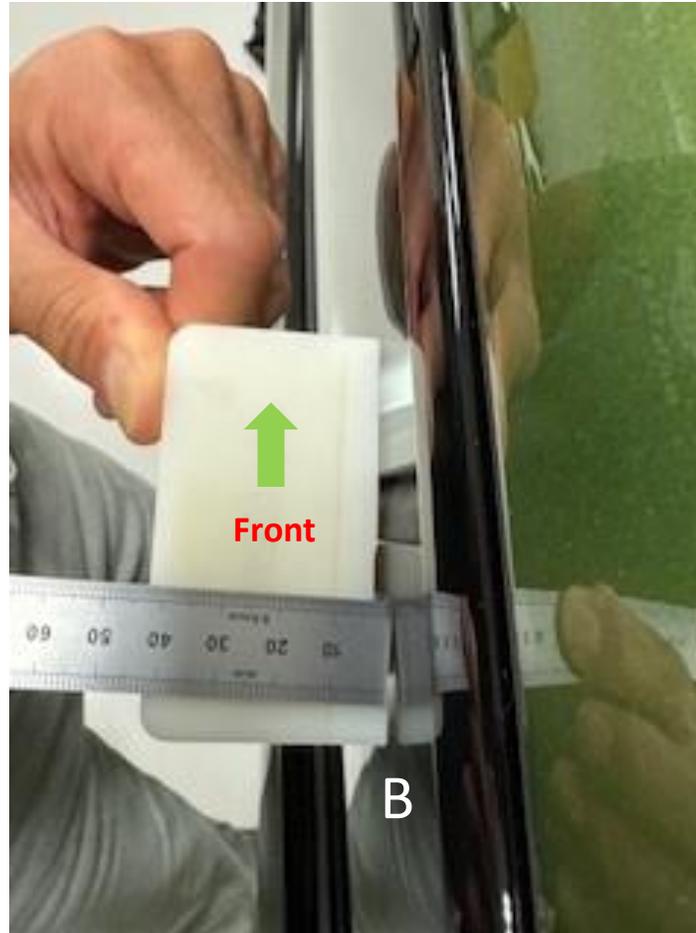
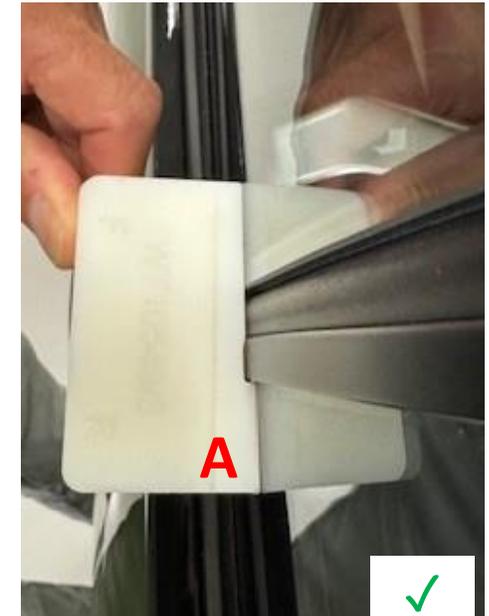
PROFILE POINT 6

Point A tool against glass is +2mm
Allowable up to 3mm refer to Point B
(Profile Tool WT10549/2)

If the measurement is out of specification refer to ElsaPro
Repair Group 64 'Slide glass checking and adjusting'

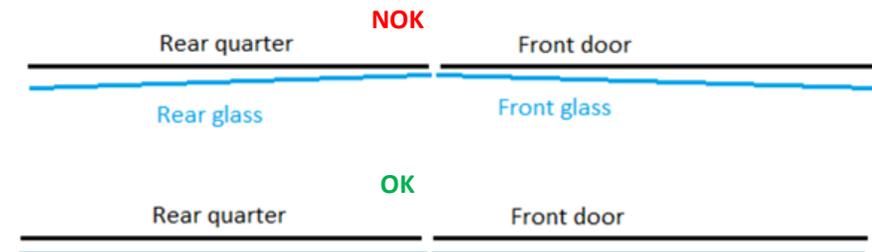
See image below, for OK and NOK after adjustment/checking

Repair Group 64 'Slide glass checking and adjusting'

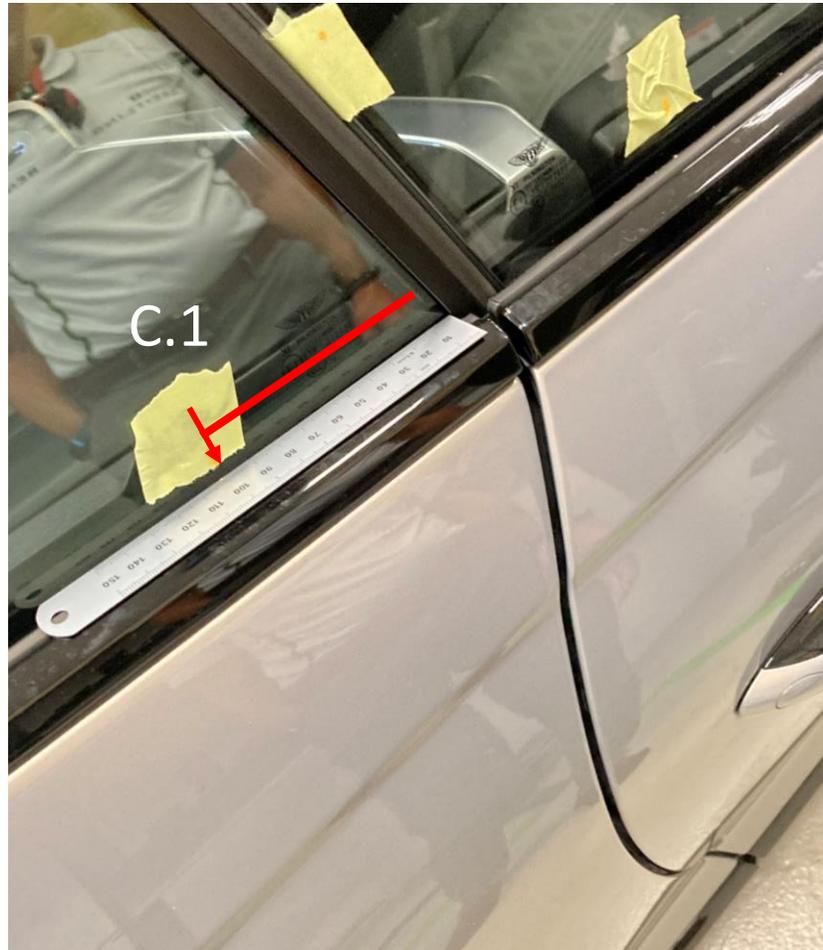
Mark on tape 100mm from div bar (C.1)

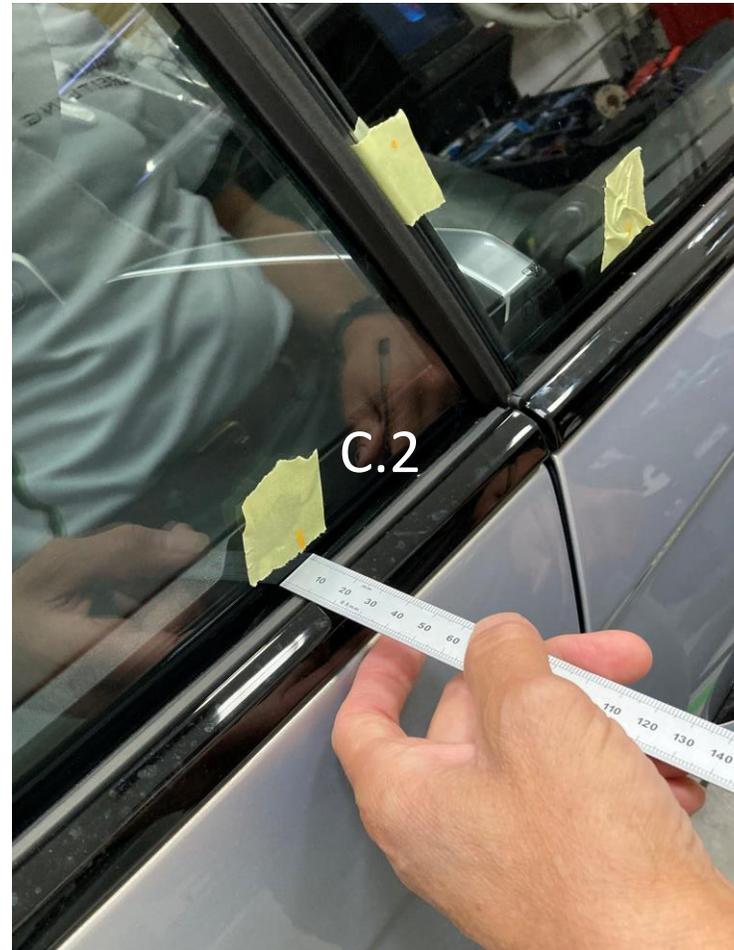
Measure seal to window gap (C.2)

Repair Group 64 'Slide glass checking and adjusting'
