Technical Service Bulletin

Topic	Window Drop Glass Operation Continental GT/GTC 19-24MY
Market area	Bentley: worldwide (2WBE),China 796 VW Import Comp. Ltd (Vico), Beijing (6796)
Brand	Bentley
Transaction No.	2080375/1
Level	EH
Status	Released for publishing
Release date	Jan 20, 2026

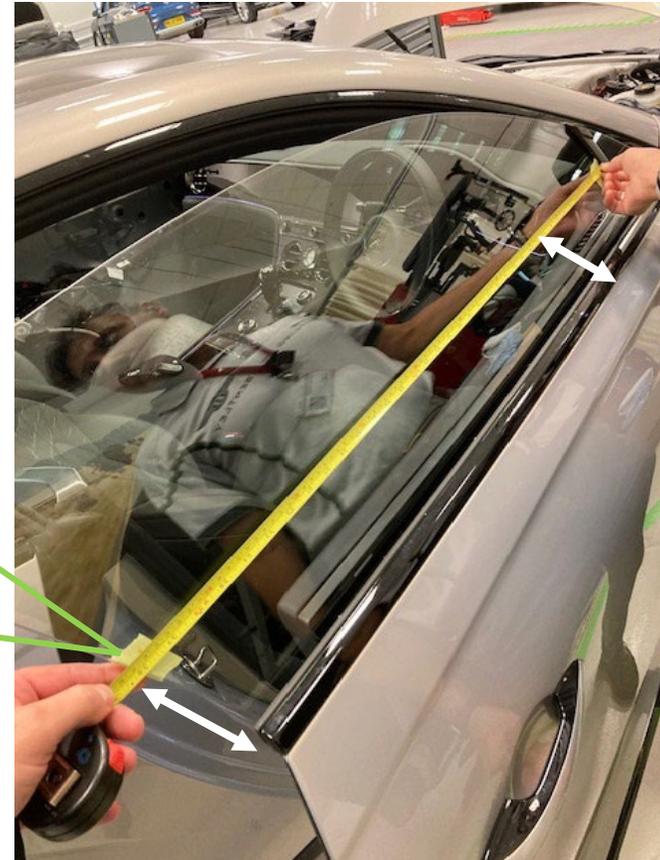
Front door glass check and set

Specification
971mm \pm 1mm

Measure 100mm up from
the waist rail

If out of specification, refer to the next slide to adjust the glass position

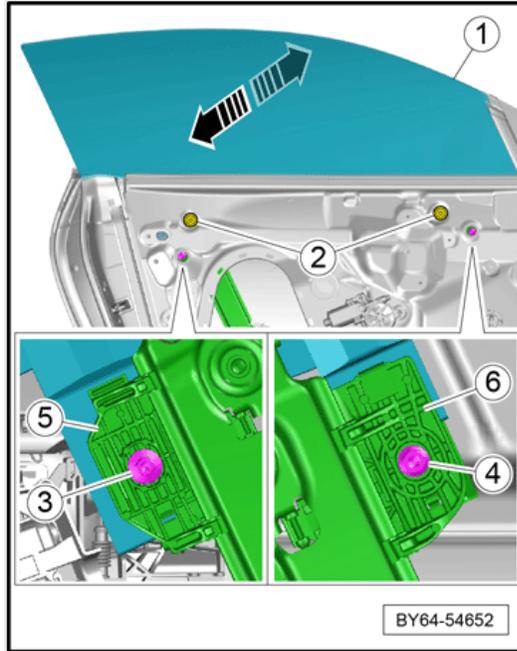
Figure 3

Loosen bolts -3- & -4- to ensure the glass sits in mounting position in its lowest position. Then resecure the bolts.

Then loosen the two purple bolts (-3- & -4-) in figure 3, raise the glass evenly as required, and re-secure the two purple bolts. Finally, return to the allen key (ratchet) adjustment to set interlock points 2, 3 and 4 to specification. Check the 971mm measurement has not altered, if so, re-adjust as required.

NOTE: If the 971 mm \pm 1mm specification shown on the previous slide is incorrect, these bolts must be loosened to adjust the glass forward or backward as needed to meet the correct specification.

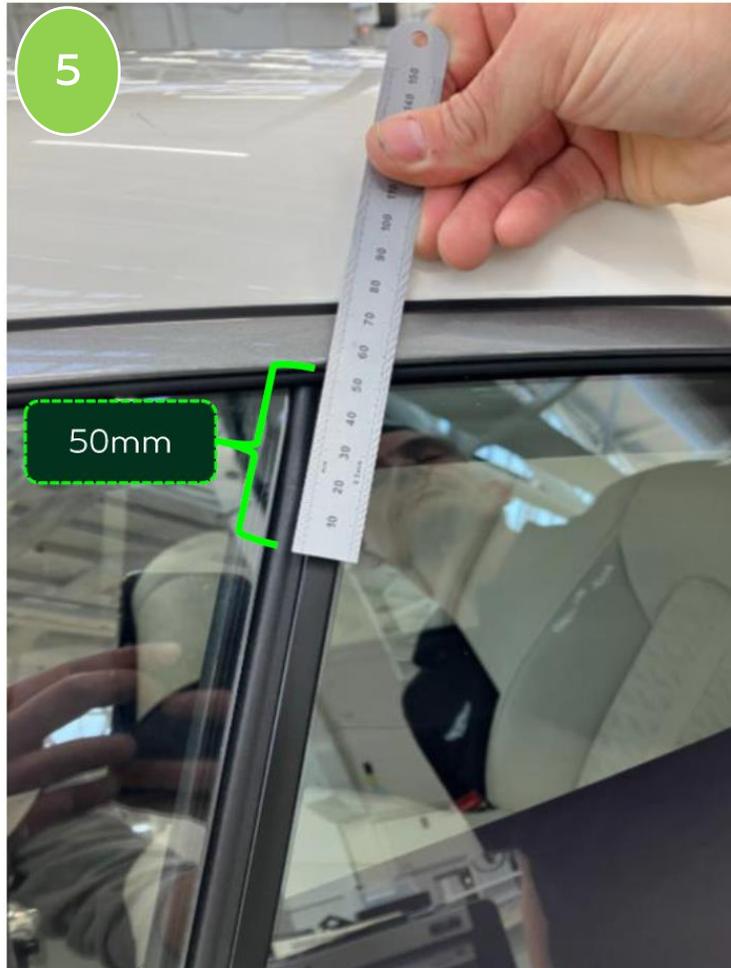
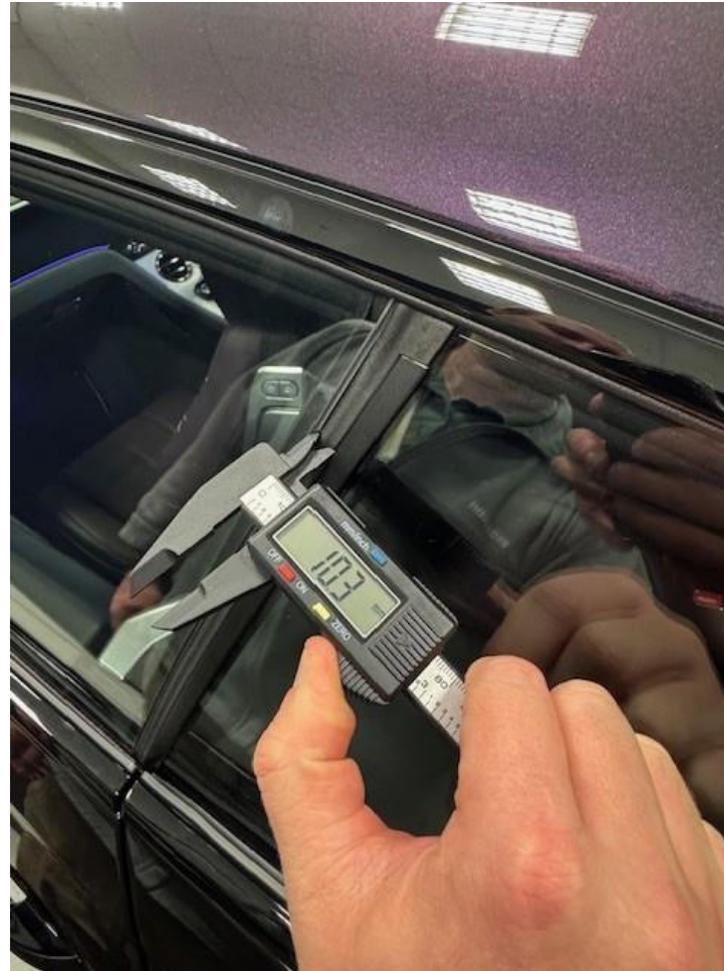
INTERLOCK POINT 5

50mm from seal

Record measurement

Specification
11mm ± 1mm
(Ruler/vernier)

Repair Group 64 'Slide glass checking and adjusting'

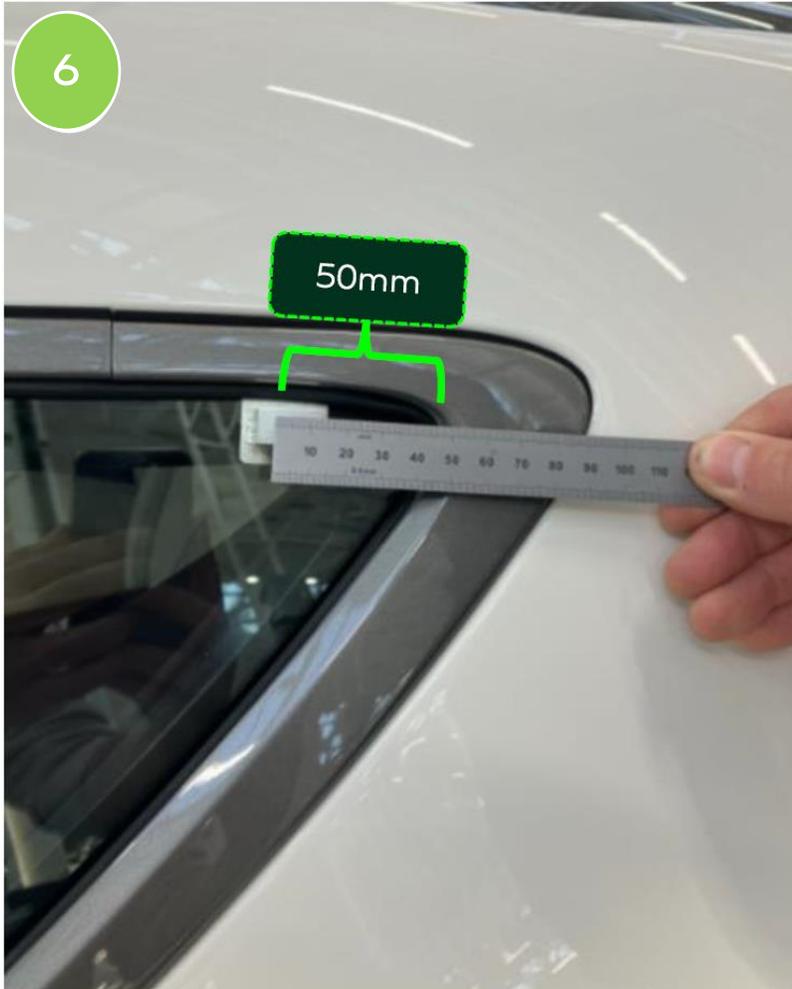
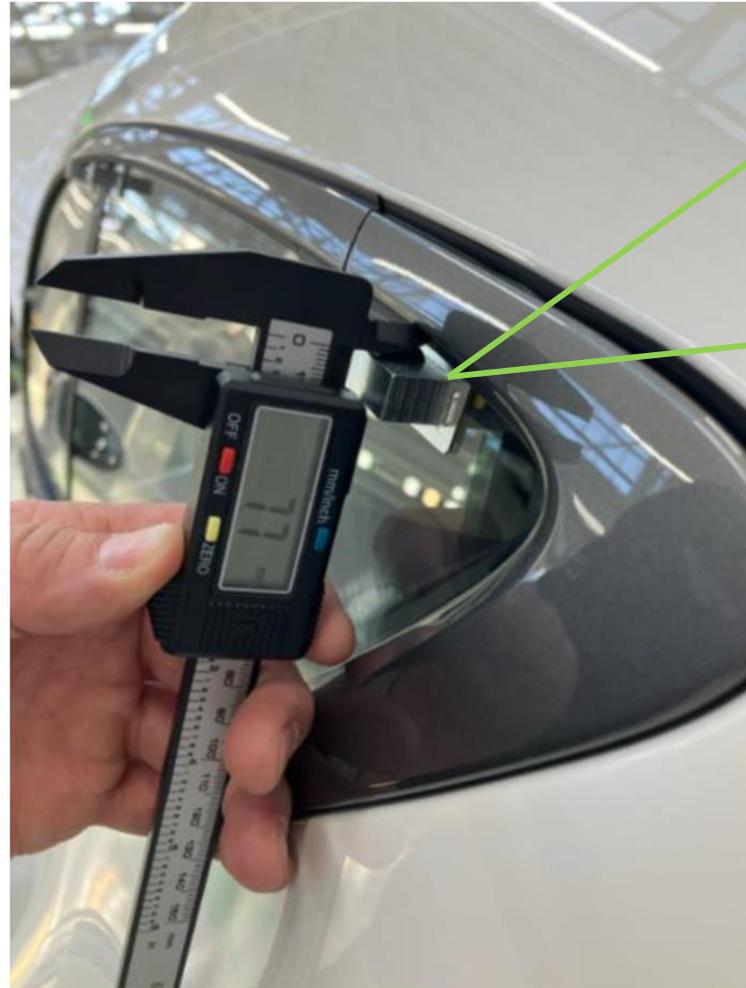
INTERLOCK POINT 6

Place block 50mm from corner point of bright ware

Record measurement for all interlock points

Specification
8mm ± 1mm
(Interlock Tool WT10549/1)

Repair Group 64 'Slide glass checking and adjusting'

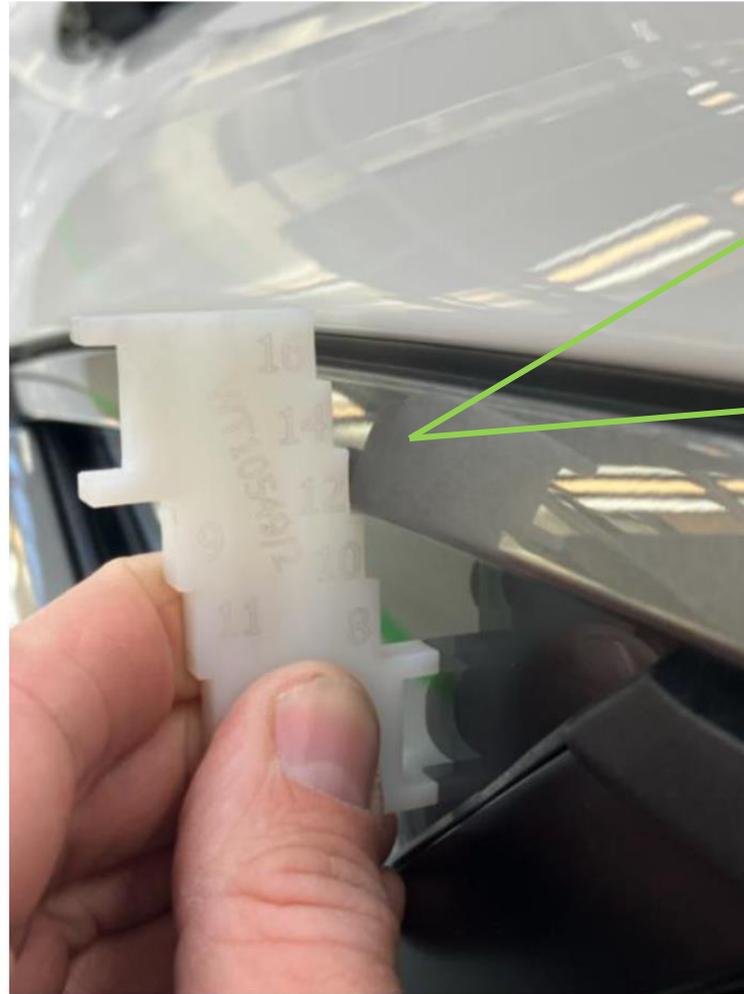
PROFILE POINT 1

50mm in front of front div
bar

Flat against glass to
brightware

Specification
10mm ± 1mm
(Profile Tool WT10549/2)

If the measurement is
out of specification refer
to ElsaPro

**Repair Group 64 'Slide
glass checking and
adjusting'**

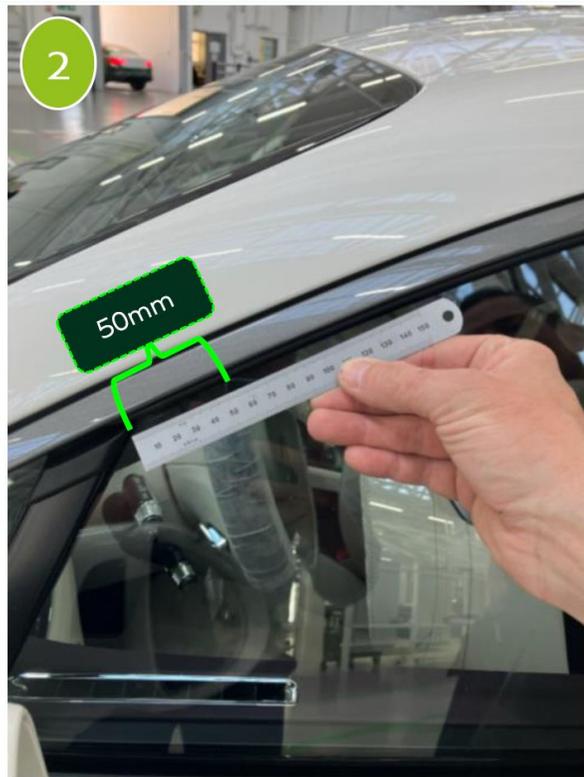
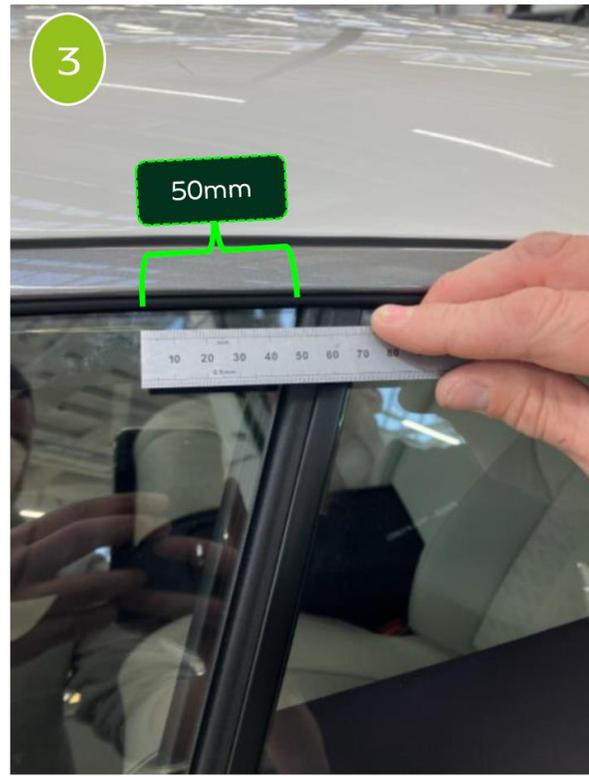
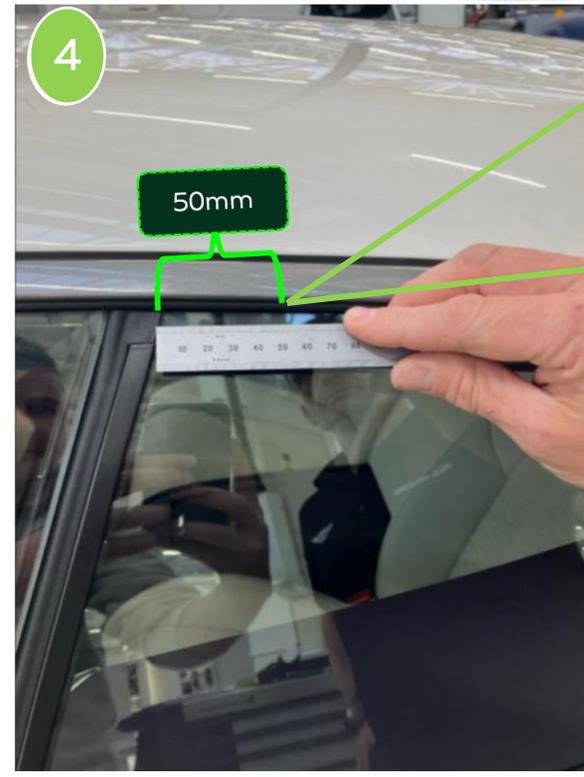
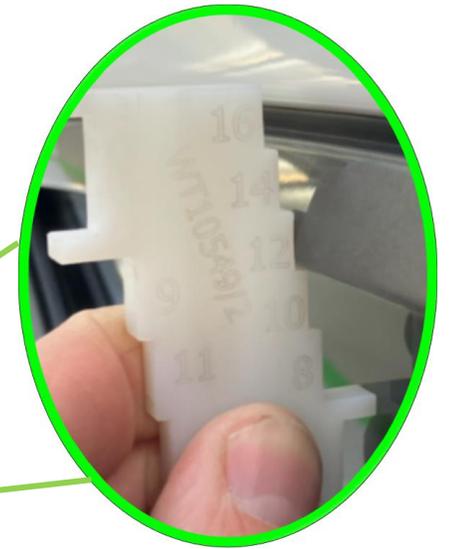
PROFILE POINT 2, 3, 4

50mm behind front
div bar

50mm in front of
rear div bar

50mm behind
rear div bar

Flat against glass to
brightware

**Repair Group 64 'Slide
glass checking and
adjusting'**

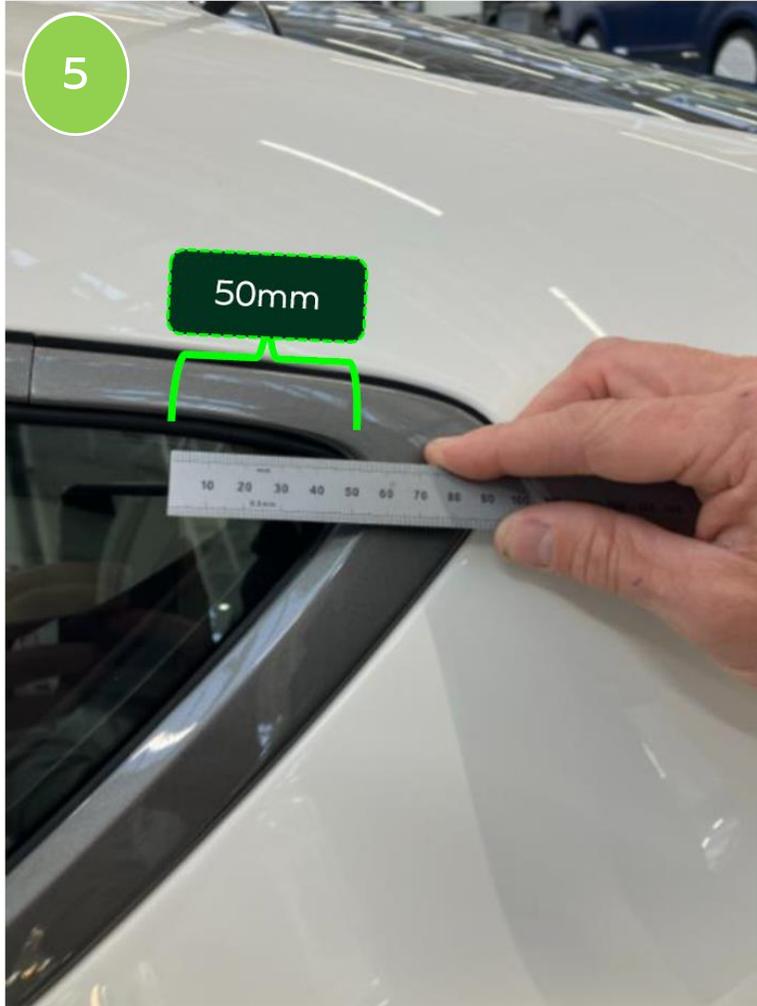
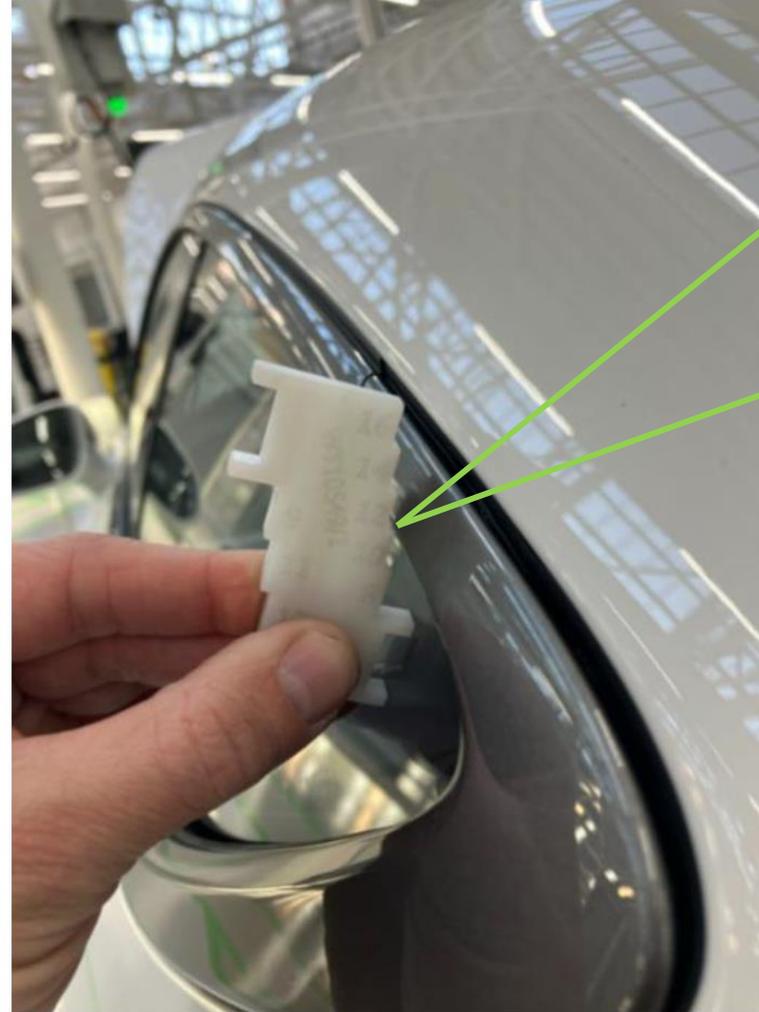
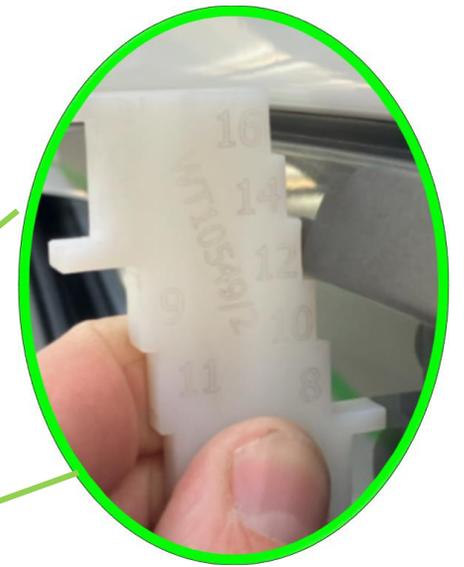
PROFILE POINT 5

50mm from corner point of bright ware

Flat against glass to brightware

Specification
10mm \pm 2mm
(Profile Tool WT10549/2)

Repair Group 64 'Slide glass checking and adjusting'

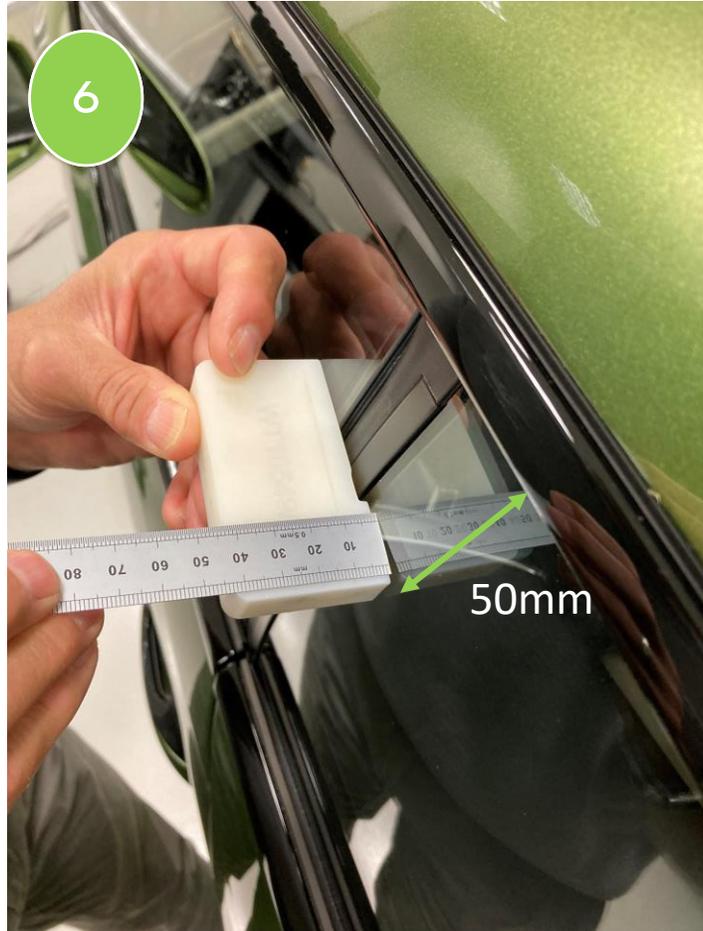
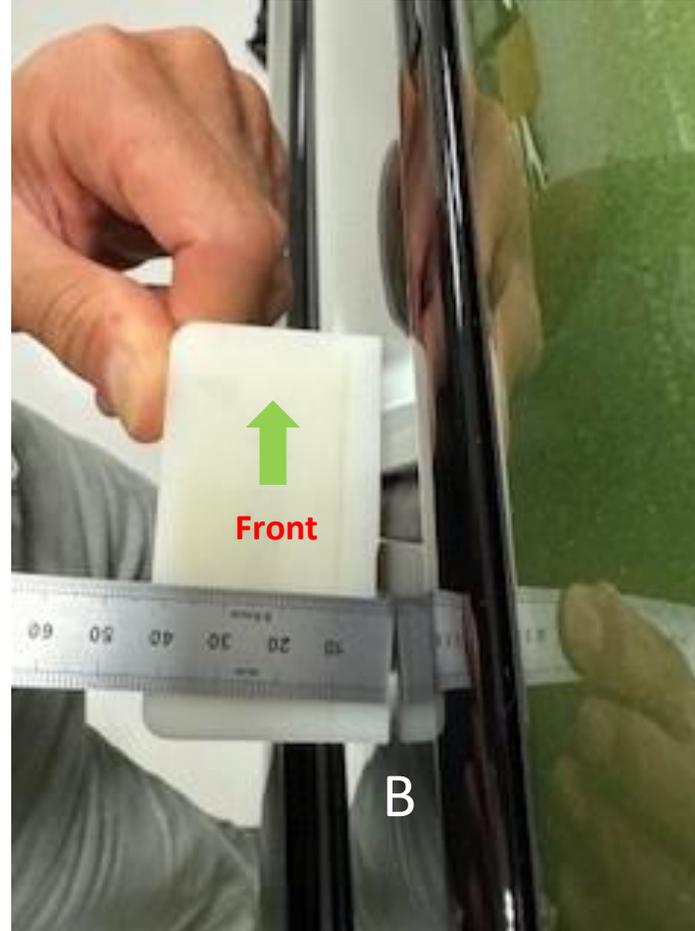
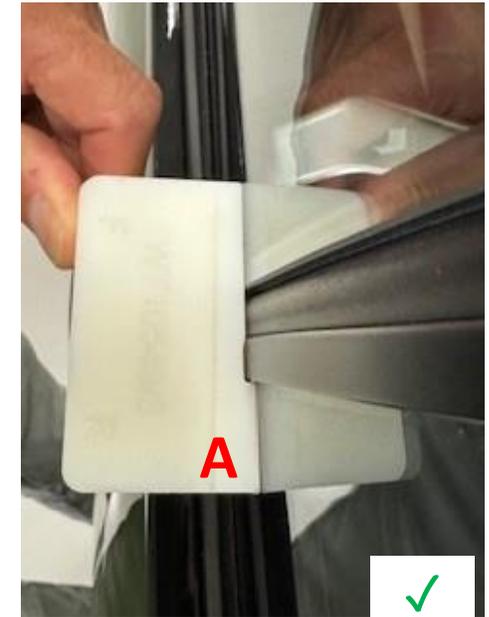
PROFILE POINT 6

50mm from upper corner

Flat against front window, measure gap

Point A tool against glass is +2mm
Allowable up to 3mm refer to Point B
(Profile Tool WT10549/2)

If the measurement is out of specification refer to ElsaPro
Repair Group 64 'Slide glass checking and adjusting'

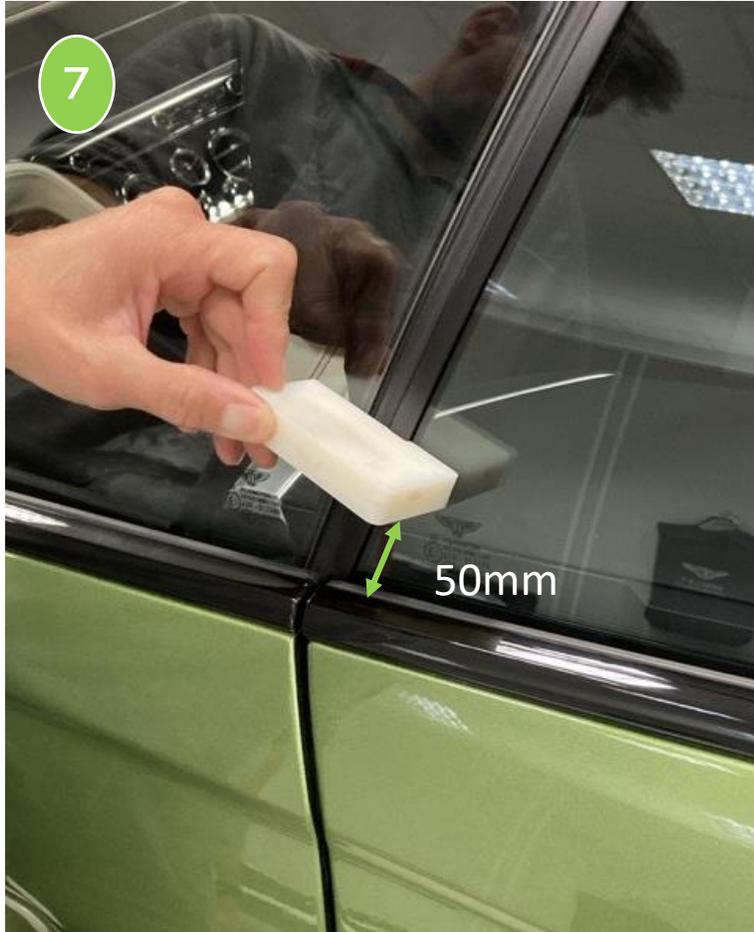
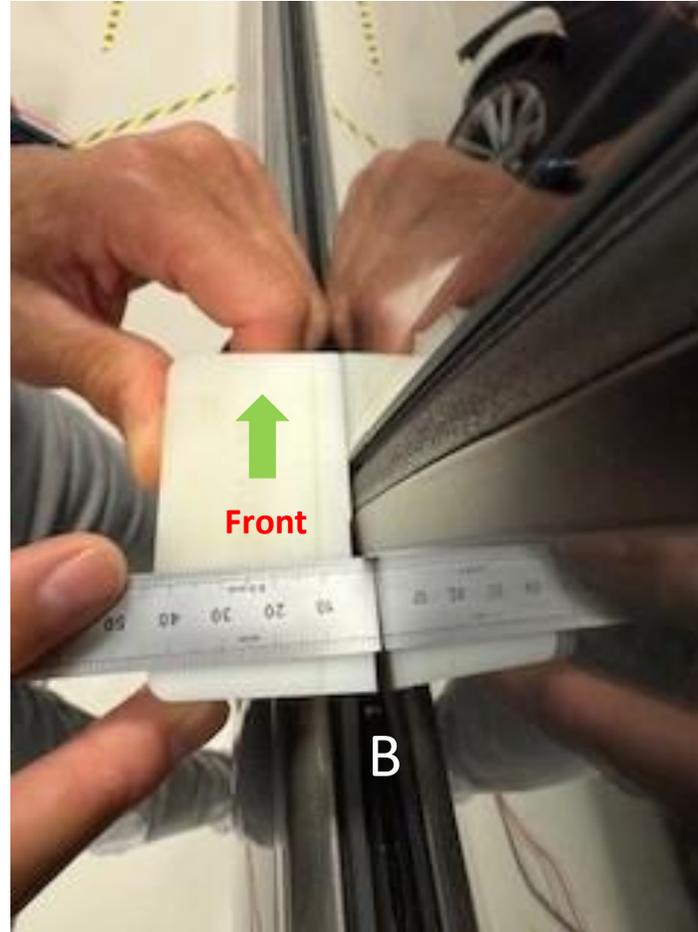
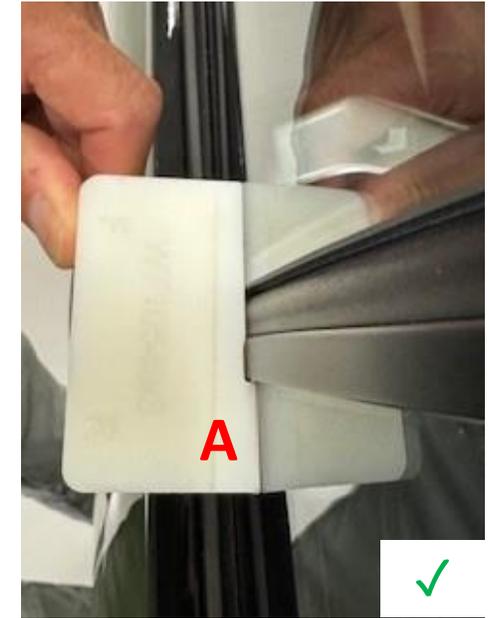
PROFILE POINT 7

50mm from lower corner

Flat against front window, measure gap

Point A tool against glass = +2mm
Allowable up to 3mm refer to Point B
(Profile Tool WT10549/2)

Repair Group 64 'Slide glass checking and adjusting'

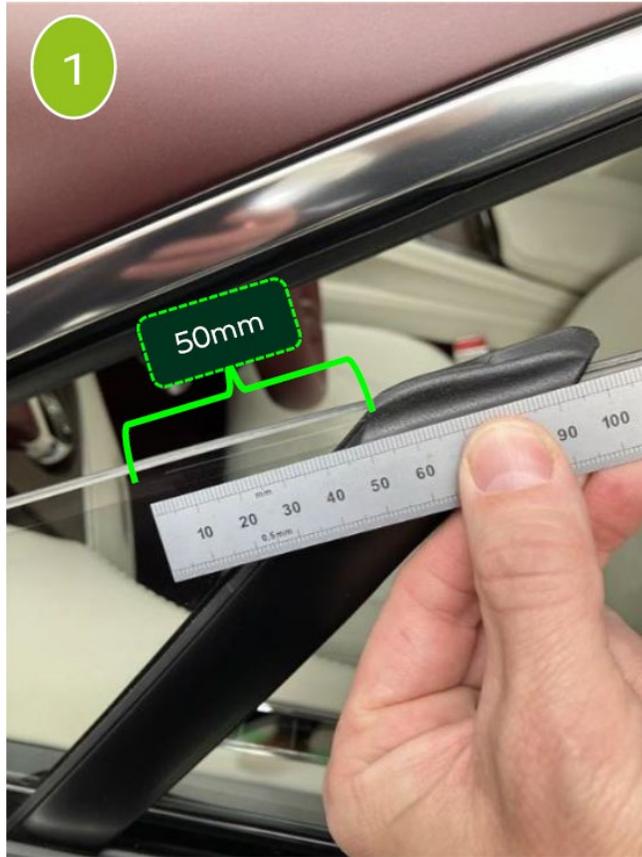
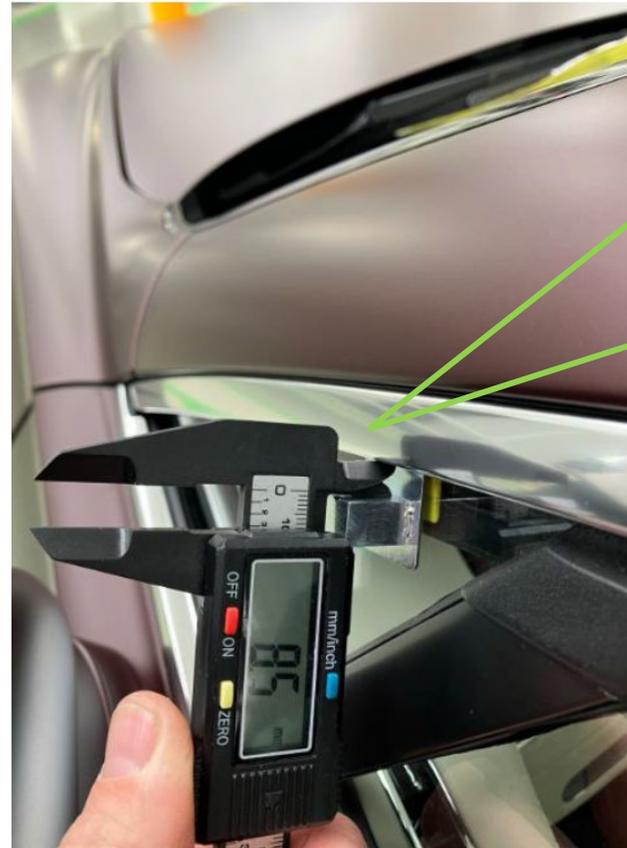
INTERLOCK POINT 1

Place block 50mm in front of front div bar

Record measurement for all interlock points

From block to bright ware for all interlock points

If the measurement is out of specification refer to ElsaPro
Repair Group 64 'Front door quarter glass – To adjust'

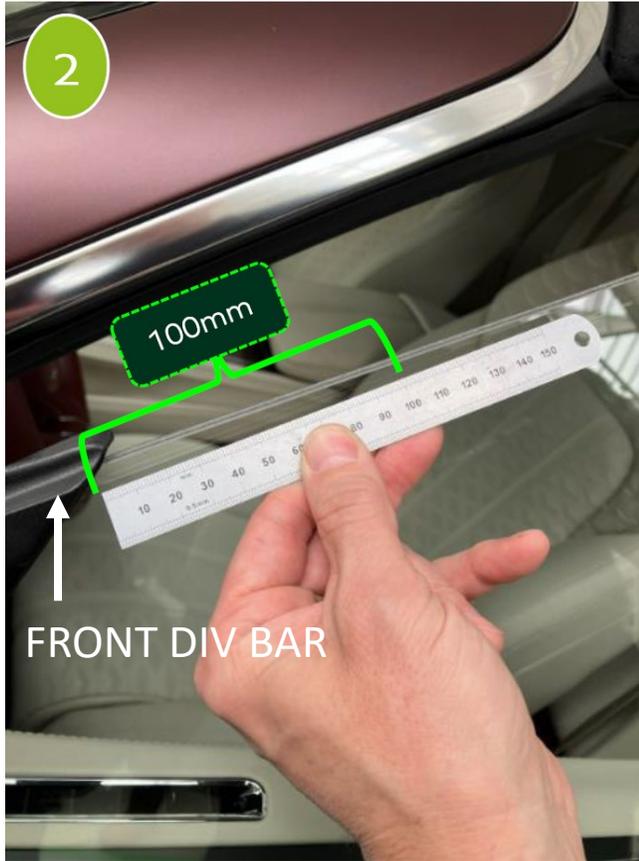
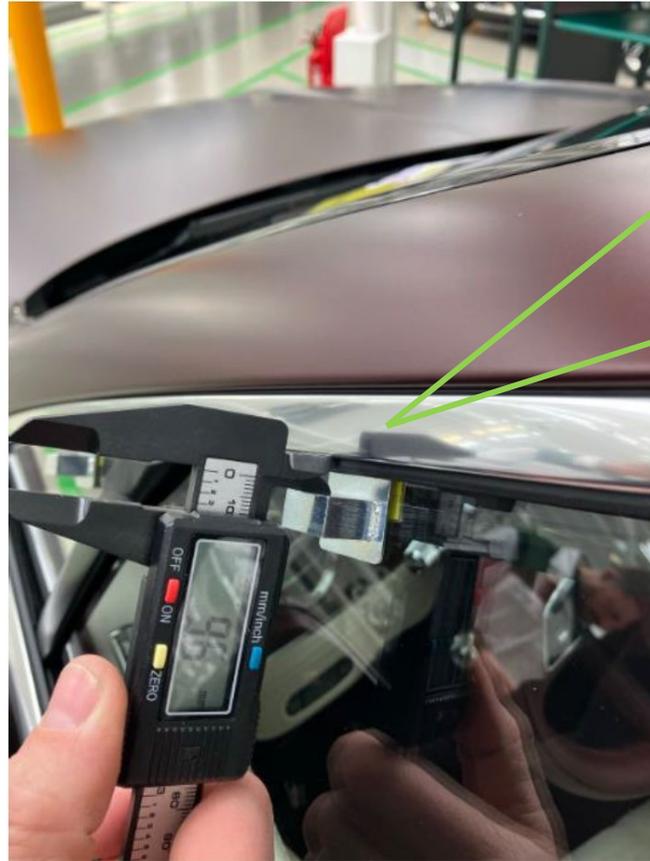
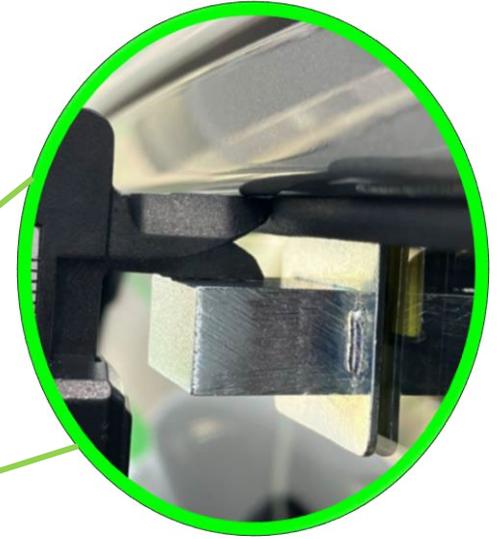
INTERLOCK POINT 2

Place block 100mm in front of front div bar

Record measurement for all interlock points

From block to bright ware for all interlock points

Repair Group 64 'Front door quarter glass – To adjust'

If the specification for interlock points 2, 3 or 4 cannot be achieved through normal adjustment, refer to page 6 of the glass reset procedure.

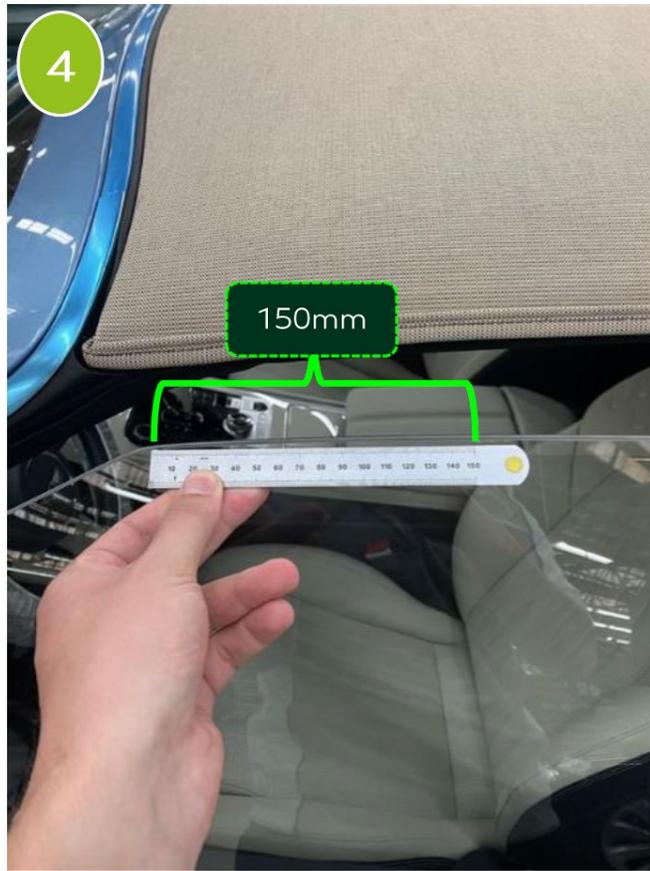
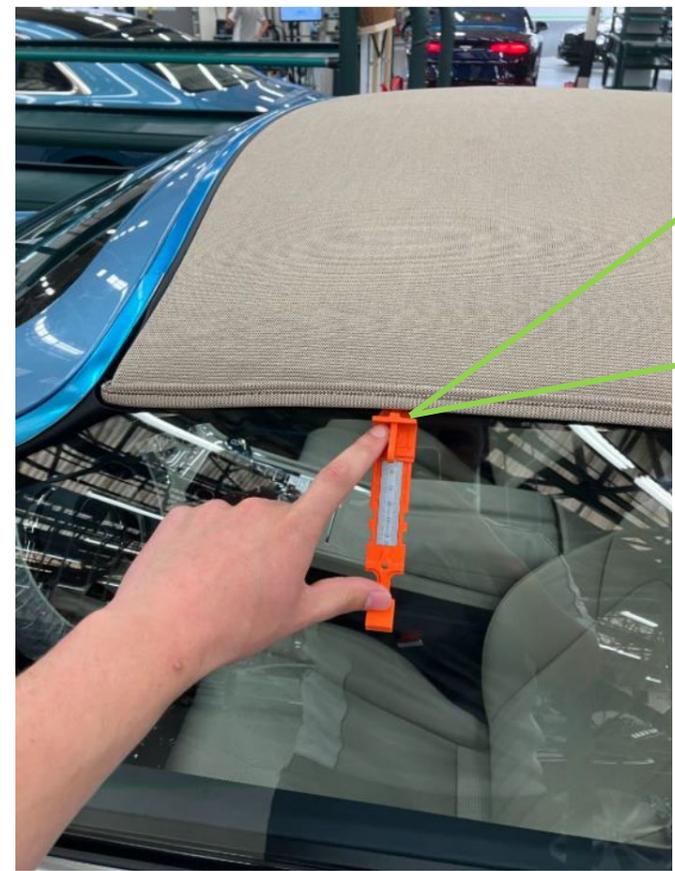
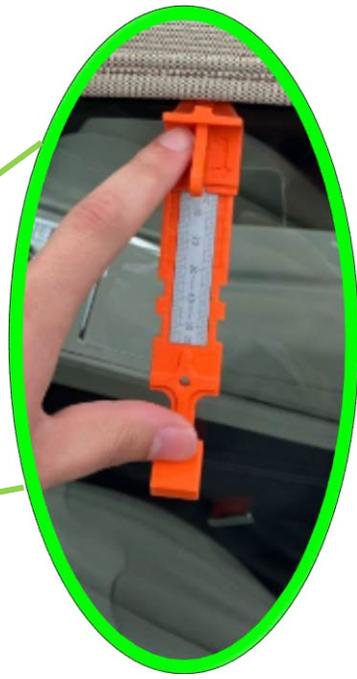
INTERLOCK POINT 3

150mm from front corner of window glass as shown

Specification
8.5mm ± 1mm
(Interlock Tool WT10554)

If the measurement is out of specification refer to ElsaPro Repair Group 64 'Front door quarter glass – To adjust'

If the specification for interlock points 2, 3 or 4 cannot be achieved through normal adjustment, refer to page 6 of the glass reset procedure.

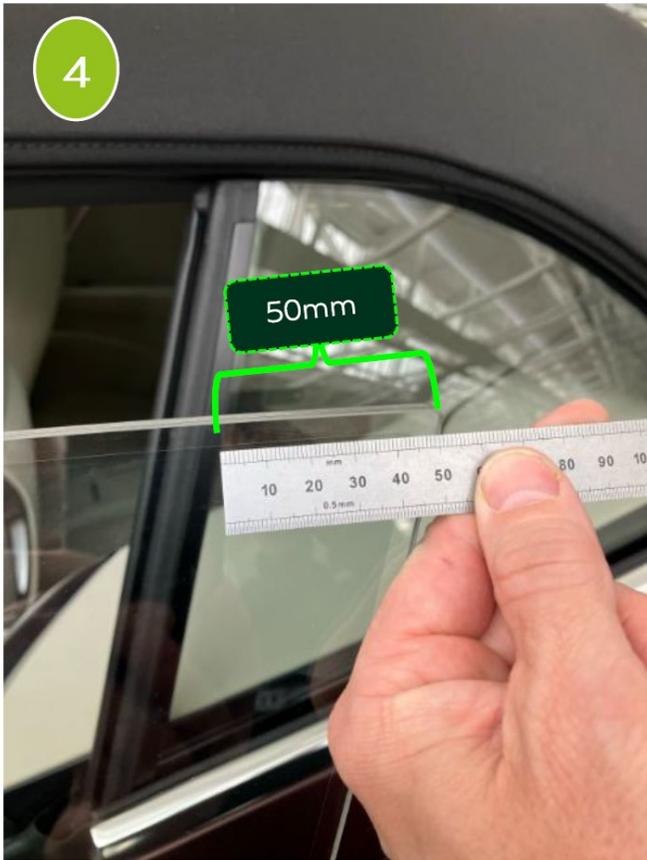
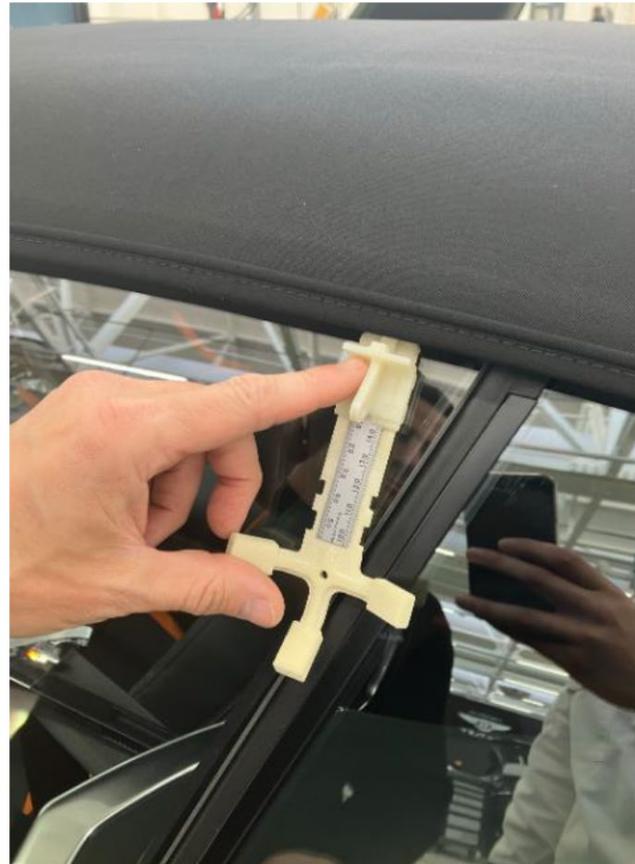
INTERLOCK POINT 4

50mm from rear edge of the front door glass as shown

Specification
8.5mm ± 1mm
(Interlock Tool WT10554)

If the measurement is out of specification refer to ElsaPro Repair Group 64 'Front door quarter glass – To adjust'

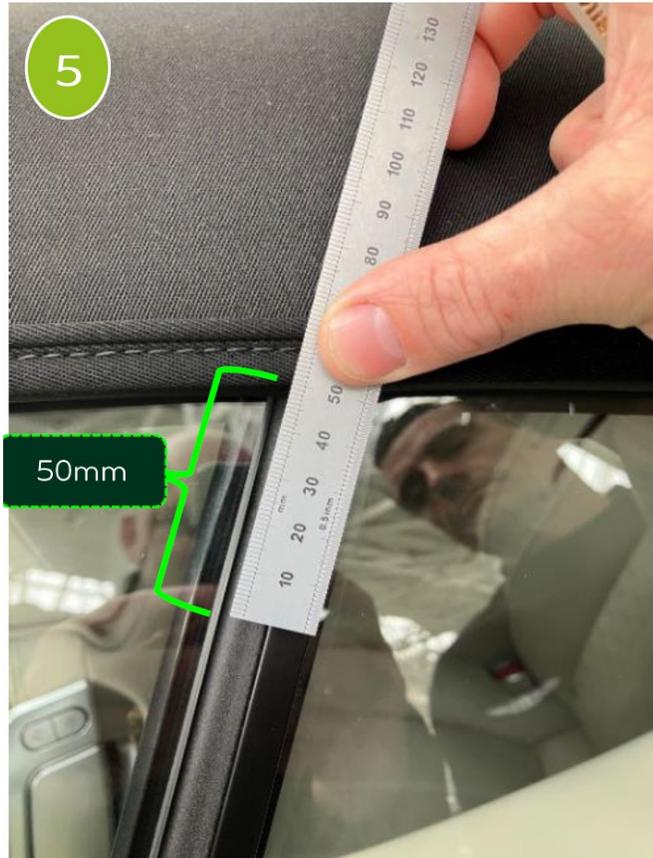
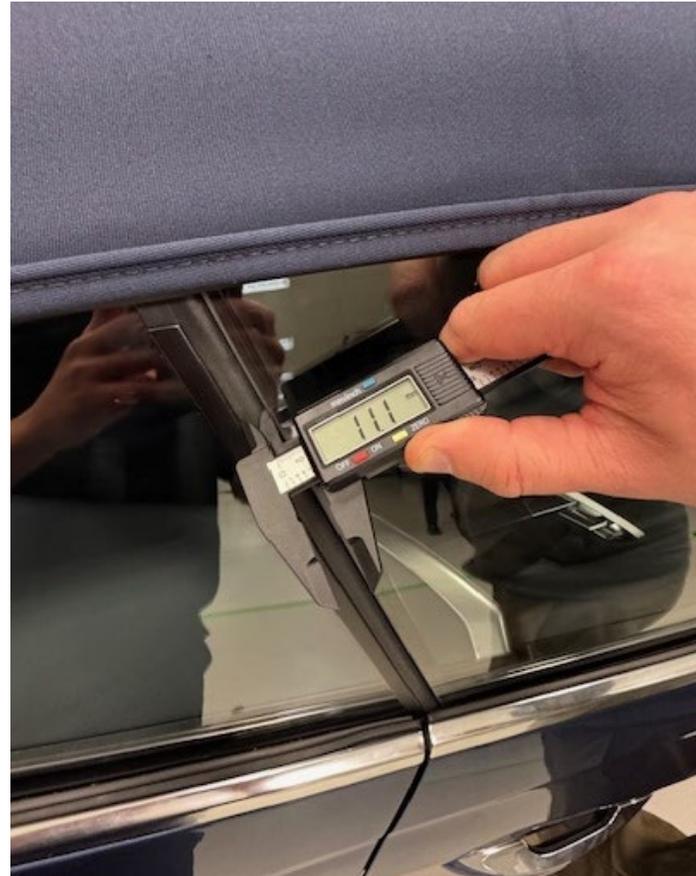
INTERLOCK POINT 5 ROOF UP

50mm from corner

Record measurement

Specification
11mm ± 1mm
(Ruler/vernier)

If the measurement is out of specification refer to ElsaPro Repair Group 64 'Front door quarter glass – To adjust'

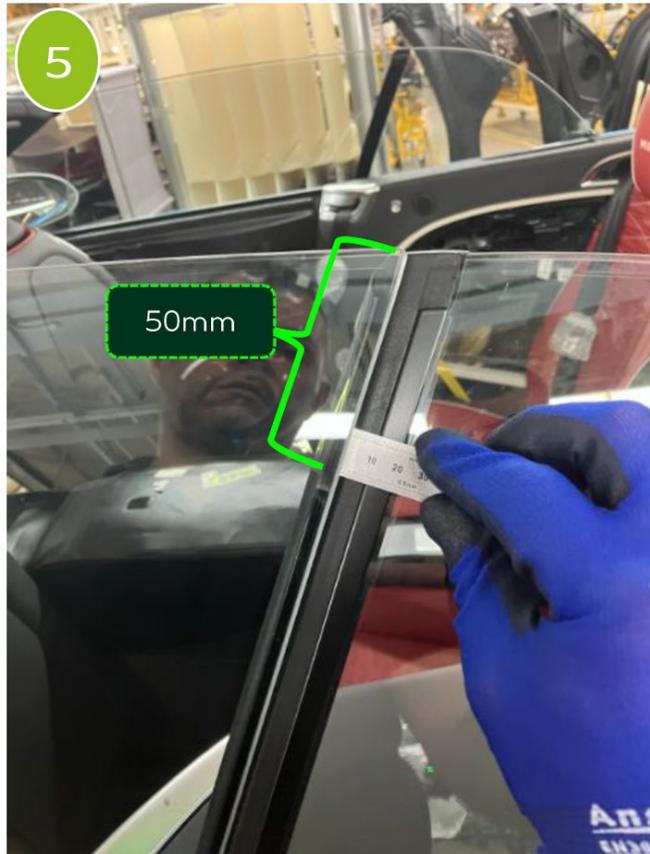
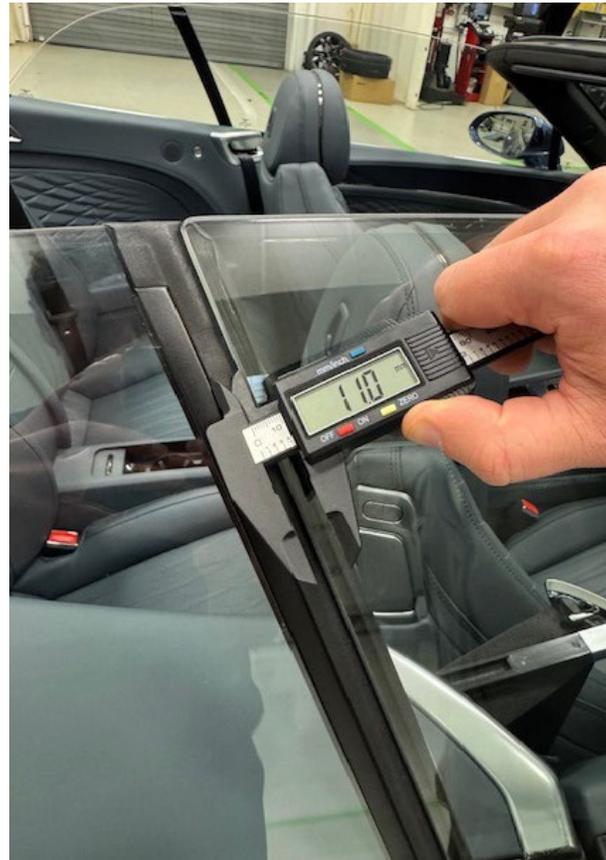
INTERLOCK POINT 5 ROOF DOWN

Take measurement
50mm from top of glass

Record measurement

Specification
11mm ± 1mm
(Ruler/vernier)

If the measurement is out of specification refer to ElsaPro Repair Group 64 'Front door quarter glass – To adjust'

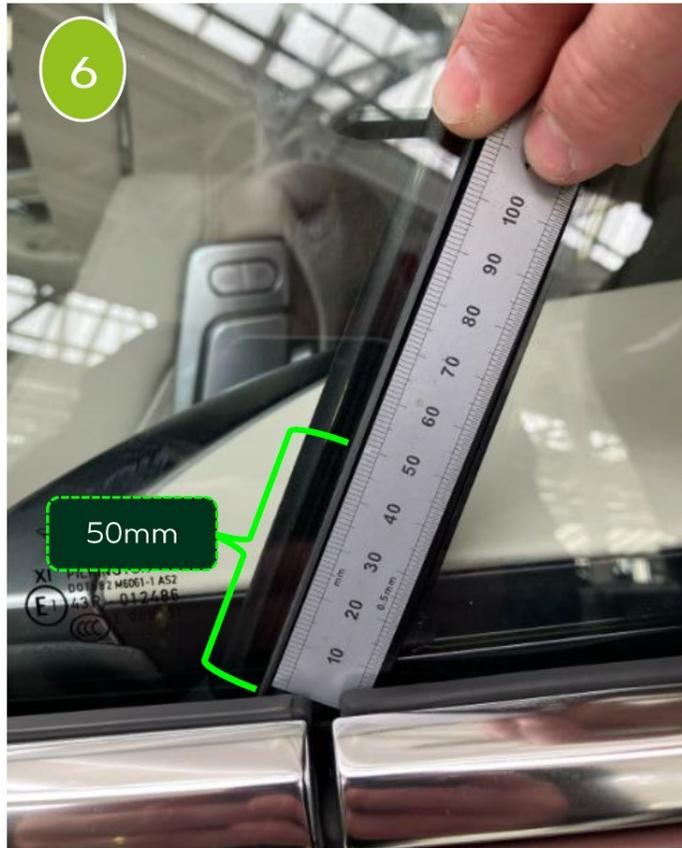
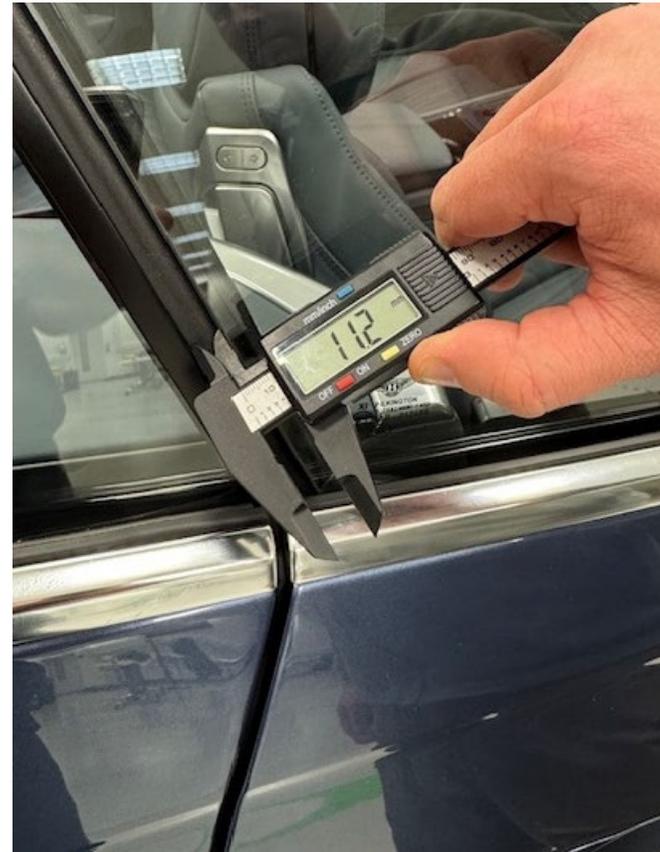
INTERLOCK POINT 6 ROOF UP & DOWN

50mm from corner

Record measurement

Specification
11mm \pm 1mm
(Ruler/vernier)

If the measurement is out of specification refer to ElsaPro Repair Group 64 'Front door quarter glass – To adjust'

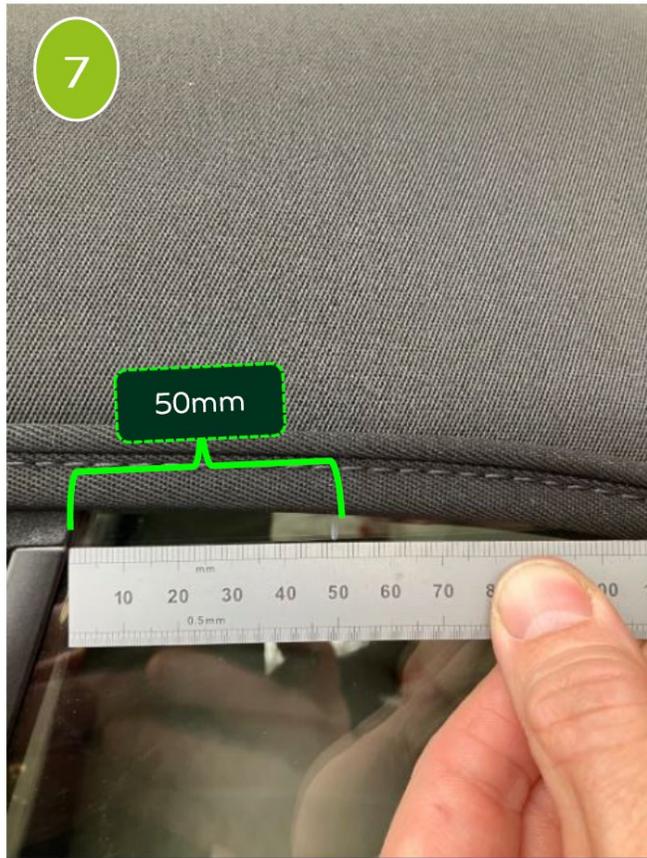
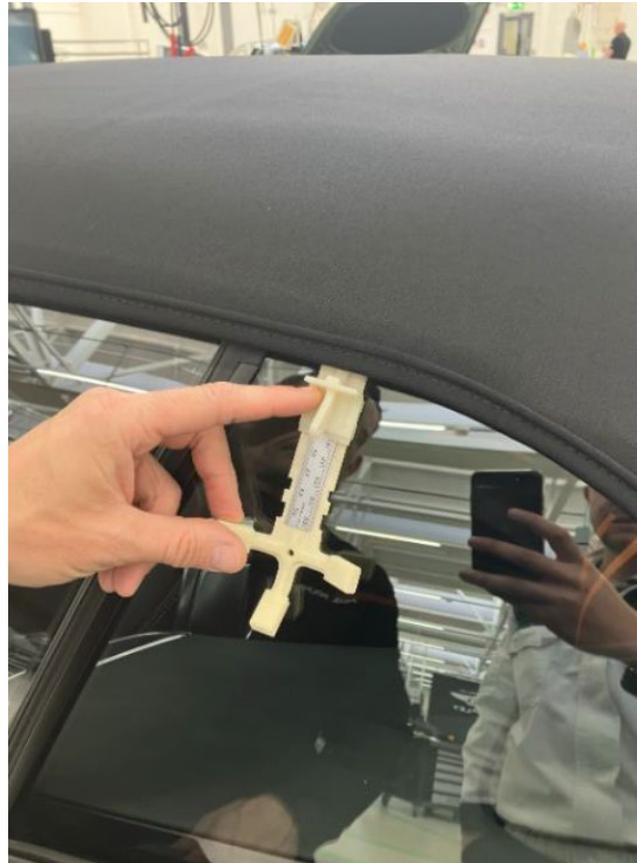
INTERLOCK POINT 7

50mm behind rear div bar

Specification
8.5mm ± 1mm
(Interlock Tool WT10554)

If the measurement is out of specification refer to ElsaPro Repair Group 64 'Front door quarter glass – To adjust'

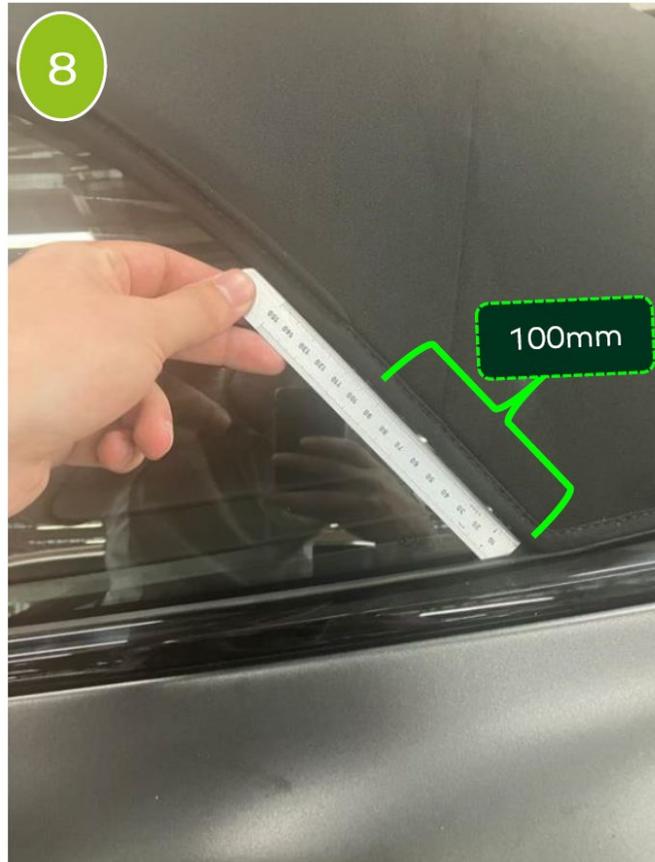
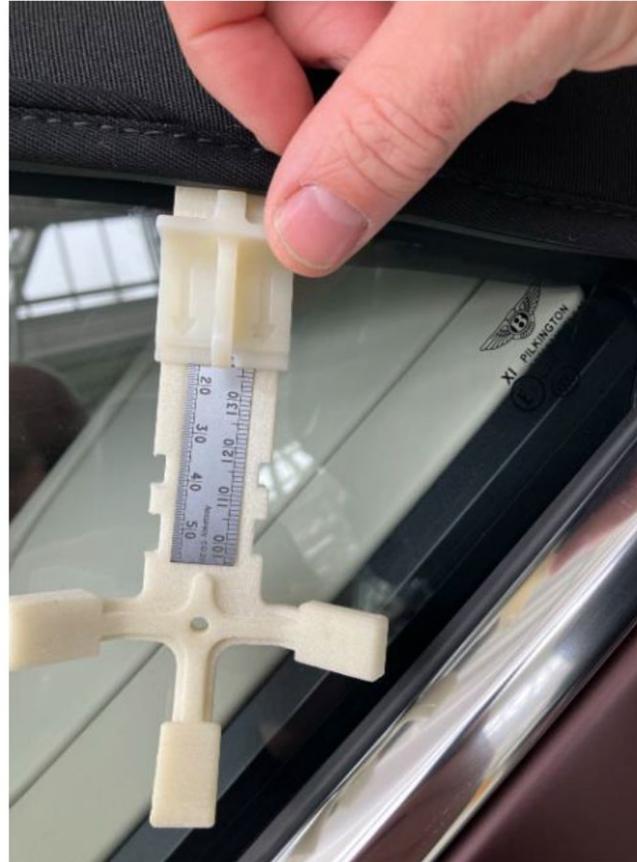
INTERLOCK POINT 8

100mm from corner

Specification
8.5mm – 16mm
(Interlock Tool WT10554)

If the measurement is out of specification refer to ElsaPro Repair Group 64 'Front door quarter glass – To adjust'
