Technical Service Bulletin

Topic	Window Drop Glass Operation Continental GT/GTC 19-24MY
Market area	Bentley: worldwide (2WBE),China 796 VW Import Comp. Ltd (Vico), Beijing (6796)
Brand	Bentley
Transaction No.	2080375/1
Level	EH
Status	Released for publishing
Release date	Jan 20, 2026

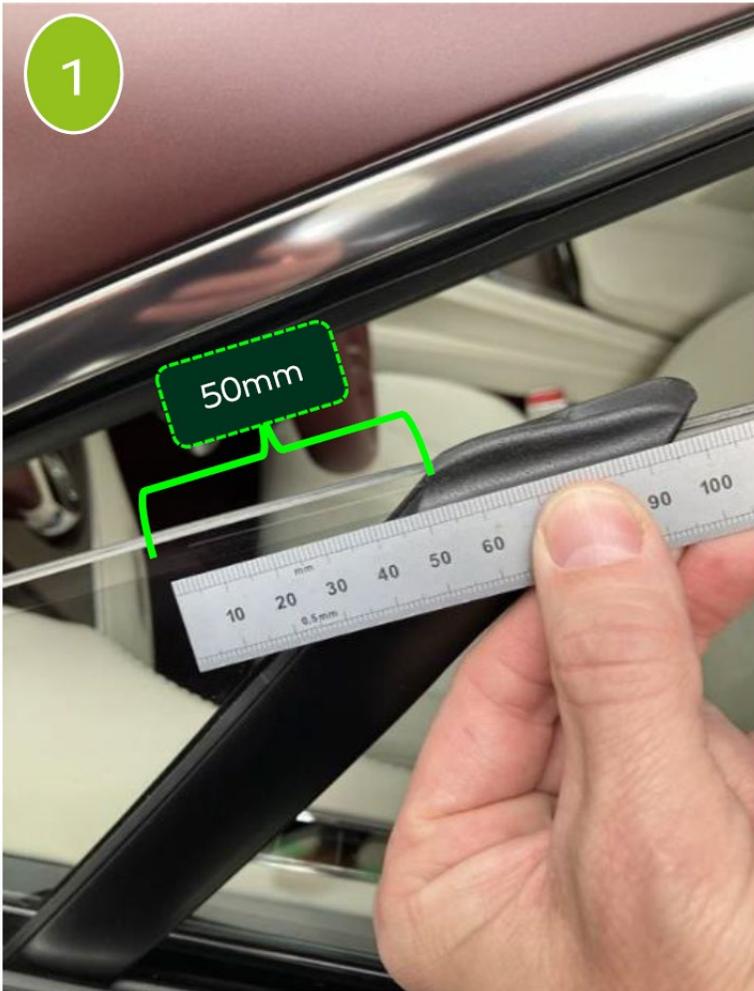
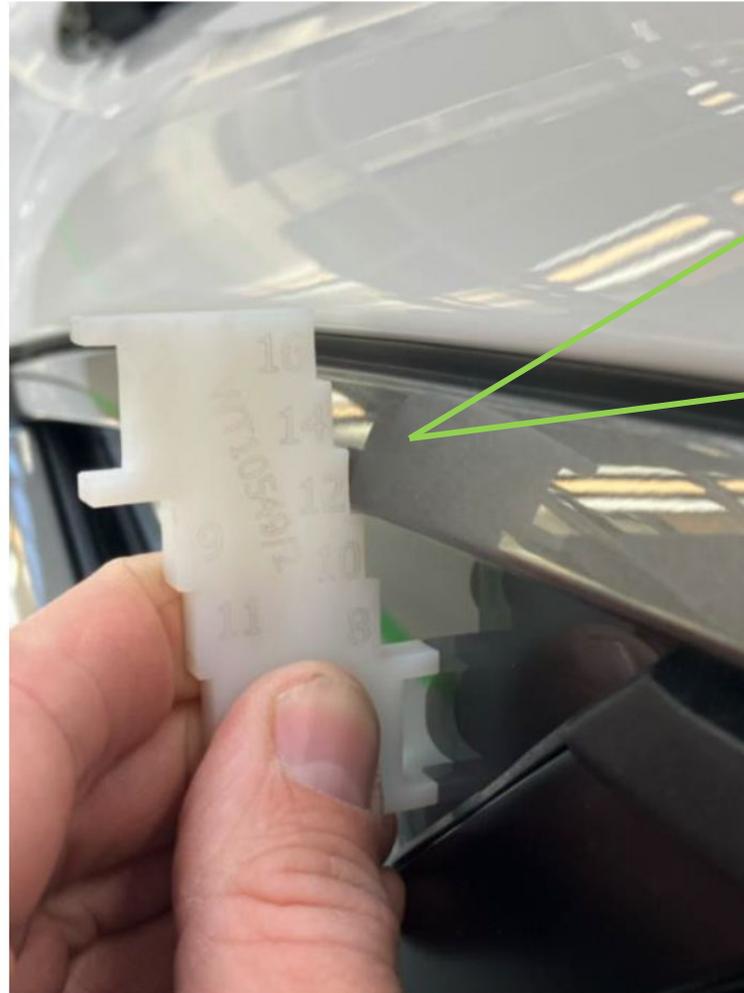
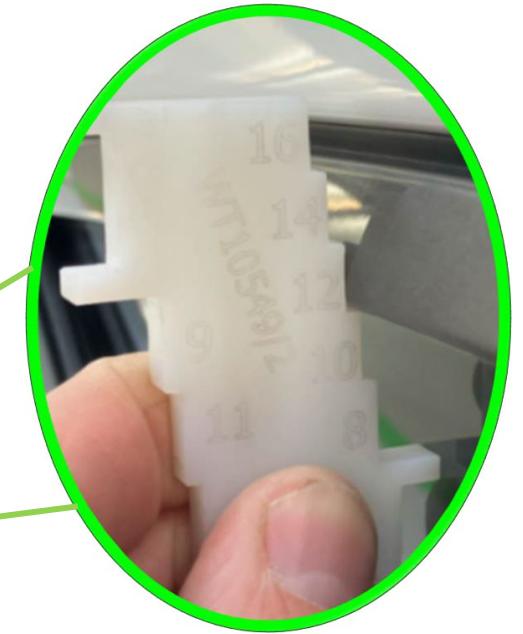
PROFILE POINT 1

50mm in front of front div
bar

Flat against glass to
brightware

Specification
10mm \pm 1mm
(Profile Tool WT10549/2)

If the measurement is out of
specification refer to ElsaPro
**Repair Group 64 'Slide glass
checking and adjusting'**

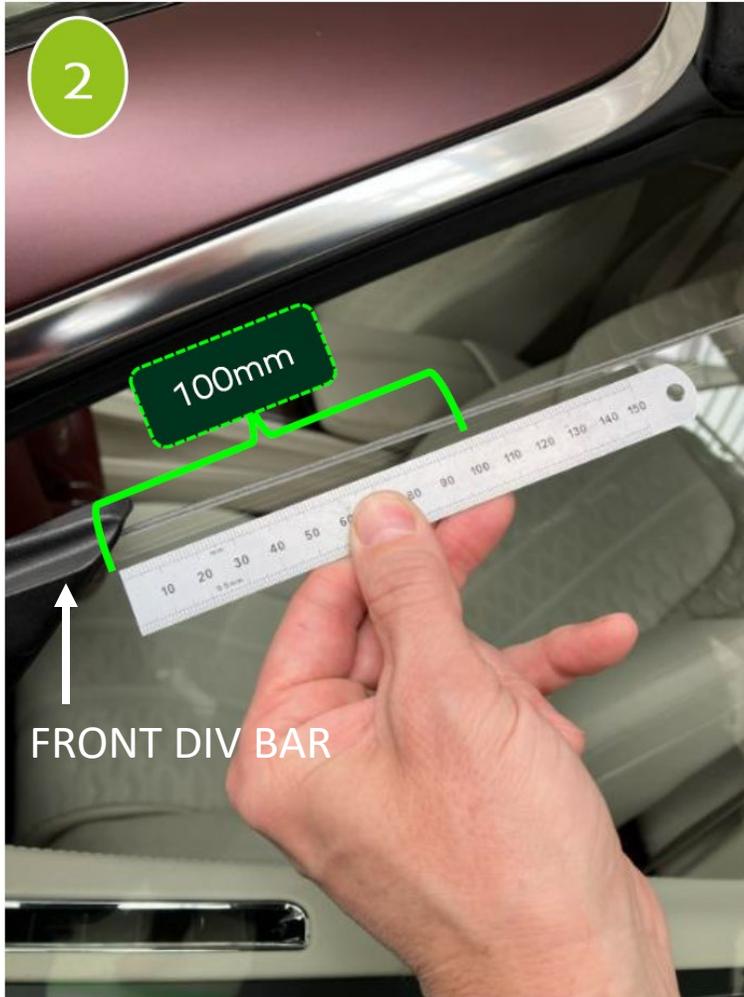
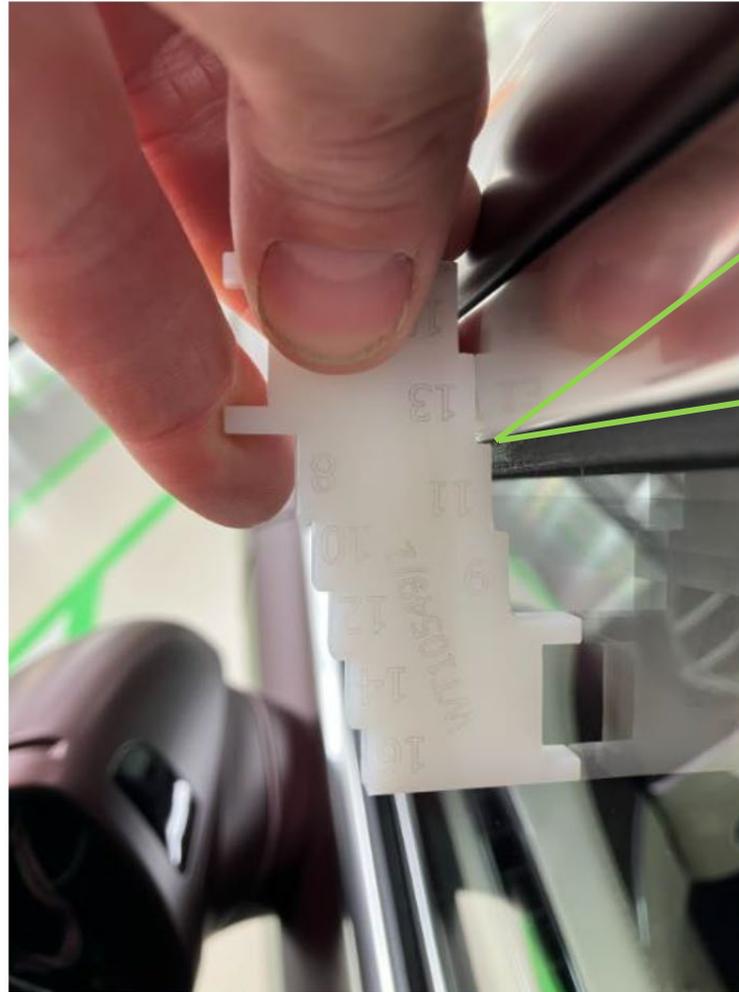
PROFILE POINT 2

Place block 50mm in front of front div bar

Flat against glass to brightware

Specification
14mm ± 2mm
(Profile Tool WT10549/2)

If the measurement is out of specification refer to ElsaPro Repair Group 64 'Slide glass checking and adjusting'

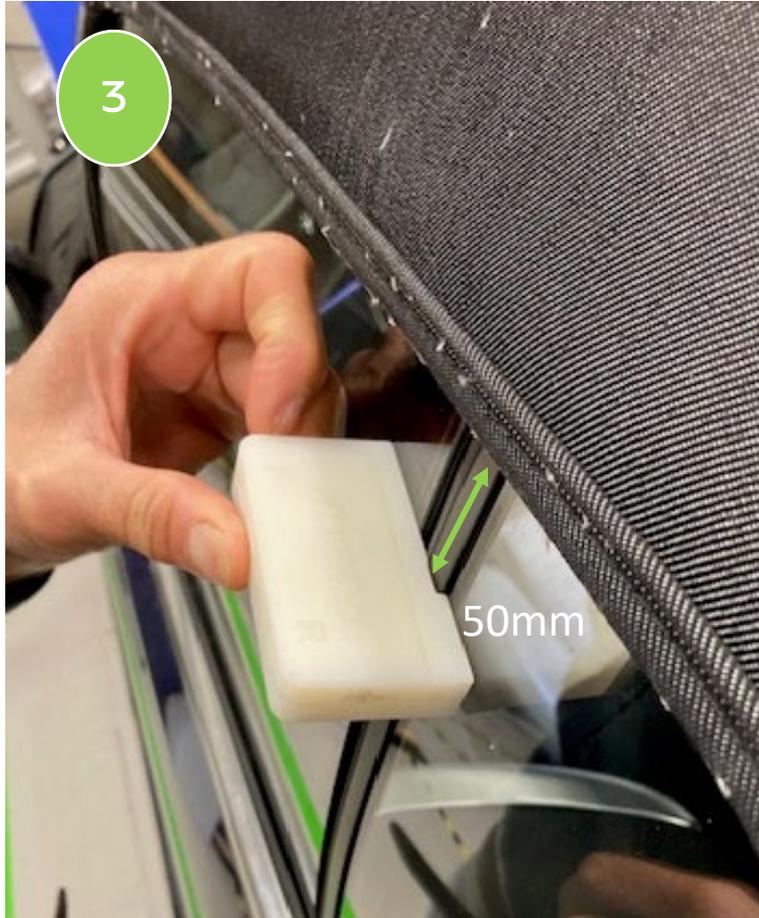
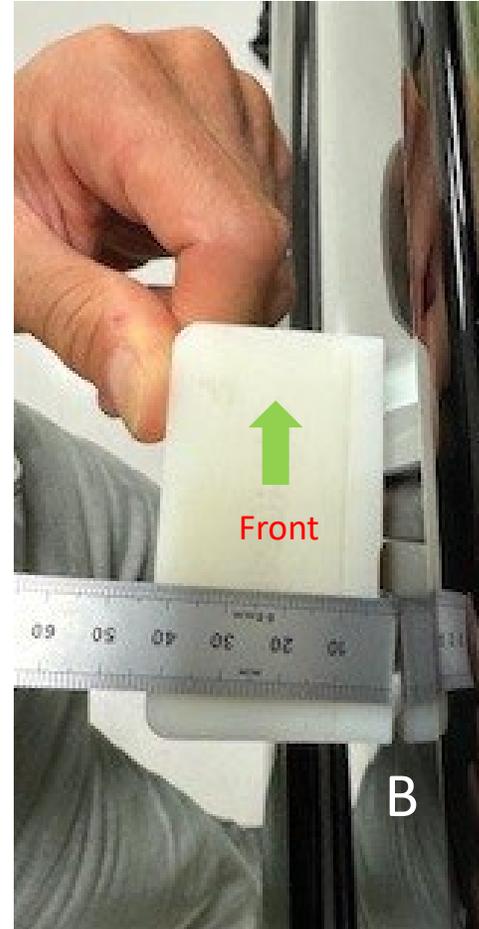
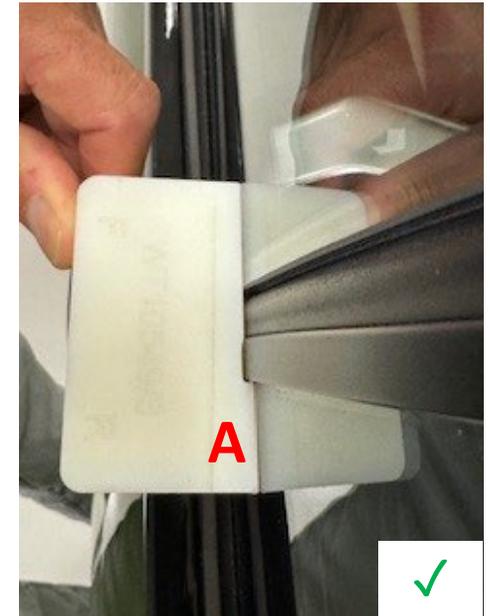
PROFILE POINT 3 ROOF UP

50mm from upper corner

Flat against front window, measure gap

Point A tool against glass is +2mm
Allowable up to 3mm refer to Point B
(Profile Tool WT10549/3)

If the measurement is out of specification refer to ElsaPro
Repair Group 64 'Slide glass checking and adjusting'

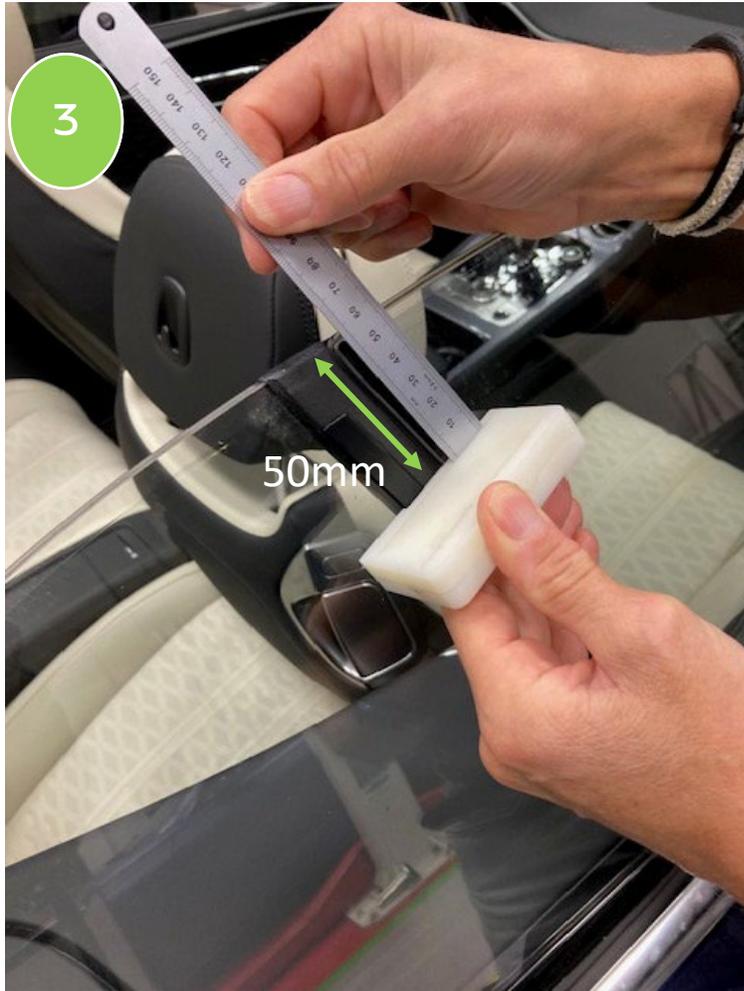
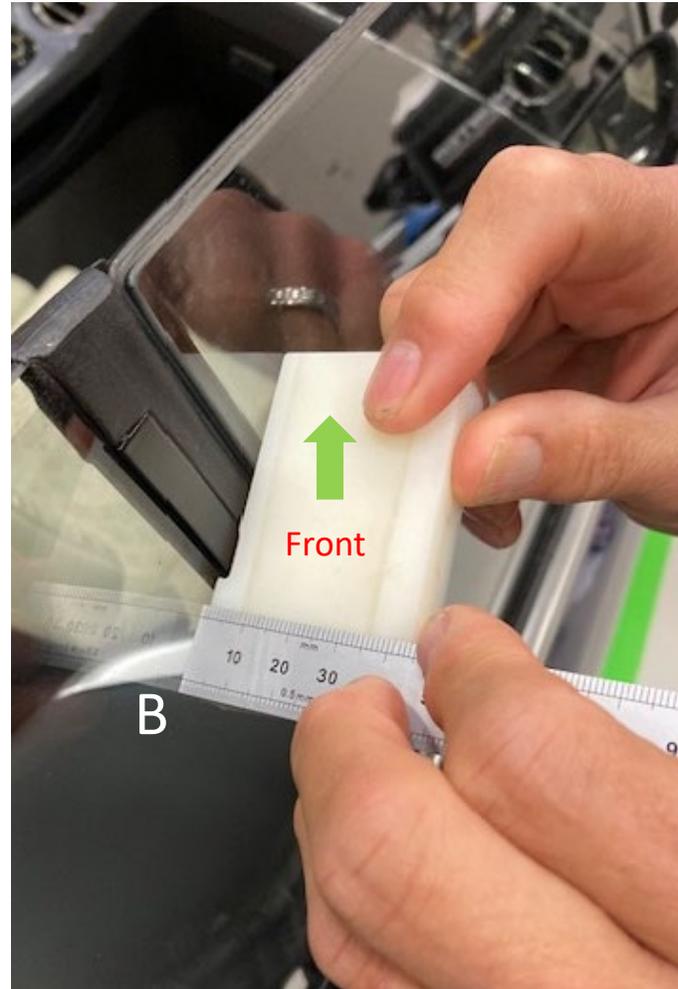
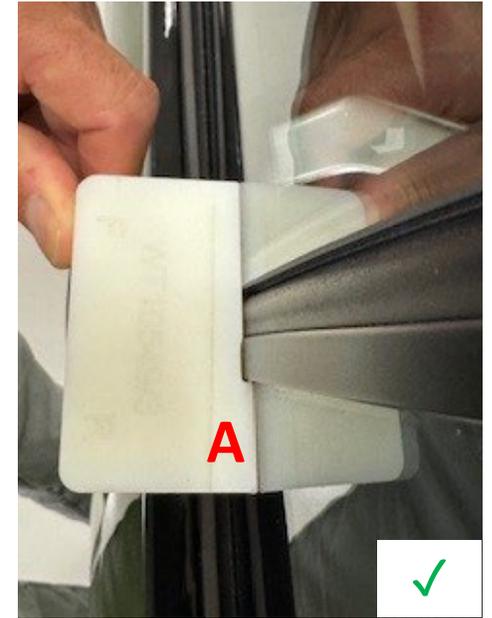
PROFILE POINT 3 ROOF DOWN

50mm from upper corner

Flat against front window,
measure gap

Point A tool against glass is
+2mm
Allowable up to 3mm refer to
Point B
(Profile Tool WT10549/3)

If the measurement is out of
specification refer to ElsaPro
**Repair Group 64 'Slide glass
checking and adjusting'**

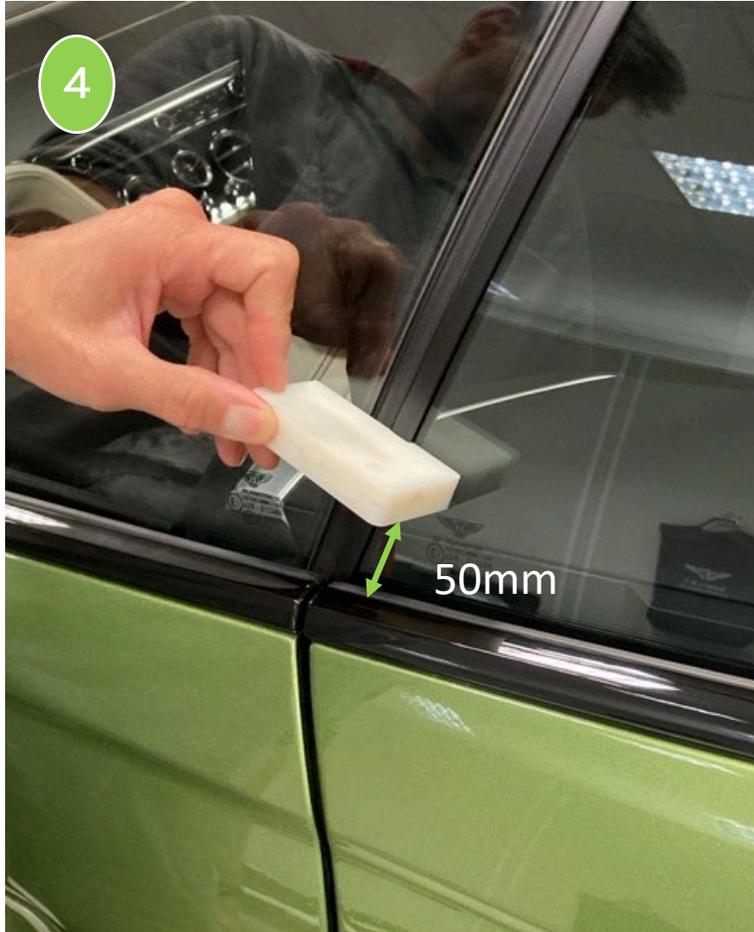
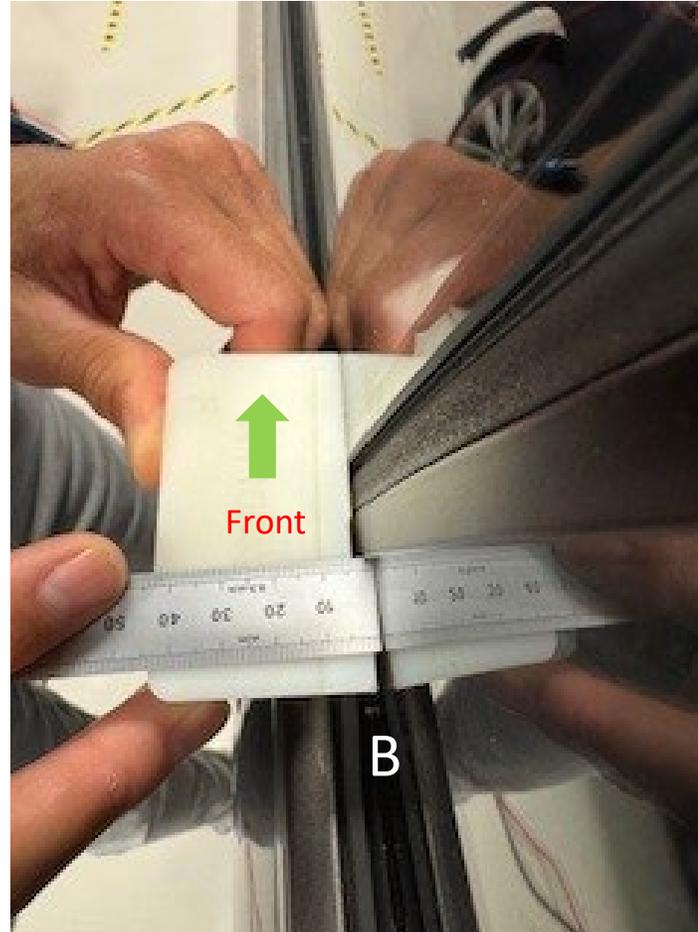
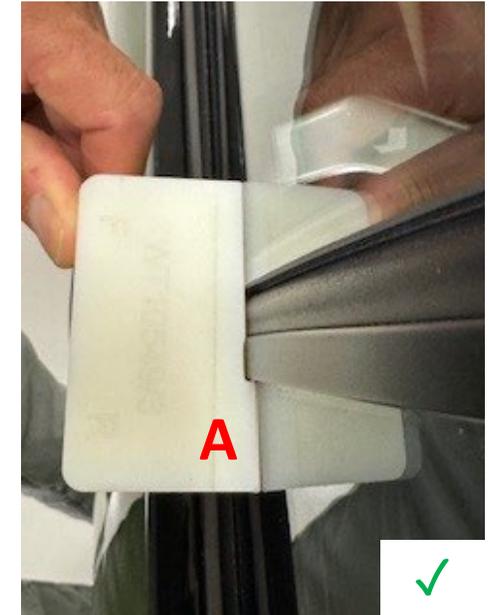
PROFILE POINT 4

50mm from lower corner

Flat against front window, measure gap

Point A tool against glass = +2mm
Allowable up to 3mm refer to Point B
(Profile Tool 17301)

If the measurement is out of specification refer to ElsaPro
Repair Group 64 'Slide glass checking and adjusting'

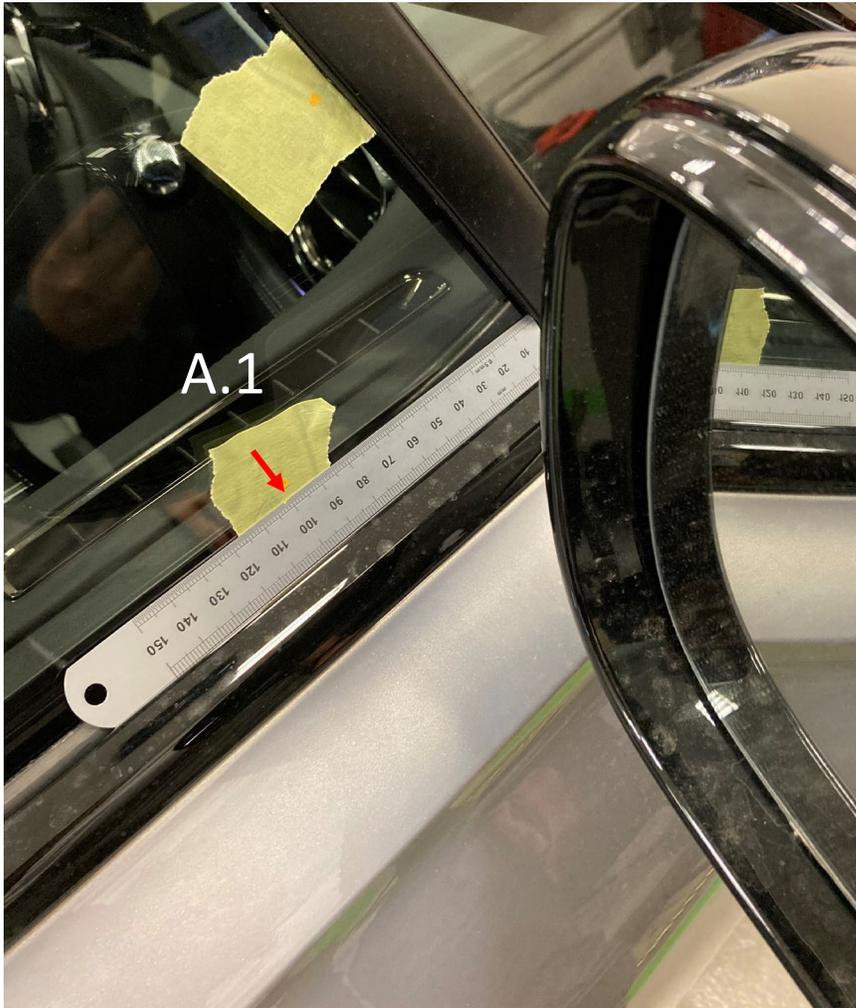
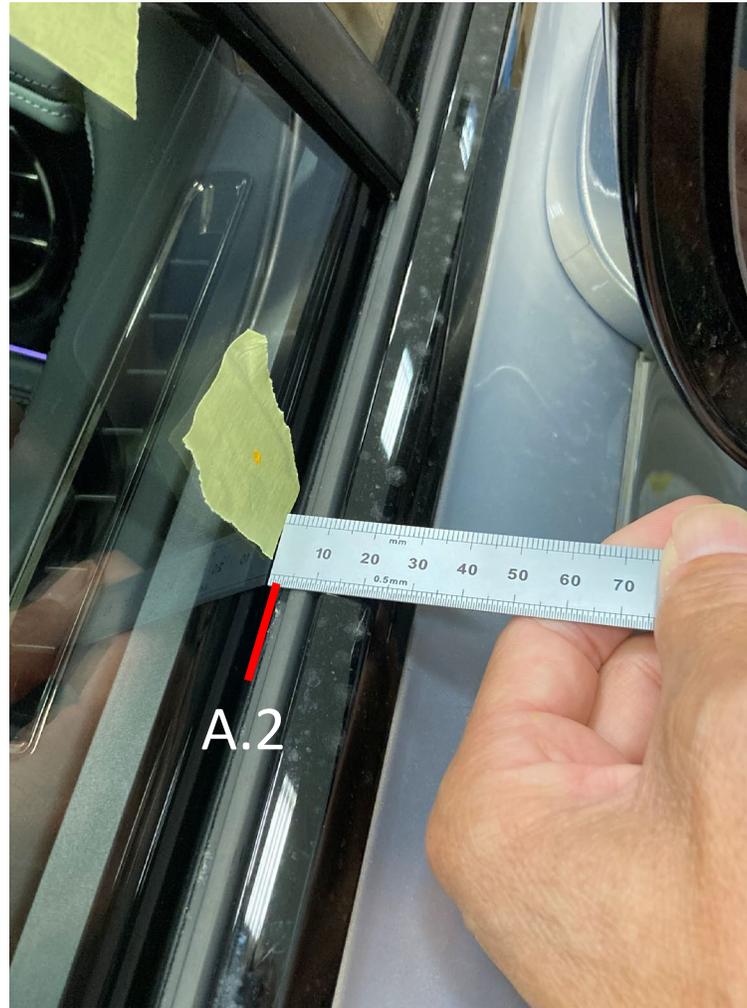
WAIST SEAL MEASUREMENT POINT A

Mark on tape 100mm from div bar (A.1)

Measure from first lip rubber seal to window glass (A.2)

Repair Group 64 'Slide glass checking and adjusting'

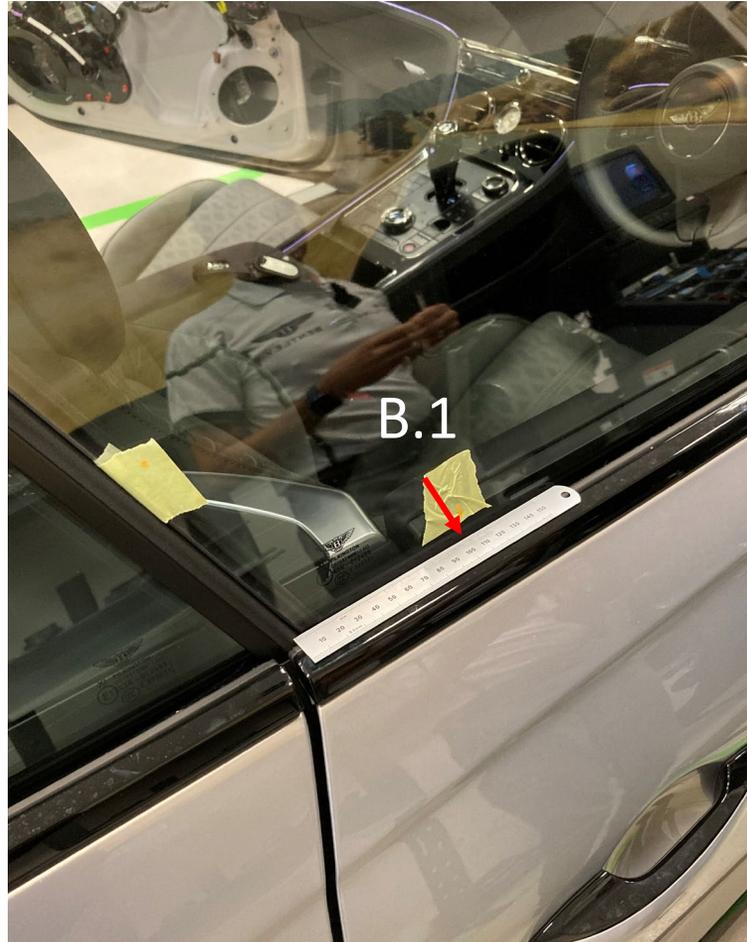
WAIST SEAL MEASUREMENT POINT B

Mark on tape 100mm from div bar (B.1)

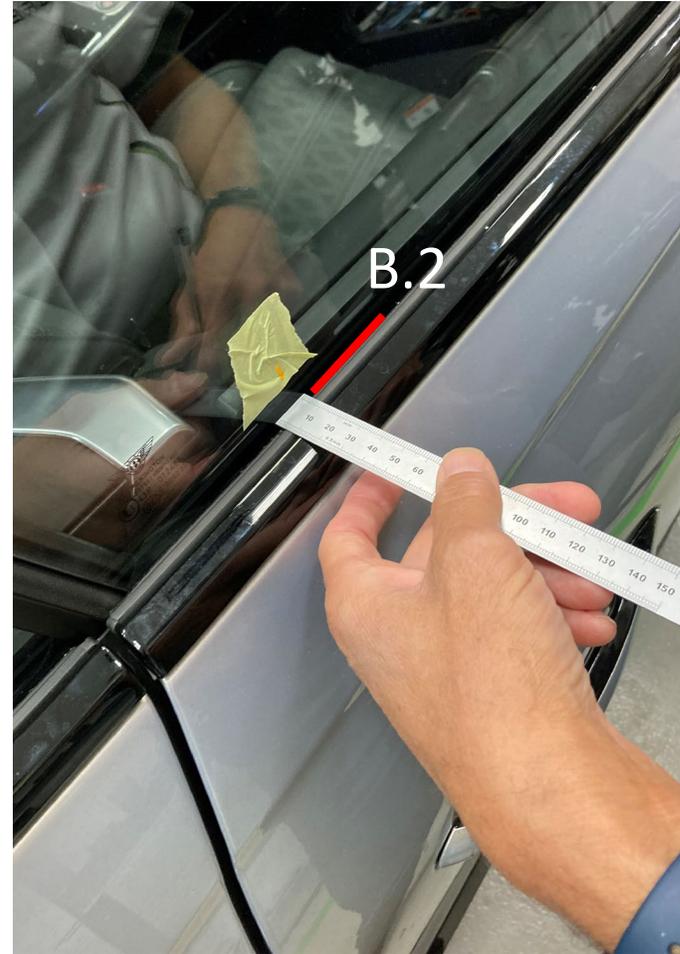
Measure from first lip rubber seal to window glass (B.2)

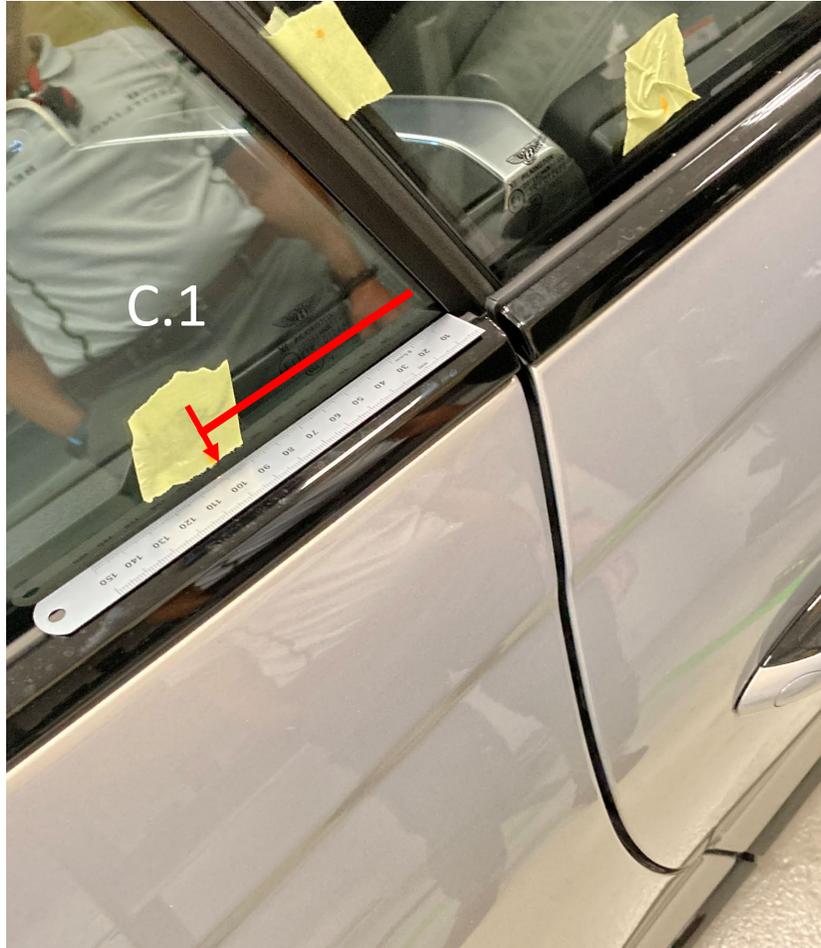
WAIST SEAL MEASUREMENT POINT C

Mark on tape 100mm from div bar (C.1)

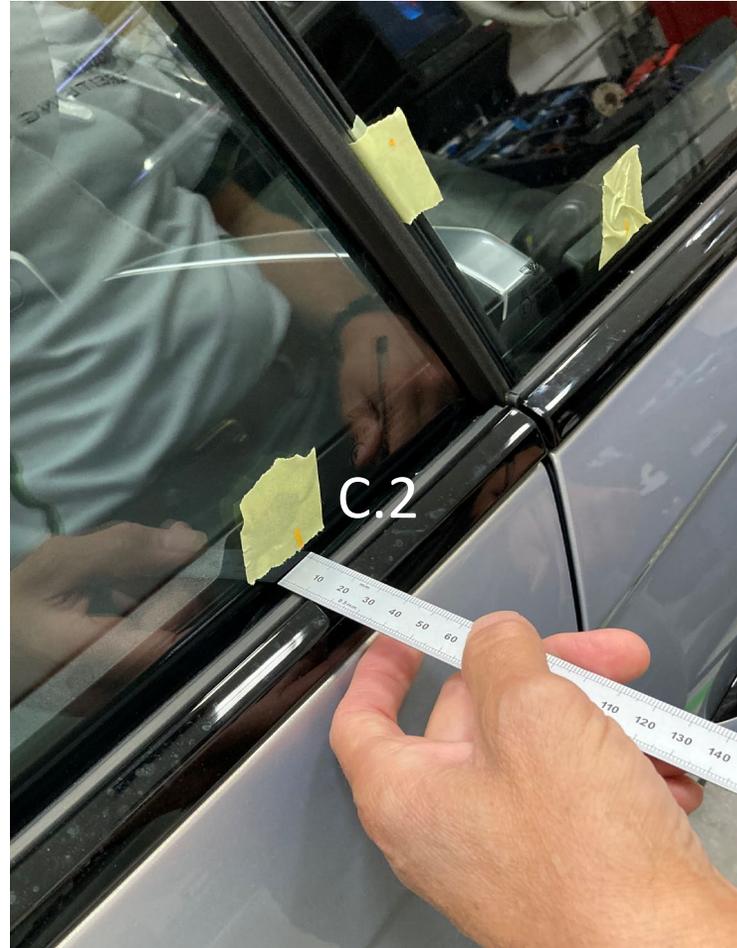
Measure seal to window gap (C.2)

If the measurement is out of specification refer to ElsaPro **Repair Group 64** 'Slide glass checking and adjusting'
