Technical Service Bulletin

GROUP HVAC	NUMBER 26-HA-001H
DATE JANUARY 2026	MODEL(S) SEE BELOW

SUBJECT: A/C VENT MODE CHANGE ISSUES/NOISES –
VENTILATOR LEVER INSPECTION & REPLACEMENT

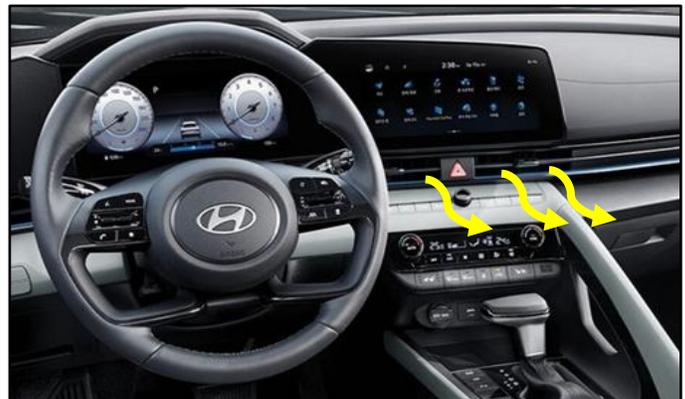
- If there is airflow out of the center vents, but other concerns are present, this TSB does **NOT** apply. Follow normal diagnostic procedures.
- If **NO** airflow is present from the forward-facing center vents, or a popping/snap noise is heard when switching modes, replace the ventilator lever and cam mode guide.

Proceed to **Ventilator Lever and Cam Mode Guide Replacement** procedure.
