01-25-09 - Service information, ID. Software (ID.S) Baseline Update ID.S 5.4.3
KD

Applicable Vehicles						
Model(s)	Year	Eng. Code	Trans. Code	VIN Range From	VIN Range To	PR Code
ID.4	2024 – 2025	All	All	All	All	V7B, V7C, V7G

Revision Table			
Instance Number	Published Date	Version Number	Reason For Update
2080124/3	1/5/2025	01-25-09	Update incorrect sequence (version) number
2080124/1	12/18/2025	01-25-07	Original publication.

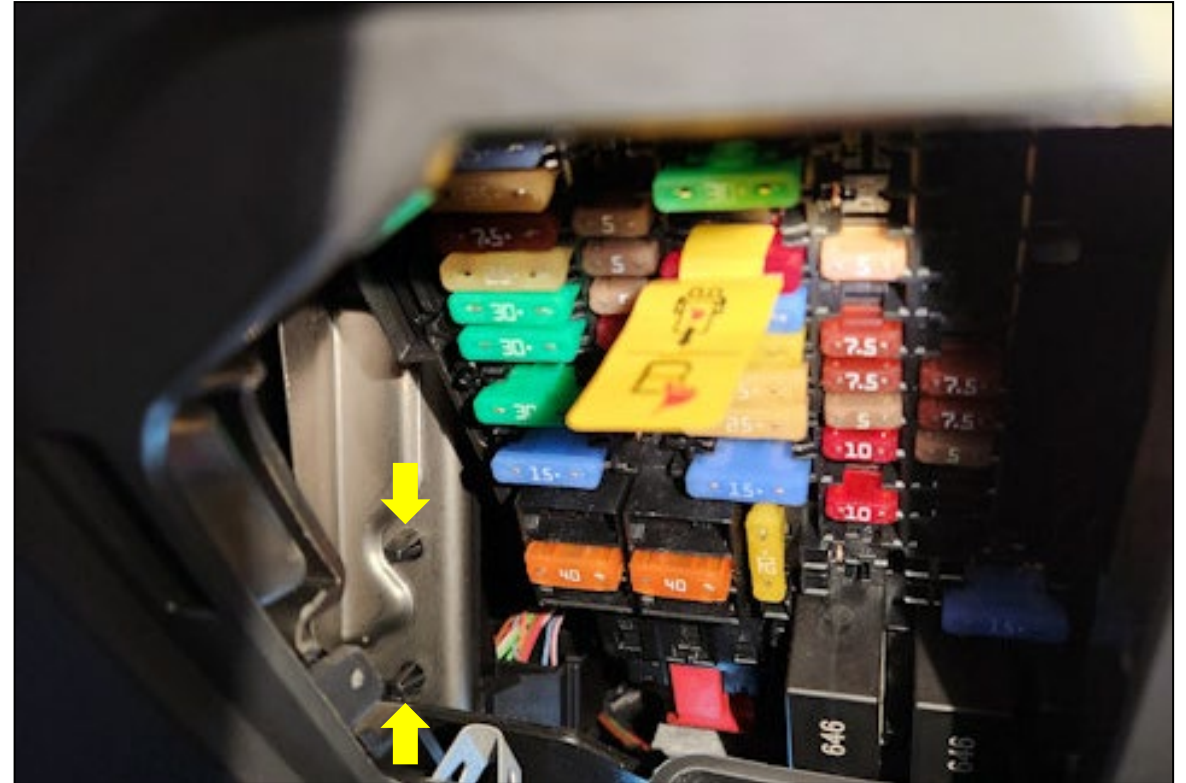
Accessing the diagnostic connection (U31)

- Remove the small access panel to the left of the steering column.
- Gently press upper and lower retainer tabs (yellow arrows) to release the bracket of the diagnostic connector (U31).

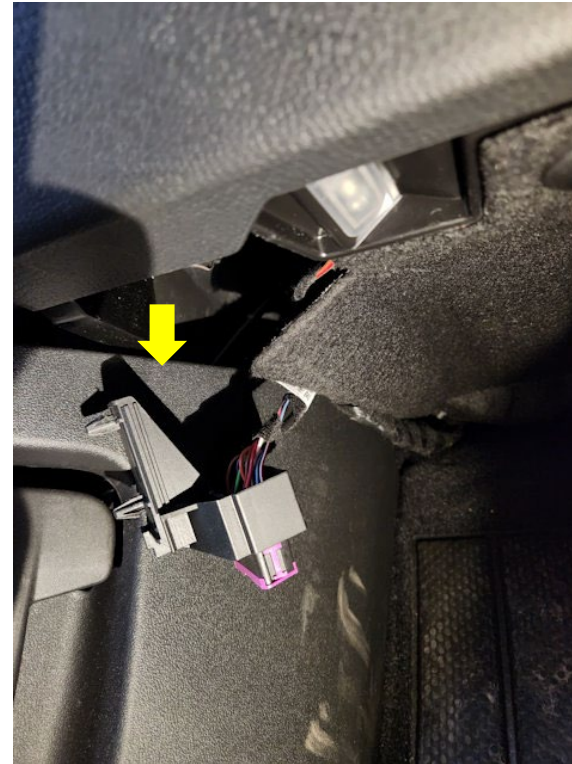
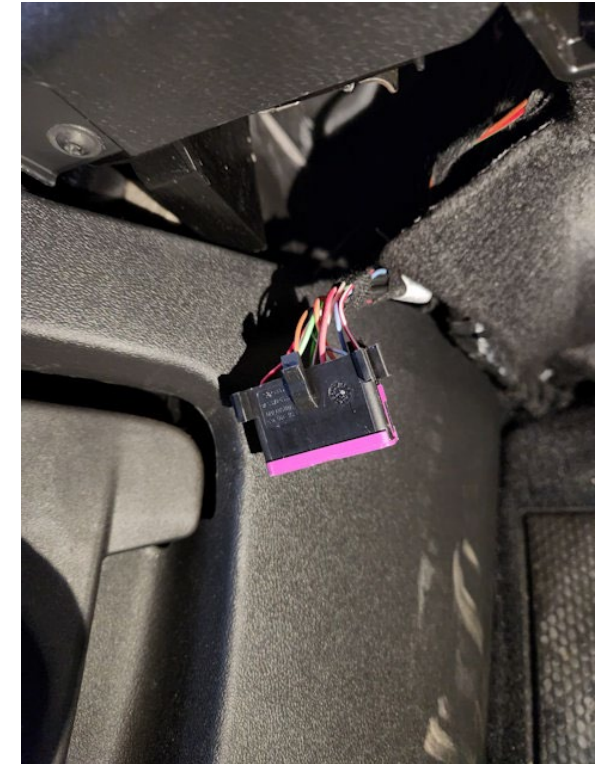
- The bracket can then be **CAREFULLY** pulled downwards into the footwell (yellow arrow) for inspection.
- The wires behind the diagnostic connection (U31) are then visible for inspection.
- If necessary, the bracket can be removed by releasing three additional retaining tabs on the diagnostic connection (U31).

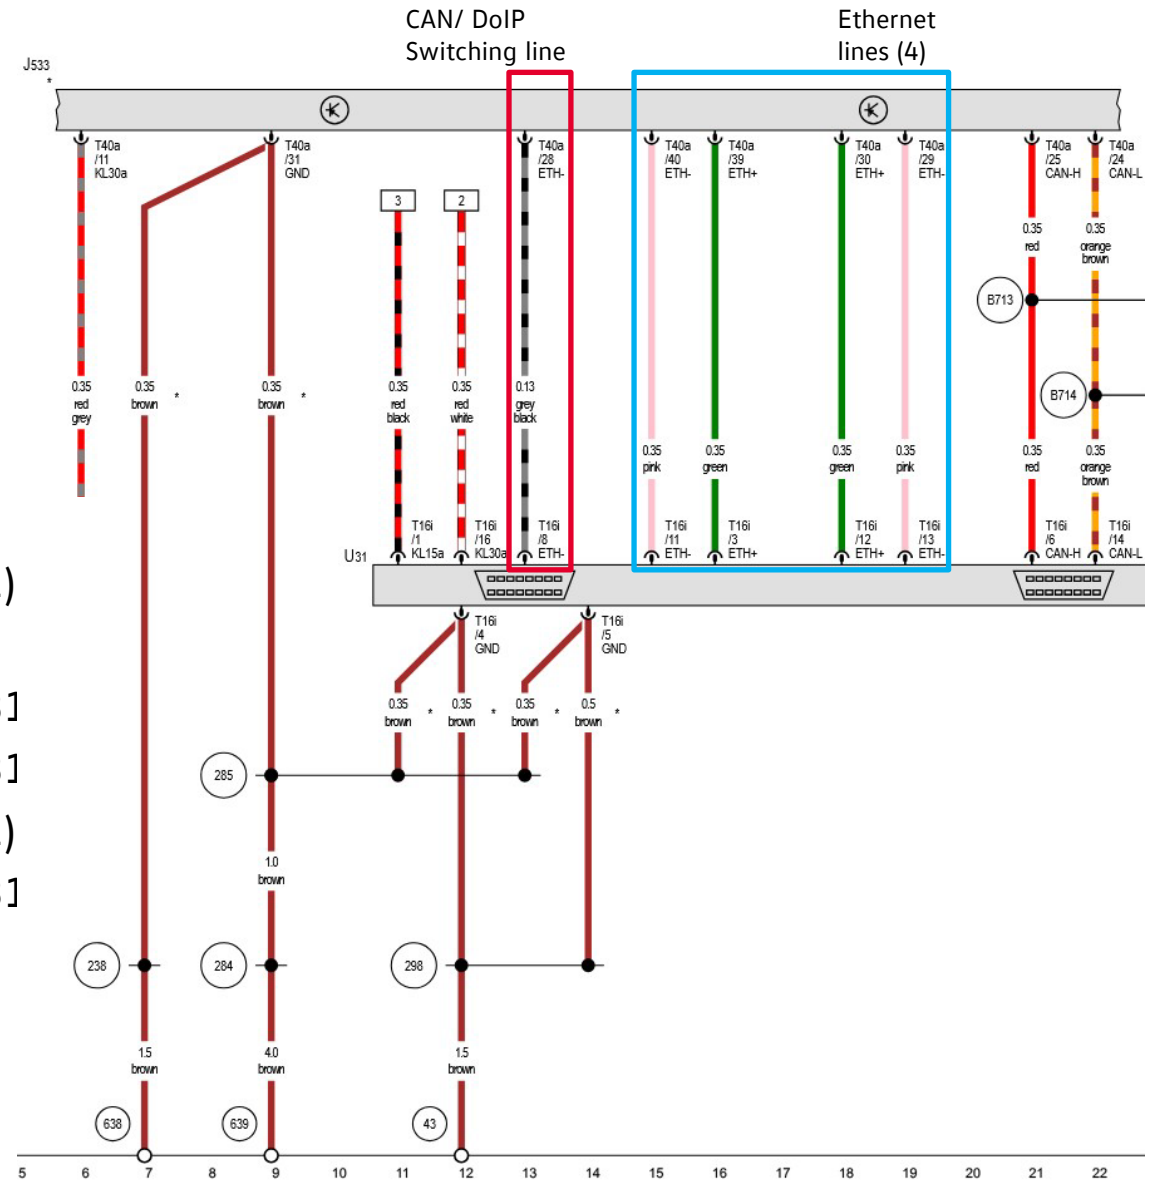
Wiring diagram of CAN/ DoIP control line and Ethernet lines

Control line for CAN/ DoIP switching (red rectangle)

Ethernet data lines (DoIP/ blue rectangle)

- T40a/30 Gateway (J533) <-> T16i/12 diagnostic connection (U31)
- T40a/29 Gateway (J533) <-> T16i/13 diagnostic connection (U31)
- T40a/39 Gateway (J533) <-> T16i/3 diagnostic connection (U31)
- T40a/40 Gateway (J533) <-> T16i/11 diagnostic connection (U31)
