**Little or No Cooling Power from the Air-Conditioning System: Checking Refrigerant Lines on Air-Conditioning Compressor (174/23)**

Model Line: **Panamera (971 / YAA / YAB)**  
**Cayenne (9YA / 9YB)**

Model Year: **As of 2019**

Concerns: **Air-conditioning compressor**

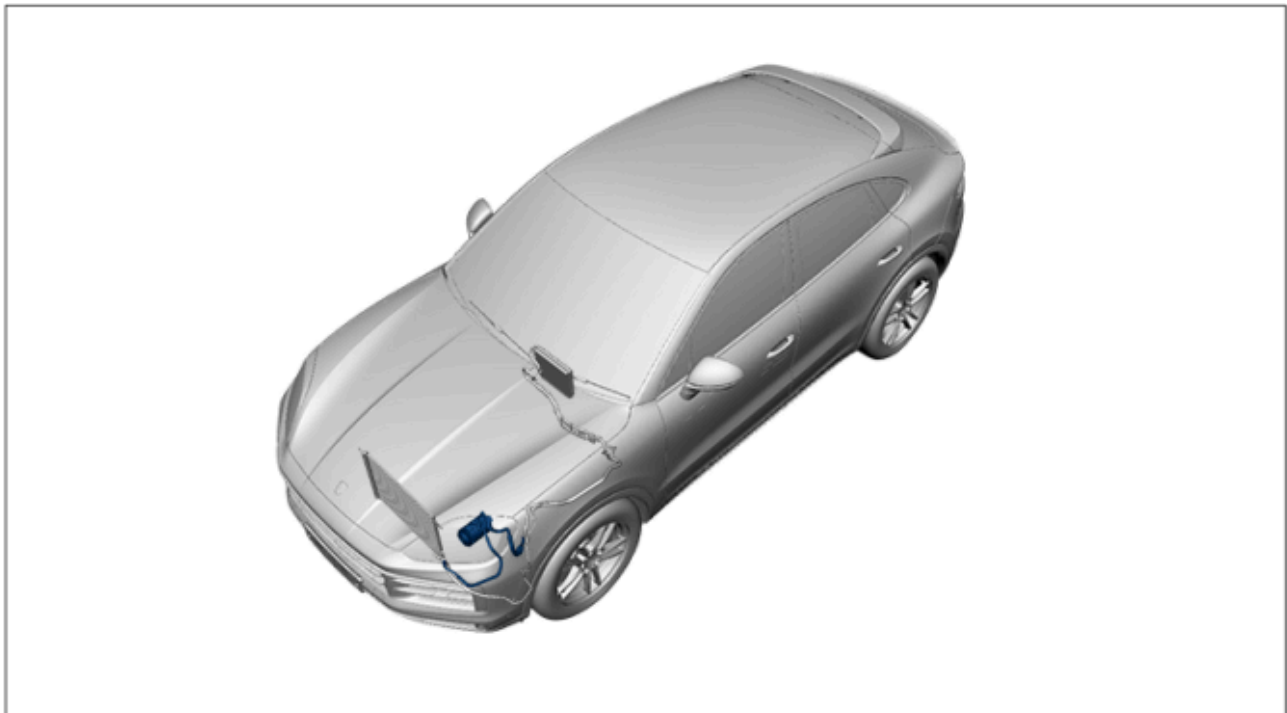
*Installation location for air-conditioning compressor / refrigerant lines (shown on the Porsche Cayenne)*

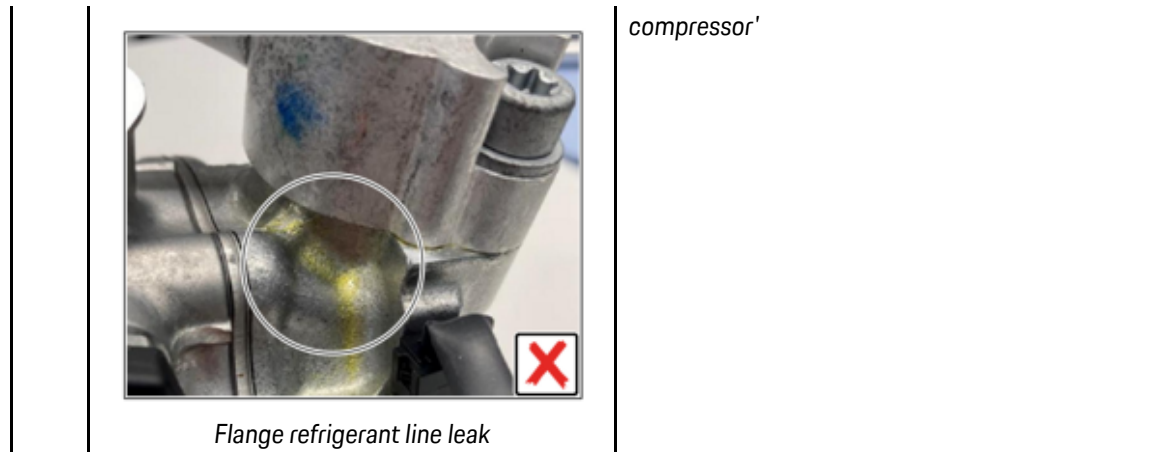
Assessment	Action
(✓)	No refrigerant compressor oil loss can be detected on flange ⇒ Oil loss on air-conditioning compressor -1- or air-conditioning compressor ⇒ Oil loss on air-conditioning compressor -2-.	Locate the complaint elsewhere. End of test. Continue with: ⇒ Technical Information '505619 Follow-up actions'
(✗)	Refrigerant compressor oil loss can be detected on flange ⇒ Oil loss on air-conditioning compressor -1- or air-conditioning compressor ⇒ Oil loss on air-conditioning compressor -2-. ⇒ Flange refrigerant line leak	Replace the O-ring of the affected refrigerant line. Continue with: ⇒ Technical Information '505619 Replacing O-ring refrigerant line on air-conditioning

- Work Procedure: 1 Replace the O-ring of the affected refrigerant line on the air-conditioning compressor.  
For procedure, see:  
⇒ Workshop Manual '874319 Removing and installing refrigerant line between compressor and condenser'  
⇒ Workshop Manual '874519 Removing and installing compressor/evaporator line (section from air-conditioning compressor to internal heat exchanger)'
