Troubleshooting AC Charging

Vehicles Affected

Models	Model Year	Model Type	VIN Range	Vehicle-Specific Equipment
Taycan (J1-I)	As of 2020	Y1A, Y1B, Y1C	N/A	N/A
Panamera (G2-I)	As of 2021	971	N/A	E-Hybrid Variants
Cayenne (E3-I)	As of 2020	9YA, 9YB	N/A	E-Hybrid Variants
Macan (H2)	As of 2024	XAB	N/A	N/A

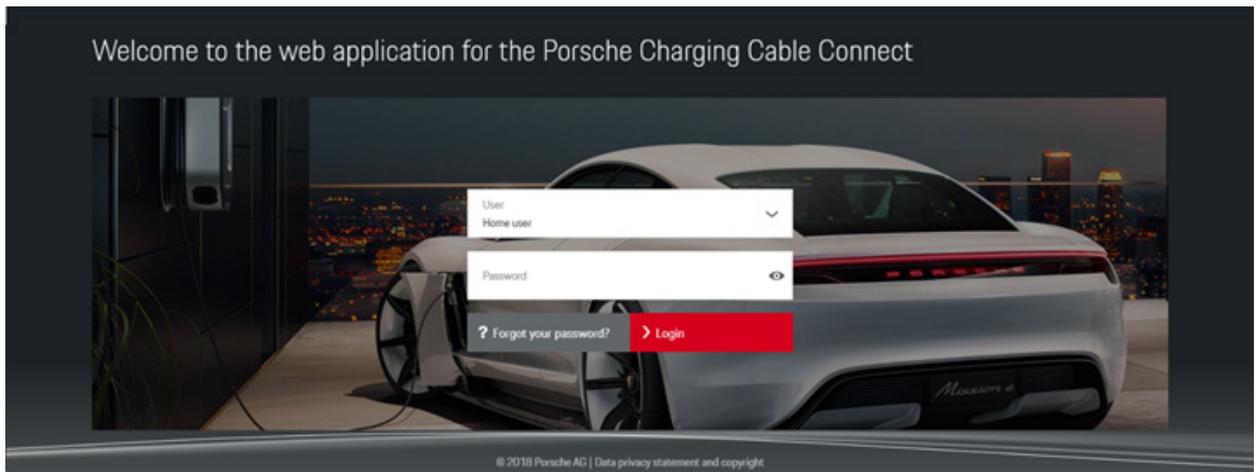
Figure 2

4. Open your internet browser (i.e. Chrome, Safari, Firefox) and go to 192.168.0.1
 - a. NOTE: When logging in via private or local IP address, a security warning may be shown on the browser. In the warning message in your browser, select Advanced then Add exception (or similar). The SSL certificate is confirmed and the browser opens the web application
 - b. Afterwards, the following site will open (see Figure 2)

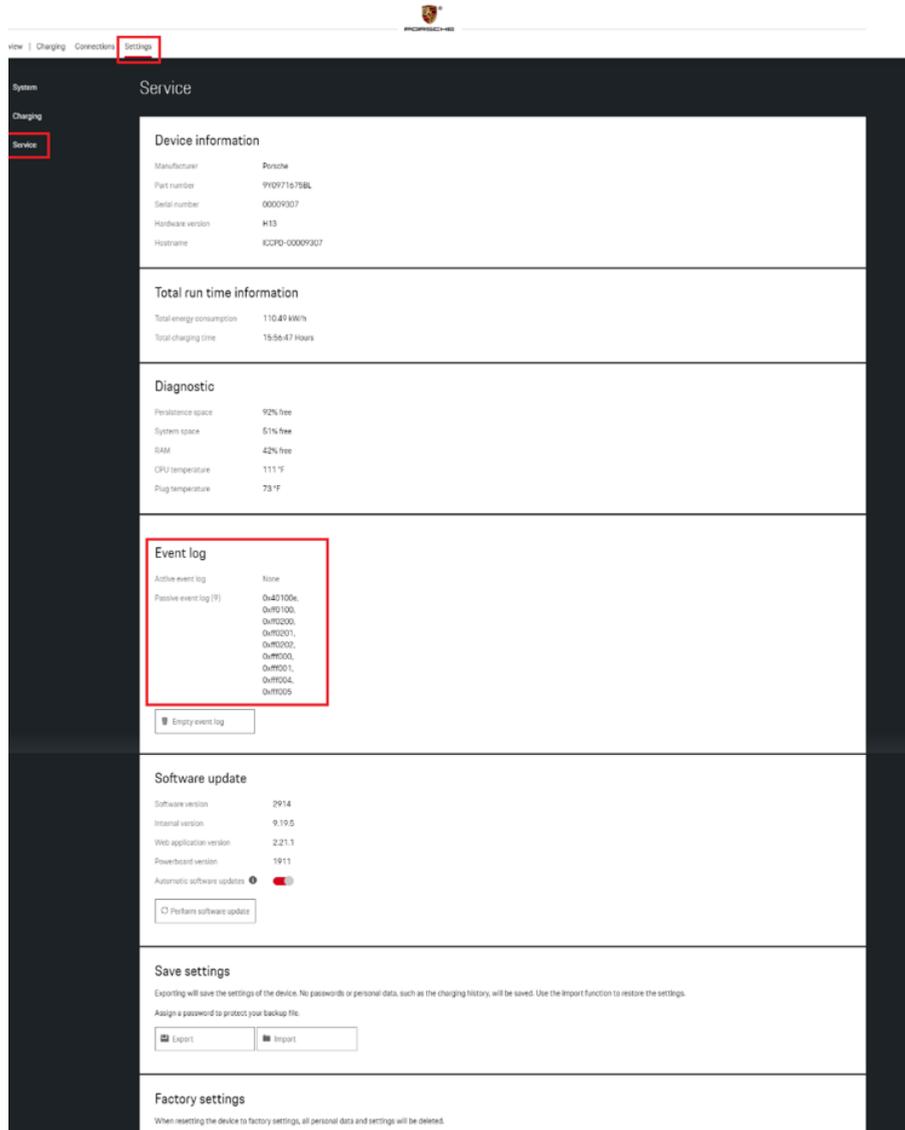
Figure 3

5. Log into the Web App as Customer Service (see "Logging into Web Application" section)
6. DTCs from the Web Application
 - a. Go to **Settings ->Service** and scroll down to **Event log** (see Figure 3)
 - b. Click the hyperlink for each DTC and save DTC data as needed (see Figure 4)
This data can also be copied & pasted into a notepad or document to be saved & shared (just be sure to capture all DTC information)

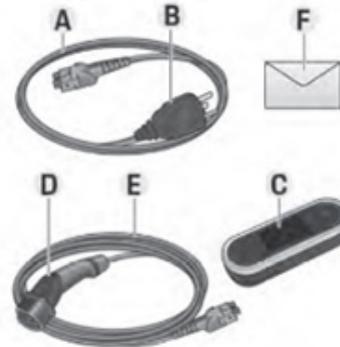
Figure 10

1. Printed on the "Letter containing access data" (F in Figure 10) included with new vehicle purchase -or- provided with a PMCC purchased via Porsche Parts
2. Via the SoliD portal, accessible by certain Technical Support and Call Center personnel
3. Via PCSS --> Vehicle --> Charging Products
