# HYUNDAI

## Technical Service Bulletin

GROUP	NUMBER
ENGINE MECHANICAL	26-EM-003H
DATE	MODEL(S)
FEBRUARY 2026	SONATA (DN8/DN8A)

**SUBJECT:** INTEGRATED THERMAL MANAGEMENT (ITM) REPLACEMENT & ECM/TCU SOFTWARE UPDATE – DTCS P218100, P2181F0, P2181F1

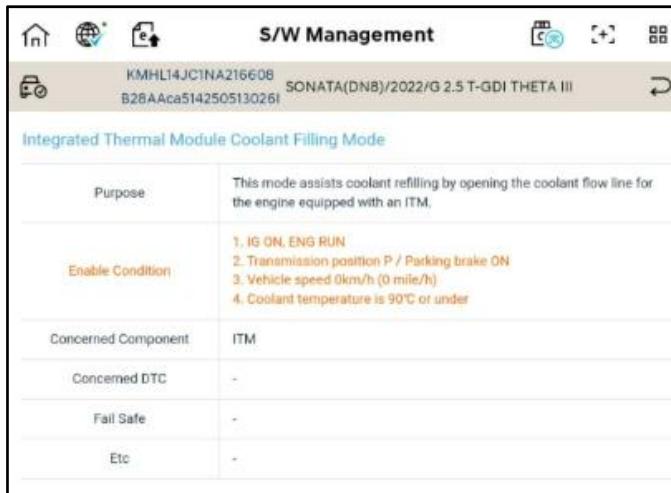
Failure to follow the ITM bleeding procedure under **S/W Management** in GDS may result in air pockets and overheating of the engine.

1. Use GDS to perform the **Integrated Thermal Module Coolant Filling Mode**.
