HYUNDAI

Technical Service Bulletin

GROUP ENGINE MECHANICAL	NUMBER 26-EM-004H
DATE FEBRUARY 2026	MODEL(S) TUCSON (NX4, NX4A)

SUBJECT: INTEGRATED THERMAL MANAGEMENT (ITM) REPLACEMENT & ECM/TCU SOFTWARE UPDATE – DTC P218100, P2181F0, P2181F1

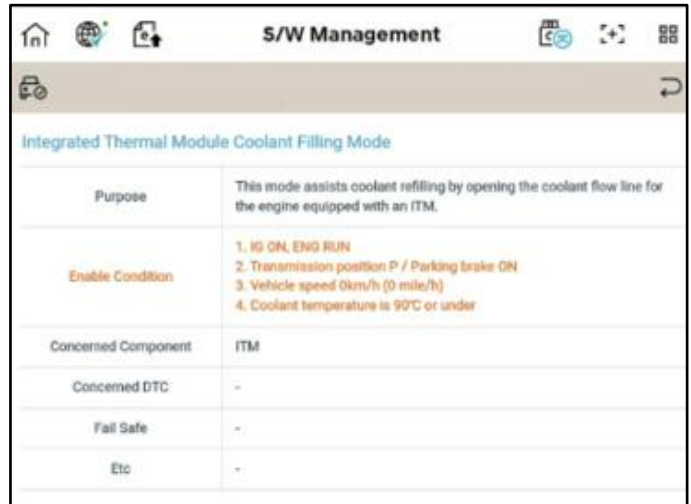
Failure to follow the ITM bleeding procedure under **S/W Management** in GDS may result in air pockets and overheating of the engine.

1. Use GDS to perform the **Integrated Thermal Module Coolant Filling Mode**.
