RAPID UPDATE

Rapid Update 812 Grecale – Multi SW Upgrade Pack

DATE: February 9, 2026

VEHICLES INVOLVED: (M182) Grecale MY23, MY24 and MY25

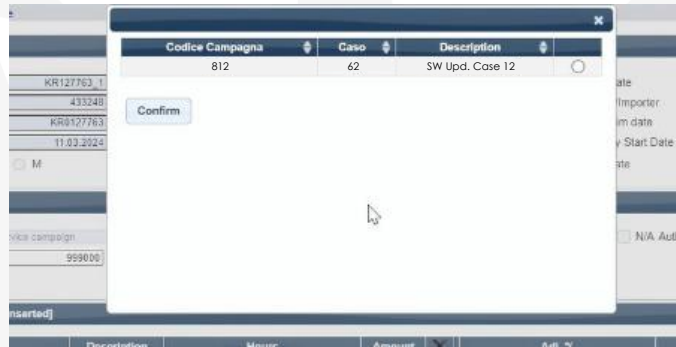
When the Service Entry is opened and a claim is created, Modis automatically recognizes the case assigned to the VIN and suggests the appropriate software. Only one case is suggested, helping to avoid errors.

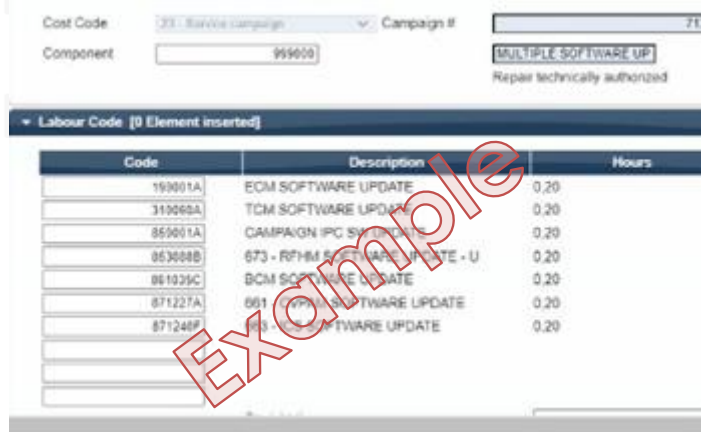
TIP: We recommend opening the claim in temporary status and confirming only the option suggested by the system. This makes it easier to understand the list of modules to be updated.

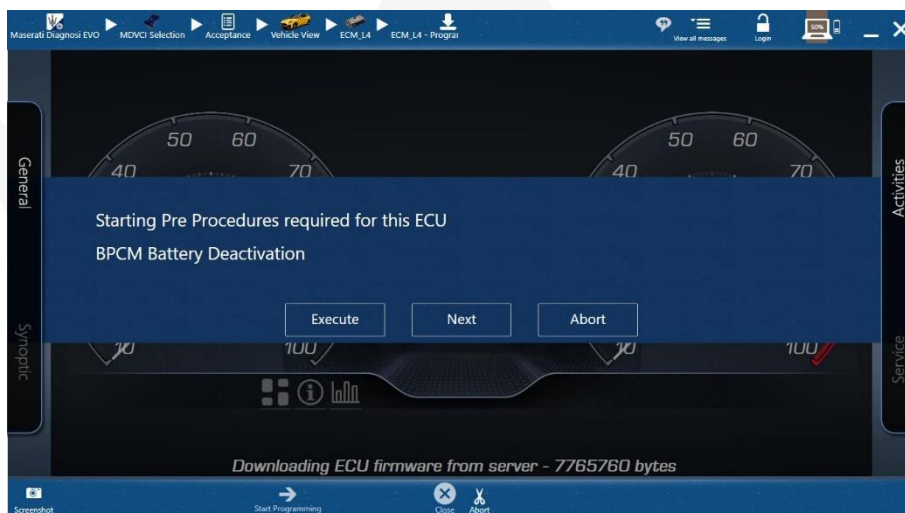
- Press “**Execute**” during the pre- procedures :
