HYUNDAI Technical Service Bulletin

NUMBER
26-BE-002H

SUBJECT: INOPERATIVE HORN ASSEMBLY REPLACEMENT

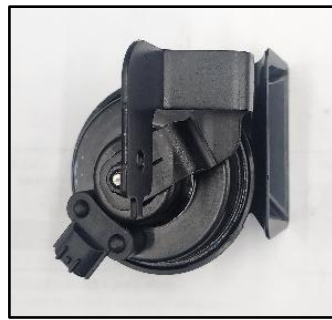
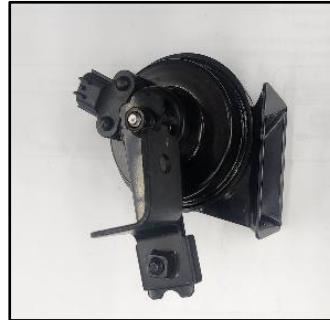
Description: Some Tucson Internal Engine Combustion (ICE), Hybrid, and Plug-in Hybrid (NX4, NX4 HEV, and NX4 PHEV) vehicles may have an inoperable horn that may be caused by foreign substances causing internal parts to oxidize. This bulletin provides instructions on how to replace both inoperable horns.
