# Technical Service Bulletin

GROUP <b>BODY ELECTRICAL</b>	NUMBER <b>26-BE-003H</b>
DATE <b>FEBRUARY 2026</b>	MODEL(S) <b>TUCSON (NX4A)</b>

**SUBJECT:** INOPERATIVE HORN ASSEMBLY REPLACEMENT

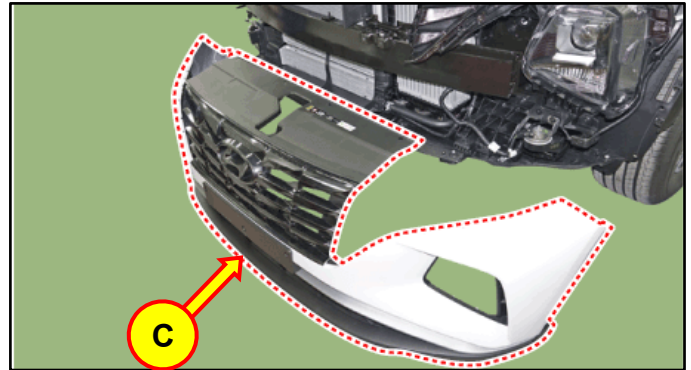
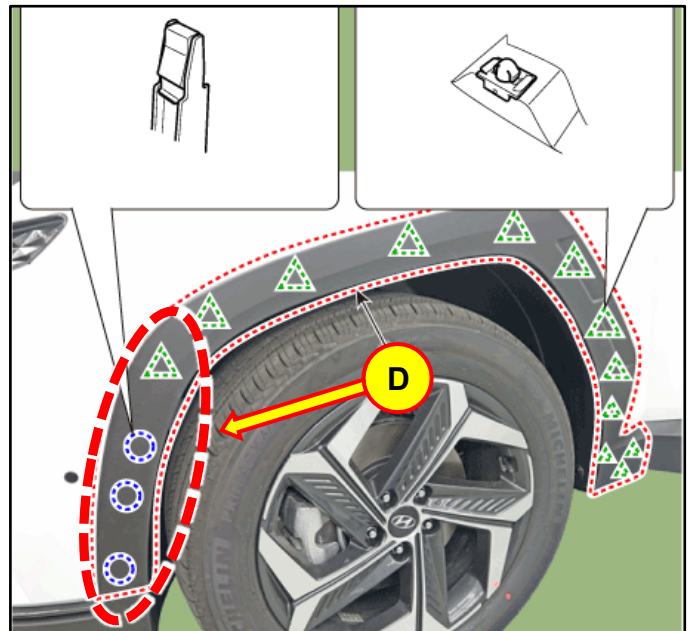
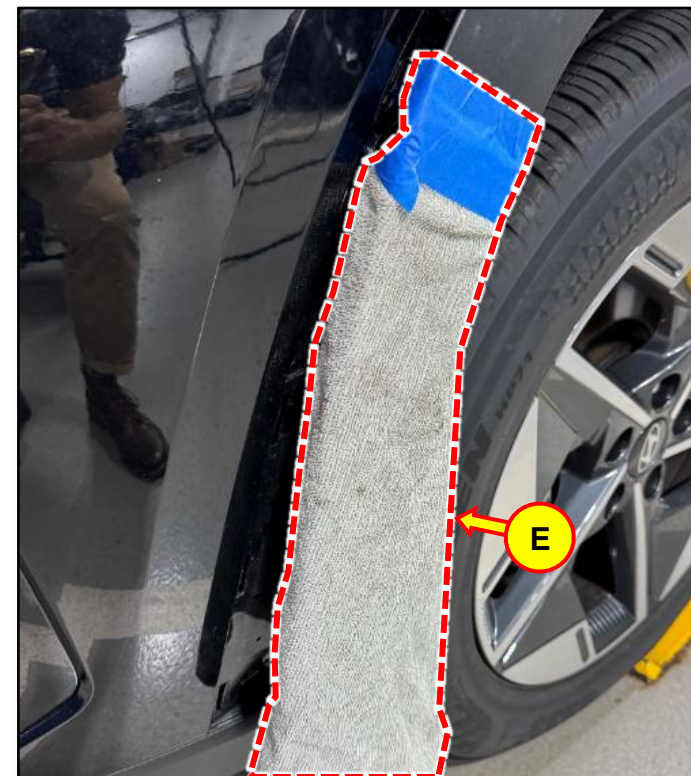
3. Refer to the shop manual to remove the front bumper assembly (C):
  - **Body (Interior and Exterior) > Front Bumper > Front Bumper Assembly > Repair procedures**

To prevent clip breakage during bumper removal, partially remove the fender garnish by detaching the front 4 clips (D).

Protect the removed portion with painter's tape and a microfiber rag (E) to avoid damage.
