Technical Service Bulletin

GROUP AUTOMATIC TRANSMISSION	NUMBER 26-AT-002H
DATE FEBRUARY 2026	MODEL(S) SANTA FE (TMA) TUCSON (NX4A)

SUBJECT: ELECTRIC OIL PUMP REPLACEMENT - DTC U028700

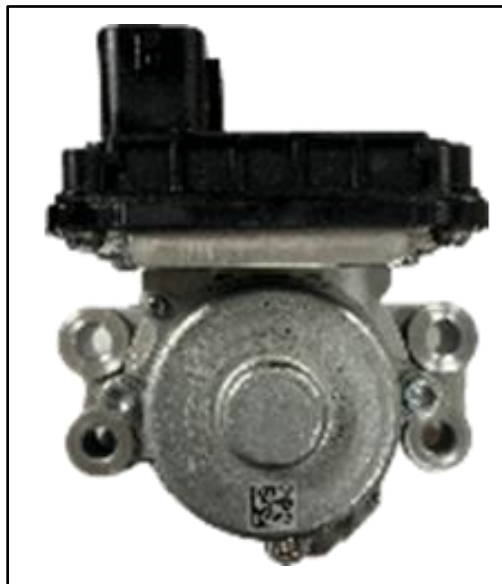
Description: Some Santa Fe (TMA) and Tucson (NX4A) vehicles equipped with a 2.5L GDI engine and 8 speed automatic transmission may have DTC U028700 (Lost Communication With Trans Fluid Pump Module) set by the transmission Electric Oil Pump (EOP). This DTC can cause the Idle Stop & Go (ISG) system to become inoperative. Follow the procedure in this bulletin to replace the Electric Oil Pump on affected vehicles.
