Water ingress at sliding sunroof

Topic number	LI77.20-P-073486
Version	2
Function group	77.20 - Electric sliding roof
Date	2/24/26
Validity	Type 463 as of model year 2019 (as of code XZ8) and sliding sunroof (code F15) type 465 with SA code 414
Reason for change	Expanded to include BR465 and adaptation of remedies

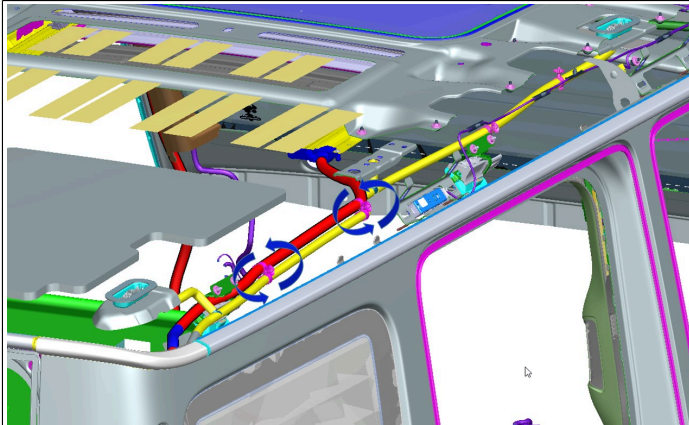
1. Incorrectly routed drain hoses: Water may accumulate in the rear area of the sliding sunroof frame (see picture #1). For example, the rear drain hoses may have been routed without sufficient slope, which consequently leads to the drains overflowing. Water can enter the vehicle interior through the headliner.
2. Sliding sunroof adjustment: An improper positioning of the tilting/sliding roof within the roof frame may, under certain circumstances, lead to increased water ingress through the seal between the sliding sunroof frame and the roof. However, one drop is permissible here.
3. Material degradation: Over time, the seal of the tilting/sliding roof may experience age-related changes in its elasticity, which could potentially affect its watertightness.

Re. cause 1:
