INSTRUCTION TO SERVICE

ITS61456		02/12/26
SECTION:	460-Windows	
SUBJECT:	Realign windshield support plate	
ISSUE:	Vertical stress crack on windshields	
SUMMARY:	Rework windshield frame per this ITS

ITS61456

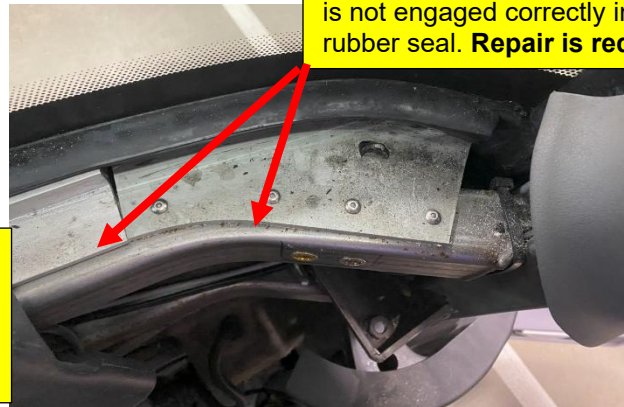
Center support profile.

The aft edges of the center and side plates are aligned that indicates that the small side plate is not engaged correctly inside the rubber seal. **Repair is required.**

3. If windshield was recently replaced due to vertical stress crack, and the new windshield has no cracks now, then the frame repair can be done from inside, without removing the windshield. Inspect side plate alignment from outside: if the aft edges of the center and side plates are aligned then repair is required. Refer to Figure 1 below.
