G2.II Panamera - Exclusive Design Taillight Faulty

Vehicles Affected

Models	Model Year	Model Type	VIN Range	Vehicle-Specific Equipment
Panamera	As of 2021 up to 2024	971	All	8VQ - Exclusive Design Taillight

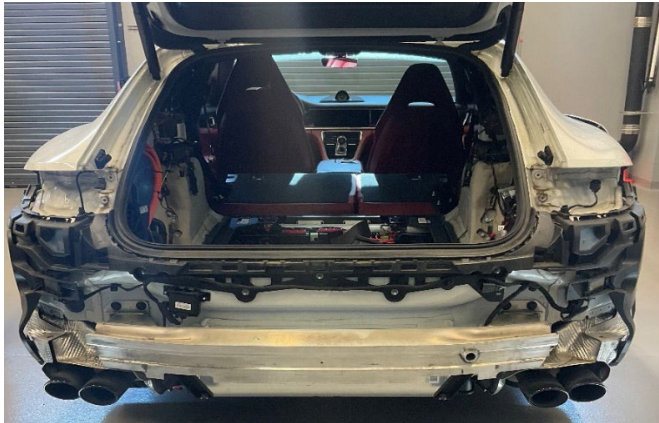
Figure 6. Rear End Prepared for Rework

1. Preliminary work (Figure 6 & 7)

- Taillights (center and left/right)
- Rear lid trim panel and rear apron/bumper cover
- Luggage compartment trim panels (center, side, and lock carrier)
- Rear lock carrier cover
- Rear luggage compartment side trim panel
- C-pillar (upper) and D-pillar trim panels
- Subwoofer (BOSE® system) and tire sealant/compressor (if equipped)
- Retaining bar for electrical system battery
