**PRODUCT CAMPAIGN BULLETIN**

| <b>APPLICABILITY:</b> | 2026MY Forester | <b>NUMBER:</b> | <b>WRG-25R</b> |
| <b>SUBJECT:</b> | Safety Recall and Stop Sale: Rear Gate Stay Bracket | <b>REVISED:</b> | <b>02/24/26</b> |

Subaru of America, Inc. (Subaru) has initiated a safety recall for certain 2026 model year Forester Vehicles to replace the rear gate stay and bracket.

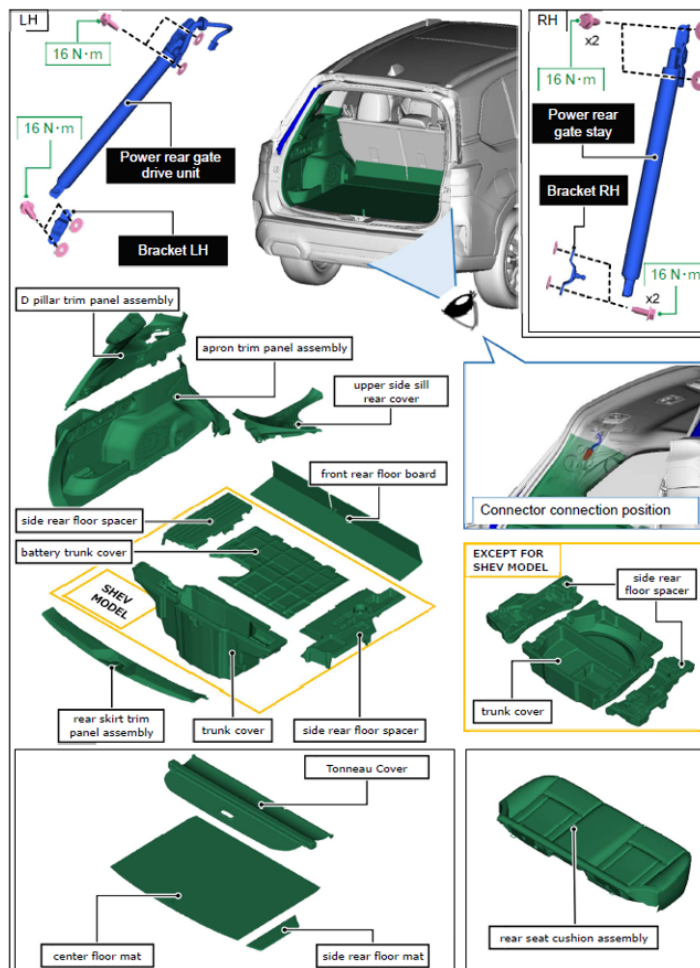
Power rear gate model:

The affected vehicles may have been manufactured with an incorrect and/or incorrectly oriented rear gate stay bracket which may cause the rear gate stay to become detached without prior warning during use.

**Important: If either part fails the inspection, both the bracket and stay, or the bracket and drive unit, must be replaced.**
