ID # CBR-439

Volvo Chassis - Water leaking Around The Windshield - Model Year 2018 and Newer

Vehicles with the 2018 body update may experience water leaks around the windshield.

Volvo Chassis - VN

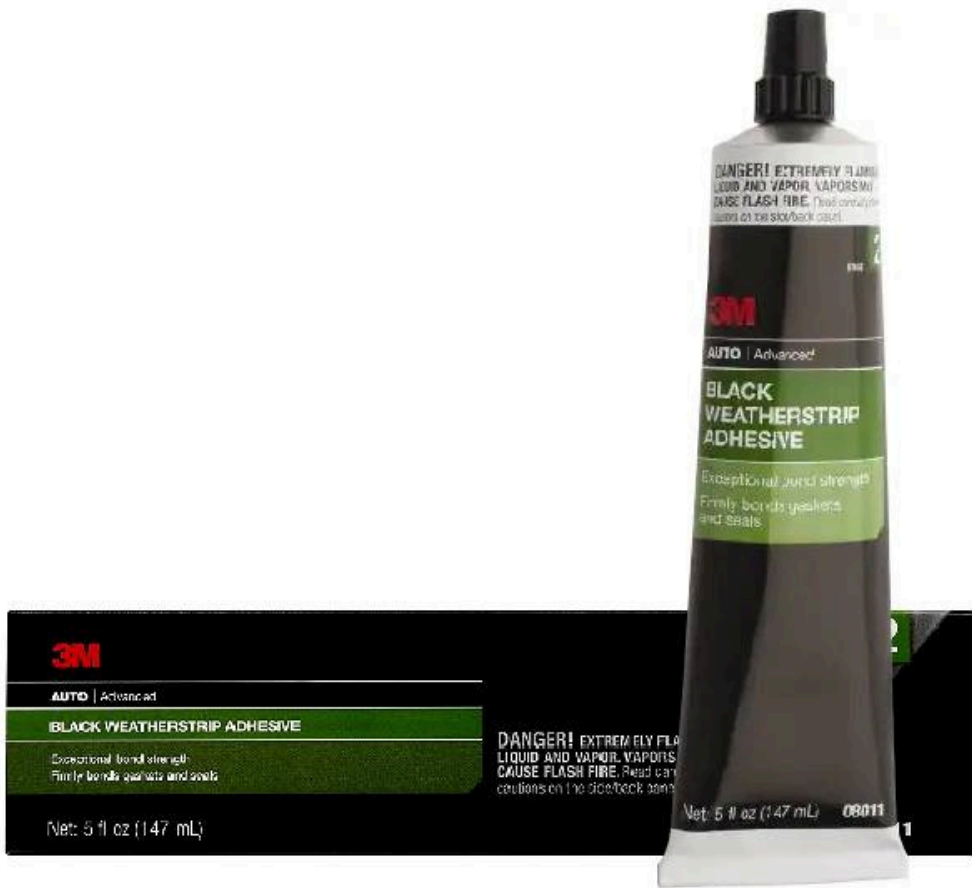
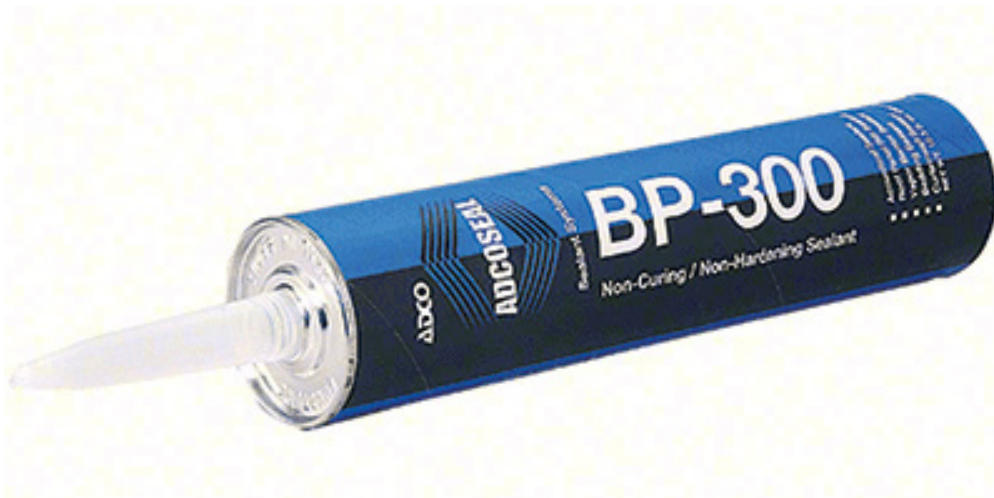
Live UI **aks At The Top Corner Of The Windshield**

This CBR solution provides the replacement procedure for properly sealing VN windshields before installing the aftermarket seal and windshield.

- Aftermarket Windshield Seal
- Sealant (BP300, 3M Super Weatherstrip and Gasket Adhesive, or similar)
- Proper Safety Equipment:
 - Chemical-resistant gloves
 - Eye protection
 - Apron or other protective gear as required by safety or company regulations

- Ensure Safety: Wear proper safety equipment (chemical-resistant gloves, eye protection, apron, etc.).
- Windshield Removal: Remove the windshield and seal only if the existing seal is leaking or damaged.

Live UI :h Weld Area: Clean the dirt and old adhesive away from the pinch weld area to minimize contamination
