## Technical Service Bulletin

### 91X4 UPDATE

### MMI Software Update – (pre-requisite to Compliance Recall 90TV)

**Applies to ALL vehicles with recall 90TV showing open in ELSA/Elsa2Go, regardless of warranty status.**

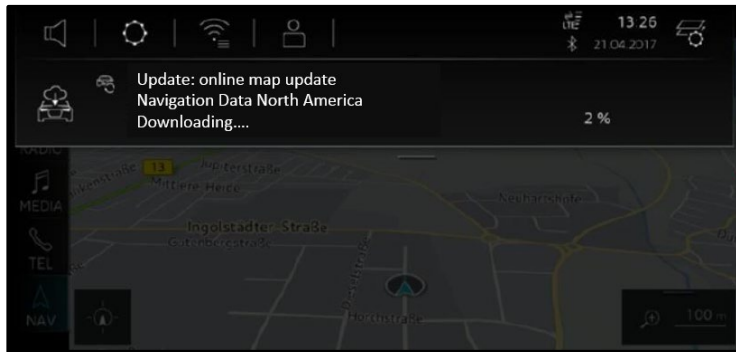
If the infotainment system happens to be in a navigation data download mode (“Downloading...,” as shown), please interrupt this by activating the slider for privacy mode (Home > Settings > Privacy settings > Activate privacy).

Please ensure that you deactivate privacy mode again after the software update is complete.

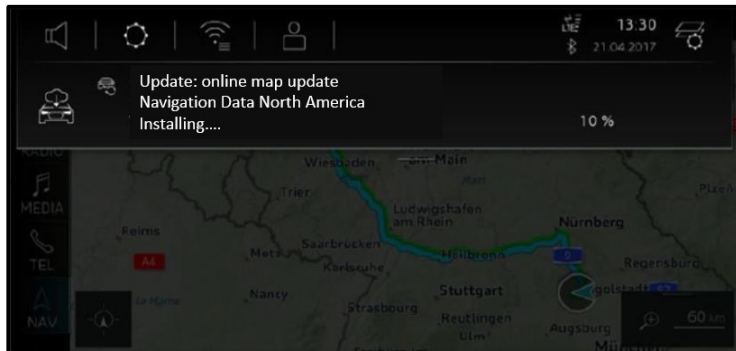
If the navigation database update is already being installed (“Installing...,” as shown), please wait and ensure that the installation is fully complete before continuing with the 91X4 software update.

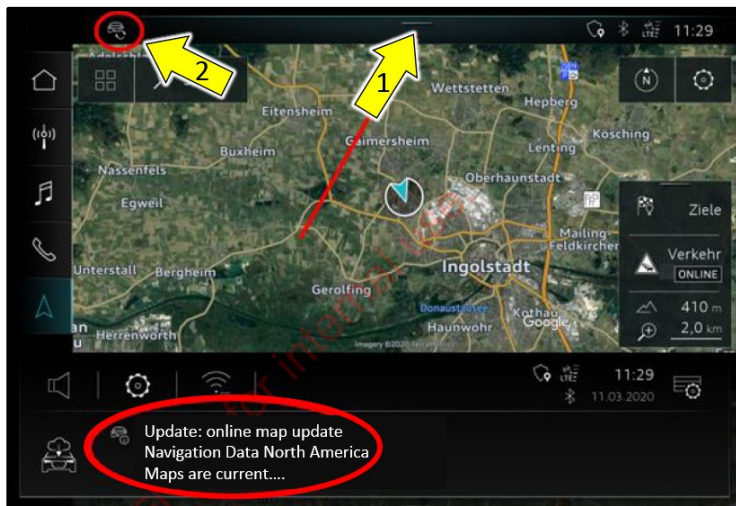
If a navigation database update is already complete, it is very important to confirm this manually in the notifications center of the MMI.
