**Document ID:** IK1201505

**Title:** S13 Integrated Powertrain Known Leak Diagnostics

**Applies To:** S13 Integrated Powertrain

This article is to walk through and assist the technician in diagnosing and repairing some of the known leaks around the **S13 Integrated Powertrain**.

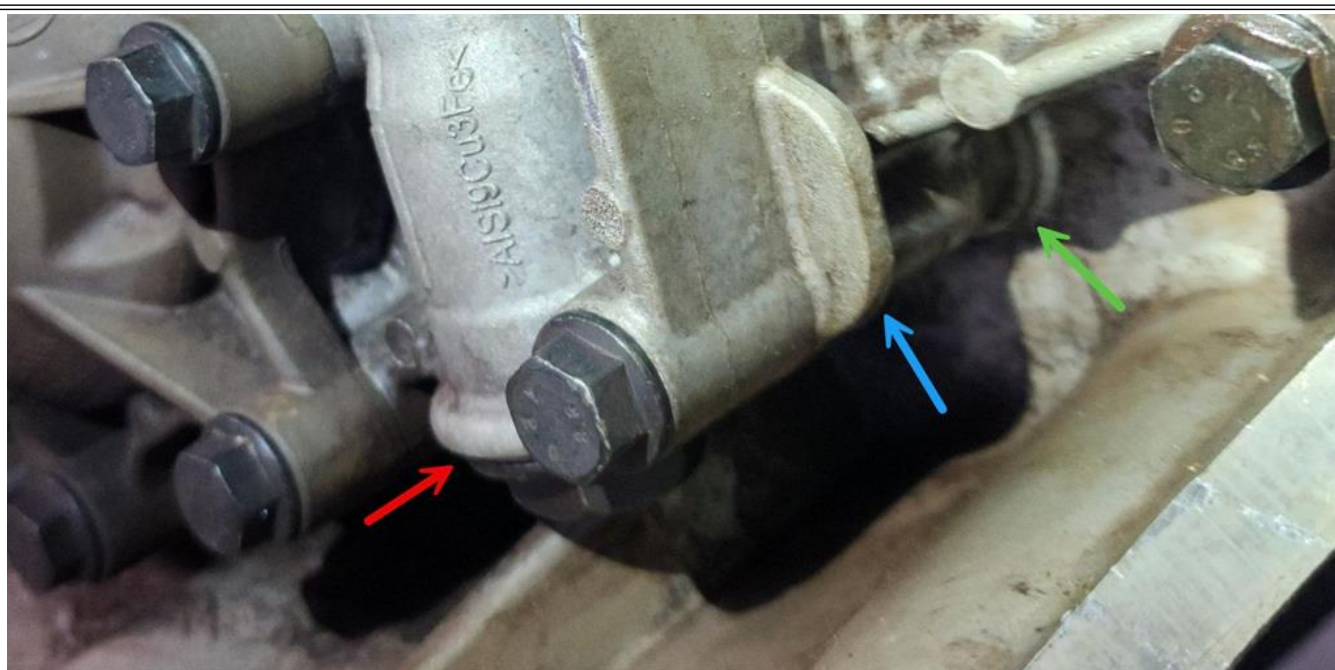
Figure 2 - Location 2 Leak Example

| Step | Front of Transmission | Decision |
|---|---|---|
| #2 | Remove the transmission for further inspection. Inspect for oil leaking behind the front cover of the transmission. See <a href="#">Figure #1</a> and <a href="#">Figure #2</a> for examples: | <b>Yes.</b> |
| | | If the leak is originating from location 2, confirm which colored arrow is the source, and provide an image for review. |

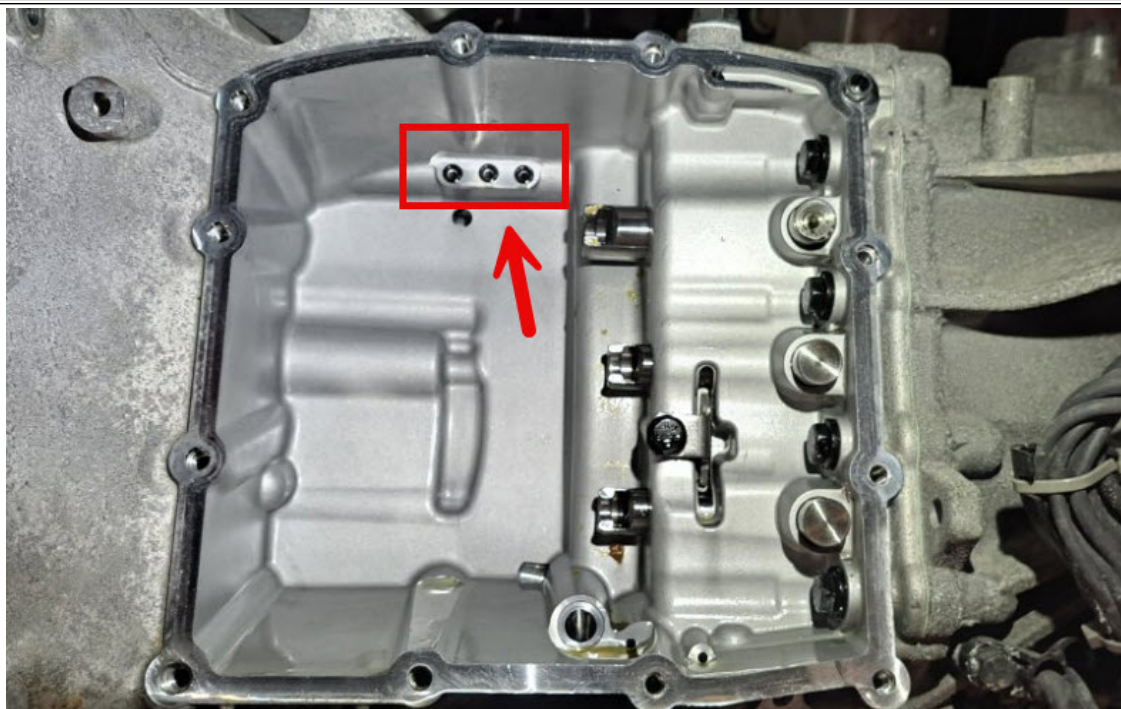
Figure 10 - Air Ports Behind the Main Valve Body

| Step | ECA Inspection/Repair | Decision |
|---|---|---|
| #5 | <p>Inspection:</p> <ul style="list-style-type: none"> <li>Remove the ECA and inspect for wetness at the pointed galley from <a href="#">Figure #8</a>.</li> <li>If wetness is observed, remove the main valve body assembly, inspect the condition of the green O-Ring as called out in <a href="#">Figure #9</a>.</li> <li>If the O-Ring is in good condition, inspect the 3 air ports at the top for wetness as shown in <a href="#">Figure #10</a>.</li> </ul> <p><b>NOTE:</b> There will be oil present in the housing behind the main valve body assembly; this is normal. The system is designed for shift rails to pass a slight amount of oil so they self-lubricate, oil that collects in the housing then flows back into the sump through one of the drilled passages. The galley with the green o-ring called out in <a href="#">Figure #9</a> is the same galley behind the ECA as</p> | <p>Repairs:</p> <p>Green O-Ring from <a href="#">Figure #9</a> - 104229N1</p> <p>Black O-Ring in shift actuators that position sensors sit in - 105465N1</p> <p>Green O-Ring on the position sensor harness connector that sits in the housing - 104440N1</p> |
