HYUNDAI

Technical Service Bulletin

GROUP CAMPAIGN	NUMBER 26-01-026H
DATE FEBRUARY 2026	MODEL(S) PALISADE (LX3) PALISADE HYBRID (LX3 HEV)

SUBJECT: ACTIVE AIR FLAP WIRING ASSEMBLY INSPECTION & REPLACEMENT (LIMITED COVERAGE CAMPAIGN LA13)

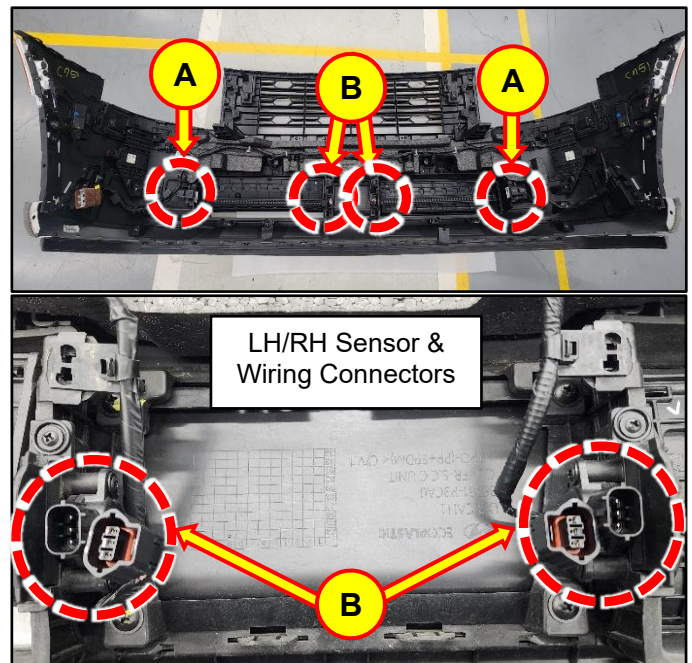
1. Disconnect the front bumper wiring and AAF actuator connectors (A) and the sensor connectors (B).

If **BOTH** LH/RH sides **FAILED** during initial inspection, proceed to the **Replacement of Front Bumper Harness, AAF Actuator(s), and AAF Sensor(s)** procedure.
