Customer Satisfaction Program 25N10

**SUBJECT: Customer Satisfaction Program 25N10**  
Certain 2017-2025 F-450 – F-600 Super Duty Chassis Cab Upfitted with an Aerial Bucket  
Frame Rail Crack

## CERTAIN 2017-2025 F-450 - F-600 CHASSIS CAB UPFITTED WITH AN AERIAL BUCKET — FRAME RAIL CRACK

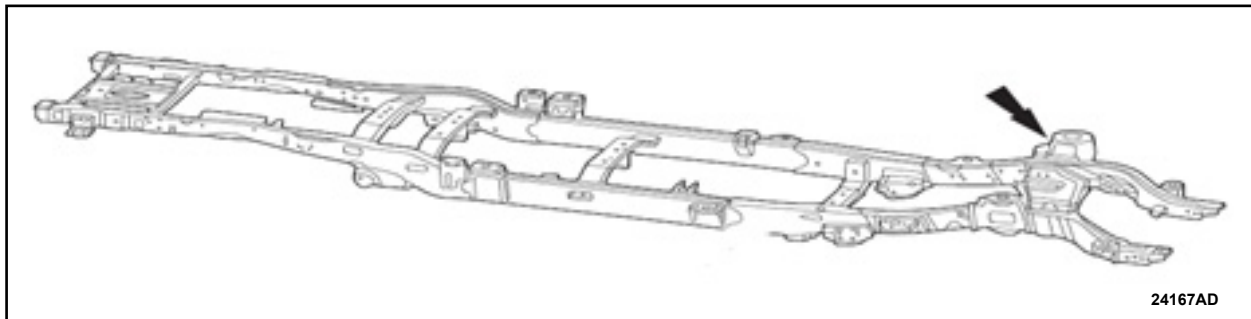
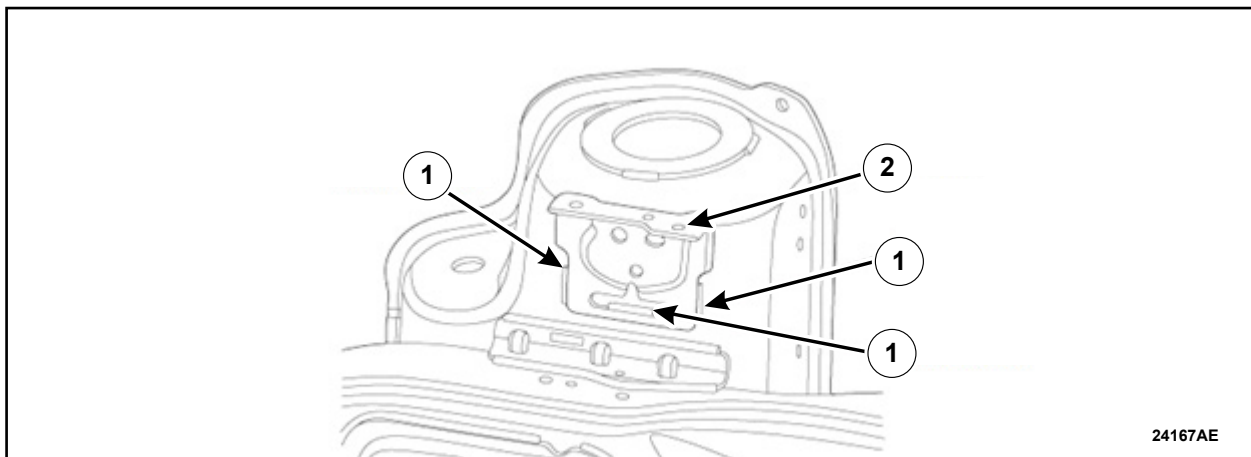
**FIGURE 13**

- (1) Remove weld.
- (2) Bracket.

1. Using an angle grinder, grind the 3 welds between the ABS bracket and the LH shock tower as shown in Figures 13 and 14.

- a. Remove and discard the ABS bracket.
- b. Finish the metal and grind the welds flat.
- c. Restore corrosion protection to areas that have been ground.
  - i. Ensure that the surface is clean and dry, and above 35 degrees F.
  - ii. Dress welds as required.
  - iii. Thoroughly clean and degrease metal surfaces using Motorcraft® Metal Surface Prep ZC-31-A.
  - iiii. Apply a coating of Daubert NOXRUST X-121B to the repair area per the manufacturer's direction.

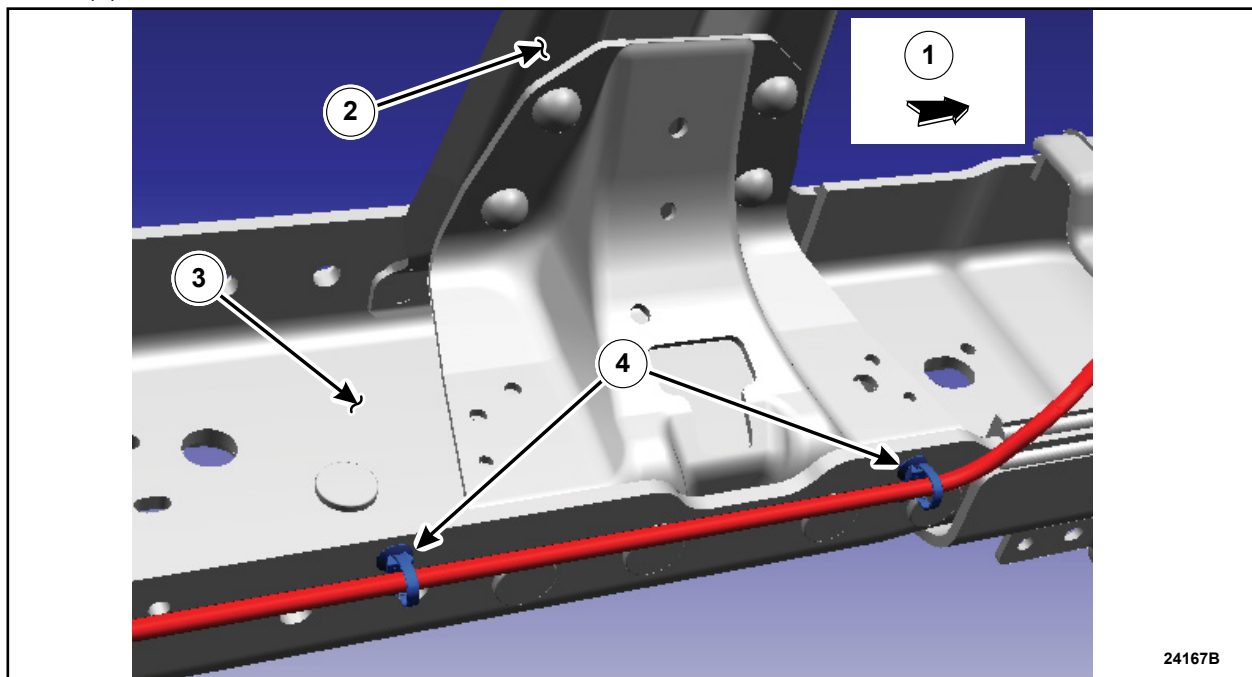
**FIGURE 15**

- (1) Front of Vehicle.
- (2) Number 4 crossmember.
- (3) Left hand frame rail.
- (4) Detach the Def retainers from the frame.

1. Detach the two (2) DEF pressure line retainers that retain the line to the frame, under the number 4 crossmember as shown in Figure 15. Position the DEF pressure line aside.

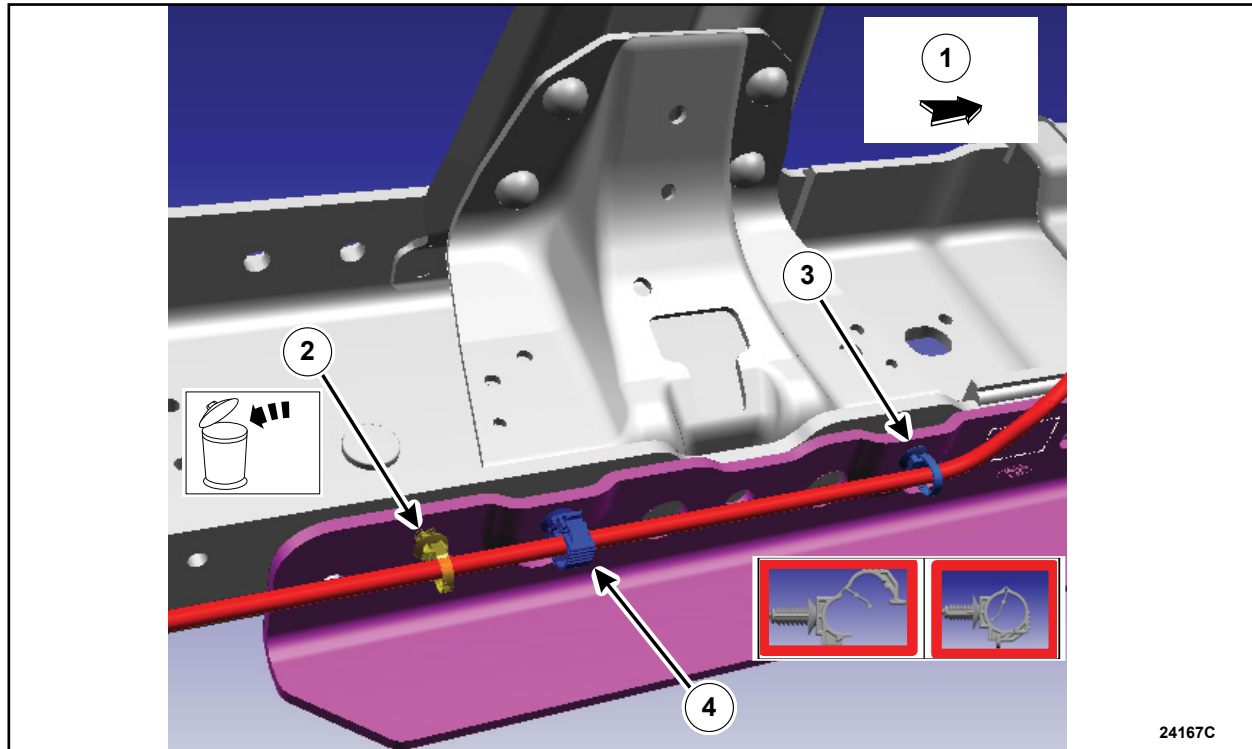
**FIGURE 16**

- (1) Front of Vehicle.
- (2) Fully remove the rear retainer from the DEF pressure line.
- (3) Reuse and install the original front DEF pressure line retainer to the lower bracket.
- (4) Attach and install the rear DEF pressure retainer.

2. Once the LH side lower bracket has been installed, position back the DEF pressure line and attach the existing front line to frame retainer to the lower bracket. Then, remove and discard the original rear line to frame retainer from the DEF pressure line. Then, attach the supplied clasp retainer to the DEF pressure line and install into the rear lower bracket retainer hole as shown in Figure 16.

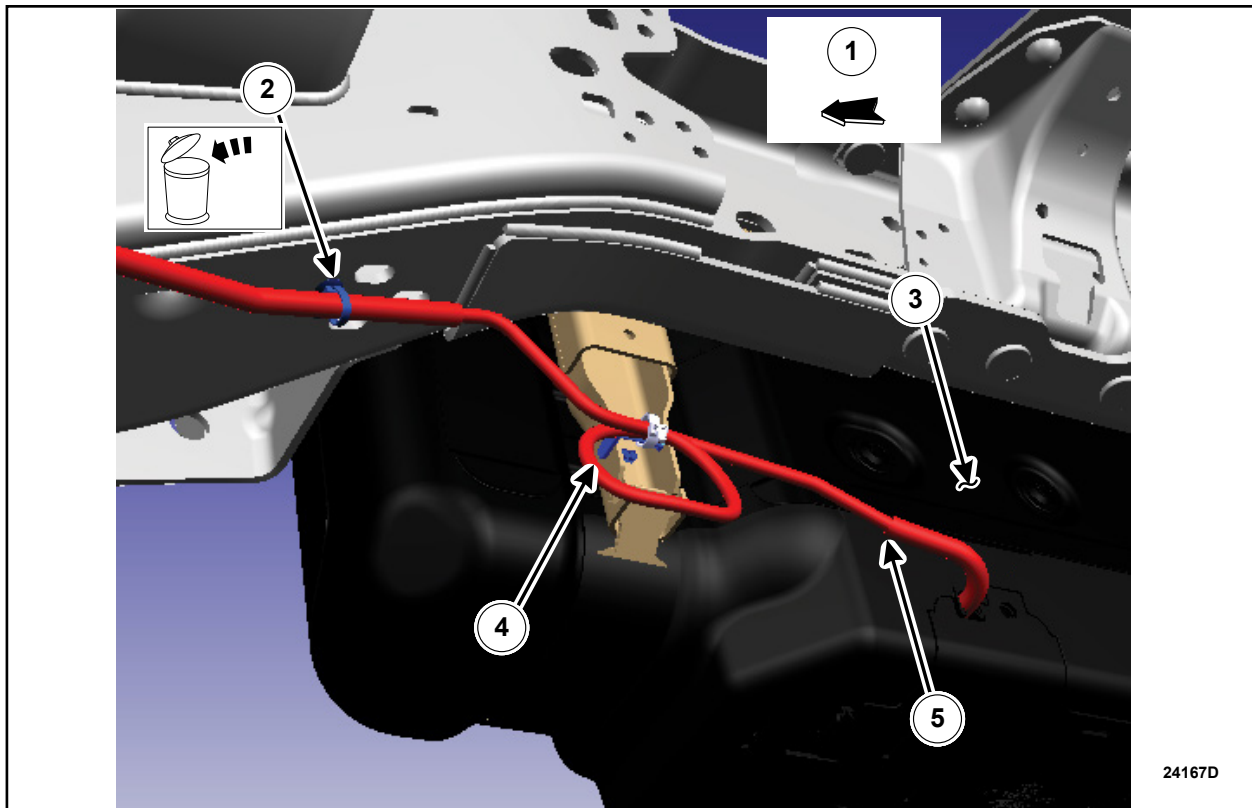
**FIGURE 17**

- (1) Front of Vehicle.
- (2) DEF pressure line retainer to frame location.
- (3) Reductant tank.
- (4) Do not disconnect or remove this retainer.
- (5) DEF pressure line.

1. Detach the single DEF pressure line retainer from the RH lower frame as shown in Figure 17. Then, completely remove and discard the retainer from the DEF pressure line.

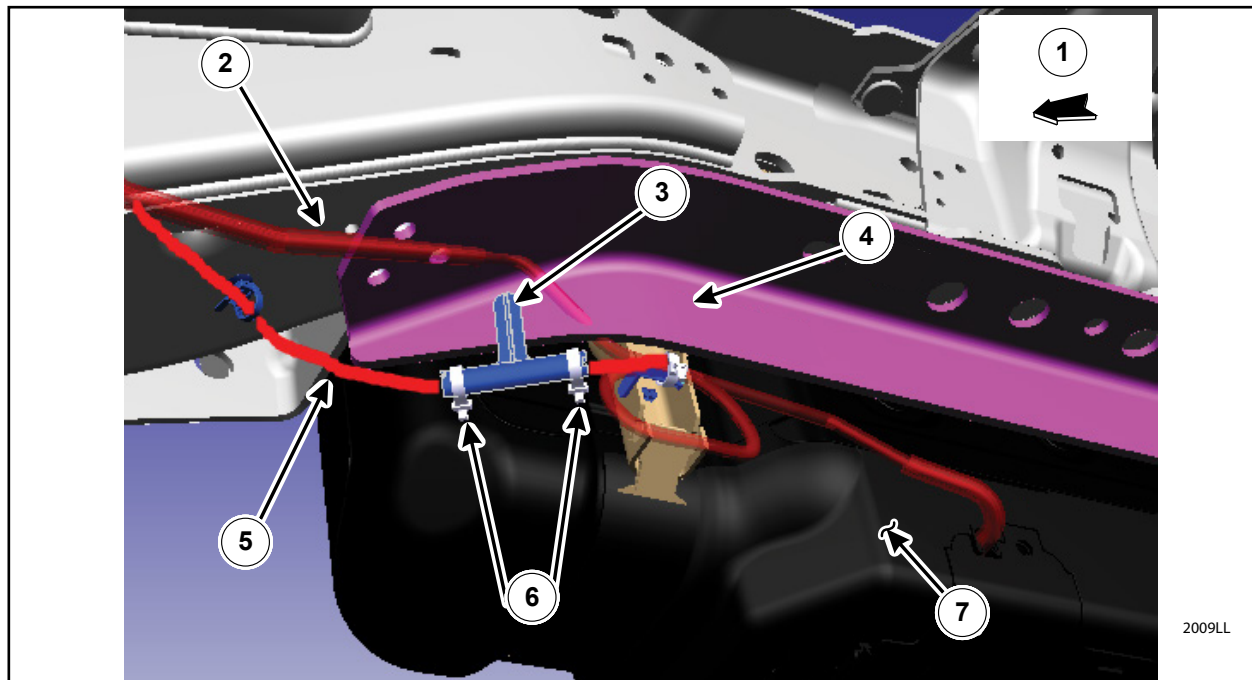
FIGURE 18

**NOTE:** Figure 18 shows the different T clip locations for between the regular cab vehicles and Crew and Super Cab vehicles. Holes are pre drilled on bracket for T clip, will need to drill new hole for routing clip.

- (1) Front of Vehicle.
- (2) Original DEF pressure line routing.
- (3) Regular cab T clip location.
- (4) Crew and super cab T clip location.
- (5) New DEF pressure line routing.
- (6) Attach the T clip to the line using zip ties.
- (7) Reductant tank.

2. Once the RH side lower bracket has been installed, install the supplied T clip to the lower bracket and route the DEF pressure line toward the T clip and attach the T clip to the DEF pressure line with two (2) of the supplied zip ties as shown in Figure 18.

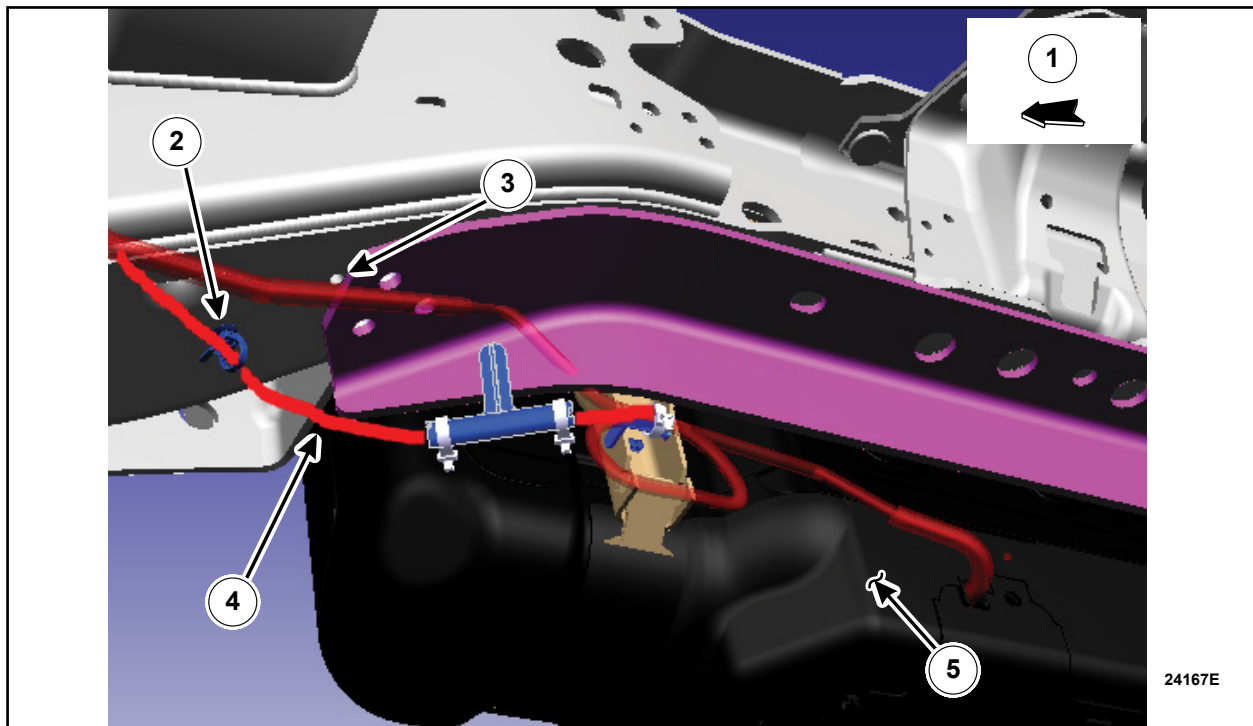
**FIGURE 19**

- (1) Front of Vehicle.
- (2) Relocate retainer hole in this location.
- (3) Original DEF pressure line retainer hole.
- (4) New DEF pressure line routing.
- (5) Reductant tank.

3. Using a drill and an 8mm (0.31 in) bit, drill a *new* hole location, for the *new* routing clip, forward of the lower frame rail bracket. Using a small brush and Motorcraft® High Temperature Anti-Corrosion Coating (PM-13-A), apply the coating in and around the hole that was just drilled, to cover any bare metal present from the drilling of the hole. Then, install the supplied push pin zip tie into the new hole location and position the DEF pressure line and secure in place with the zip tie as shown in Figure 17.

**NOTE:** The *new* drill hole location should be determined by positioning the DEF pressure line in its natural relaxed position toward the frame and marking a location for the *new* drill hole, forward of the *new* reinforcement bracket as shown in Figure 19.

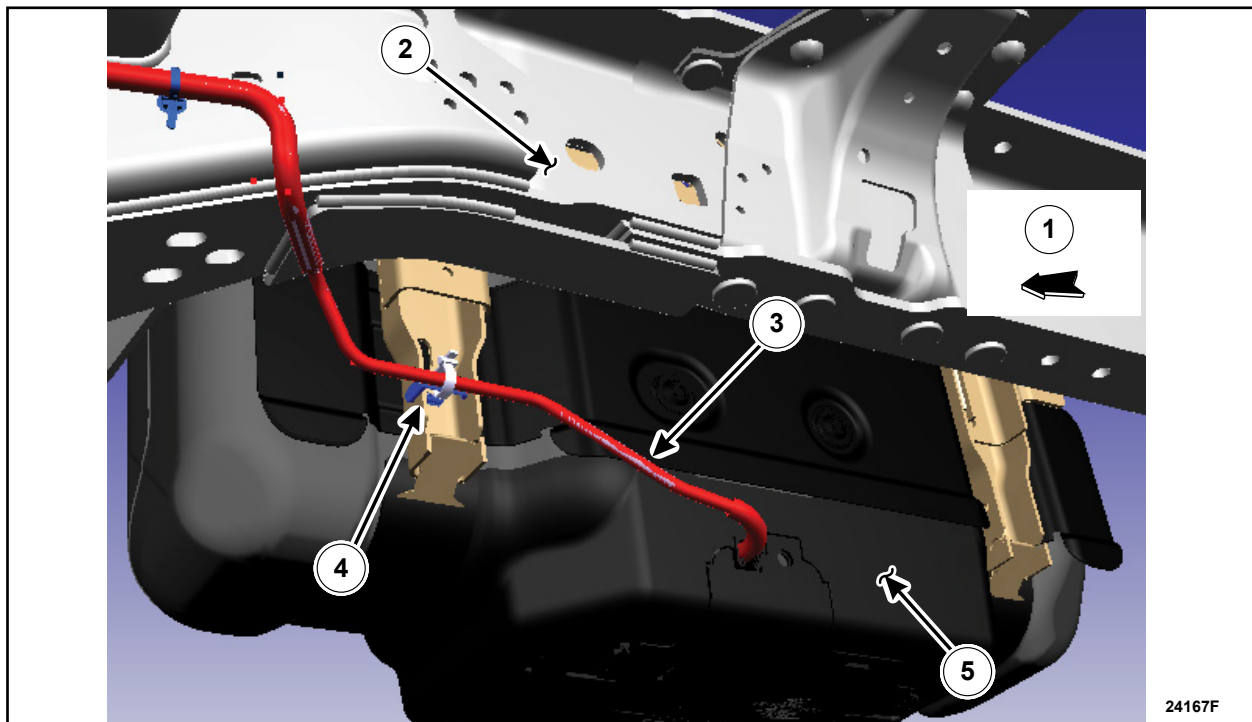
**FIGURE 20**

- (1) Front of Vehicle.
- (2) Right hand frame rail.
- (3) DEF pressure line.
- (4) Remove and discard the clip and zip tie.
- (5) Reductant tank.

1. Remove and discard the clip and zip tie from the area shown in Figure 20.

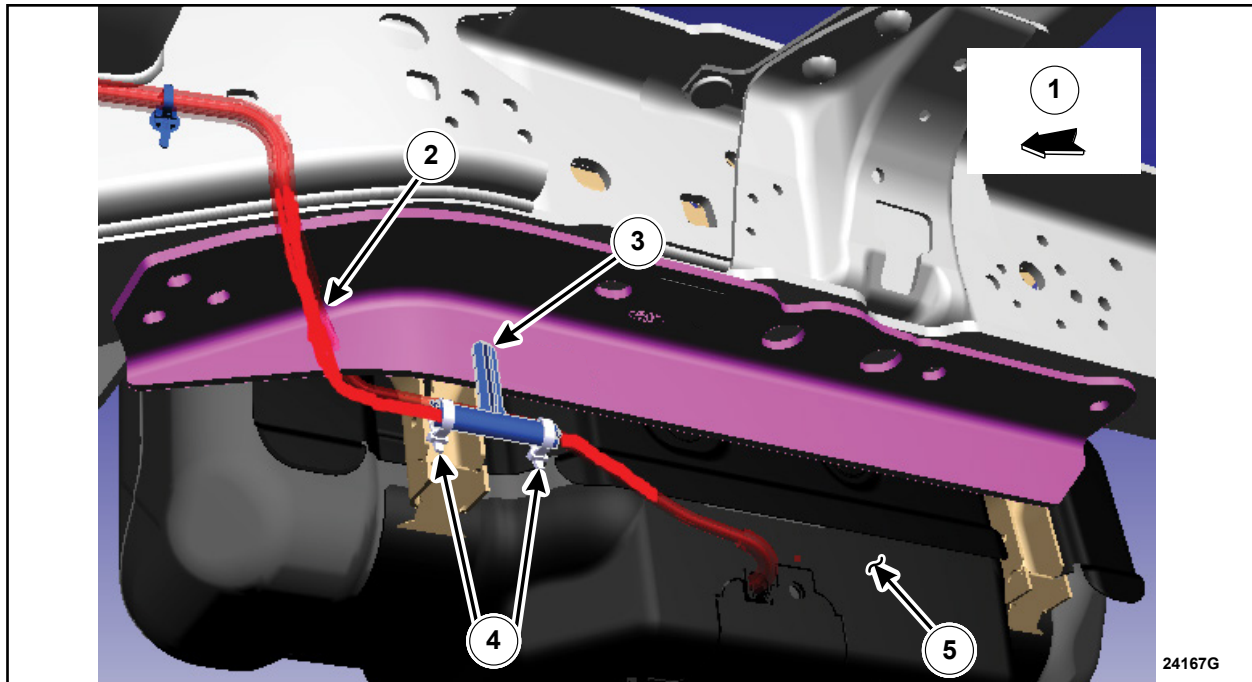
**FIGURE 21**

- (1) Front of Vehicle.
- (2) New DEF pressure line routing.
- (3) T clip location.
- (4) Attach the T clip to the line using zip ties.
- (5) Reductant tank.

2. Once the RH side lower bracket has been installed, install the supplied T clip to the existing hole in the lower reinforcement bracket and route the DEF pressure line toward the T clip and attach the T clip to the DEF pressure line with two (2) of the supplied zip ties as shown in Figure 21.

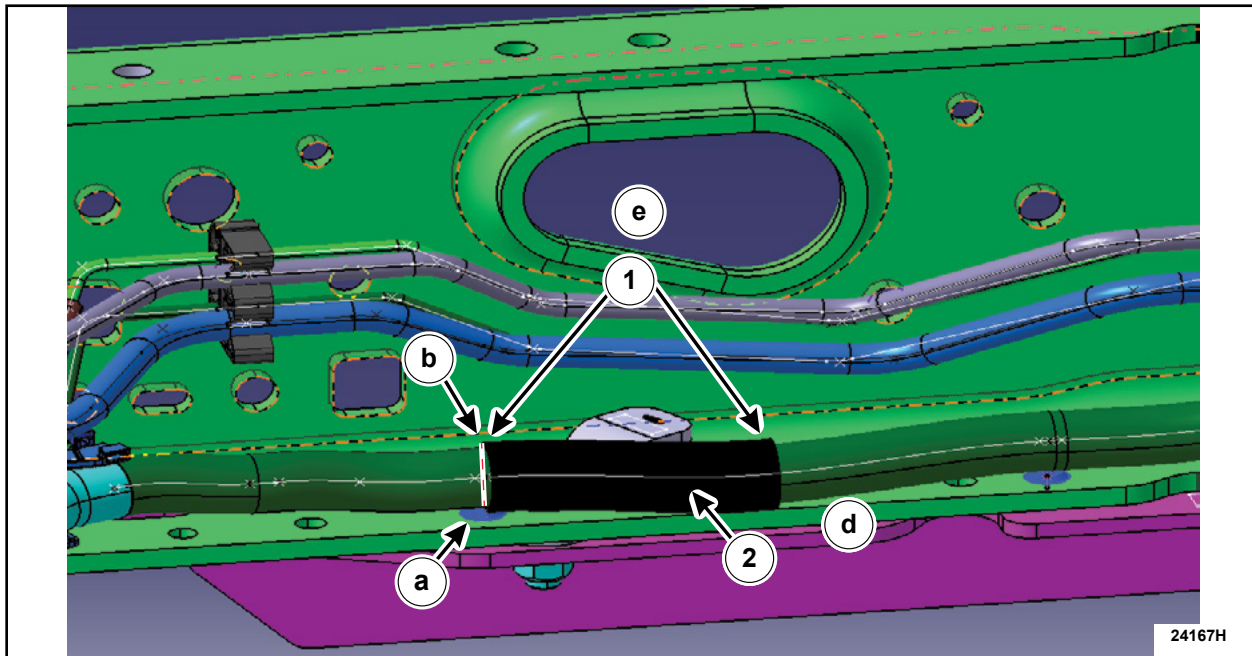
**FIGURE 22**

- (1) Secure both ends with anti-abrasion tape.  
(2) 100 mm long crush shield.

- Remove the tie strap push pin (a) from the hole indicated in Figure 22.
- Mark the location of the push pin on the harness (b).
- Cut off the existing push pin from the harness removed in sub-step a.
- Install the provided crush shield (d) on the harness with the rear edge of the shield aligning the mark made in second bullet point (above). See Figure 22.
- Secure both ends of the crush shield with the supplied Coroplast Tape (e).
- Install the supplied push pin zip tie in same location as the previously marked (original) location on the harness (b).

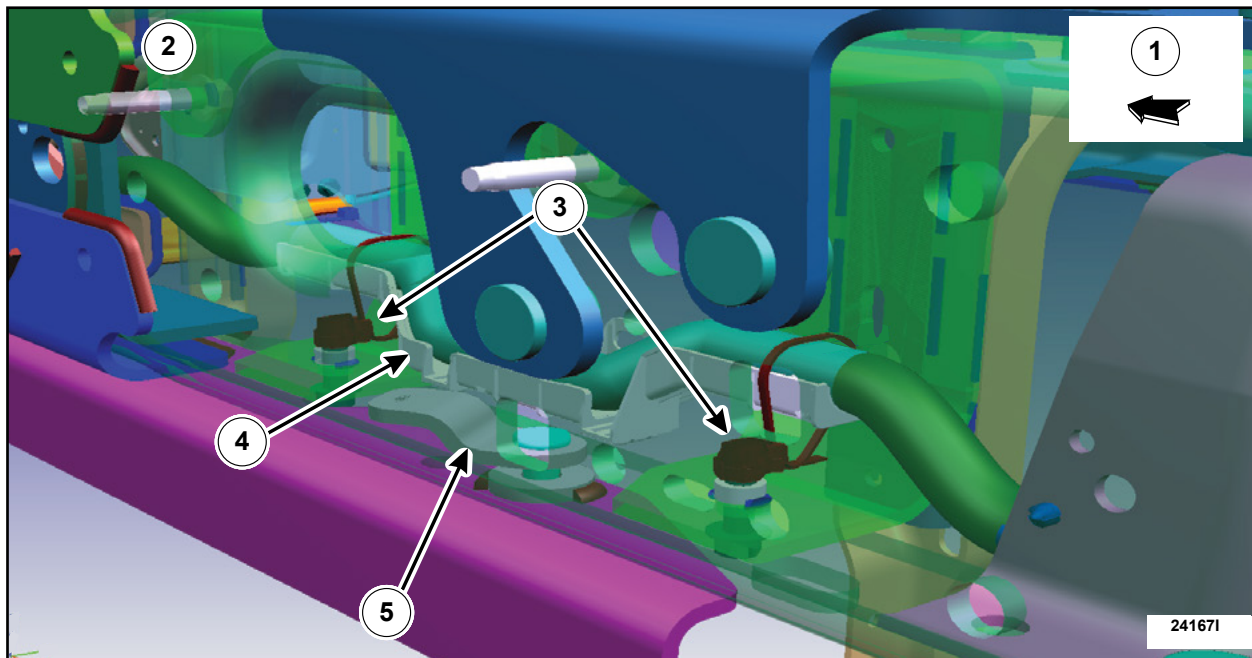
**FIGURE 23**

- (1) Front of Vehicle.
- (2) Left hand side frame rail transparent view.
- (3) Stud clip locations and inboard direction.
- (4) Wire harness shield.
- (5) Lower bracket rear flag stud.

- a. Position the supplied stud clips onto the studs with the zip ties side facing inboard as shown in Figure 23.
- b. Secure the harness to the stud clips with the zip ties.
- c. Ensure that the harness shield is positioned above the flag stud and the stud clips are fully seated on the studs.

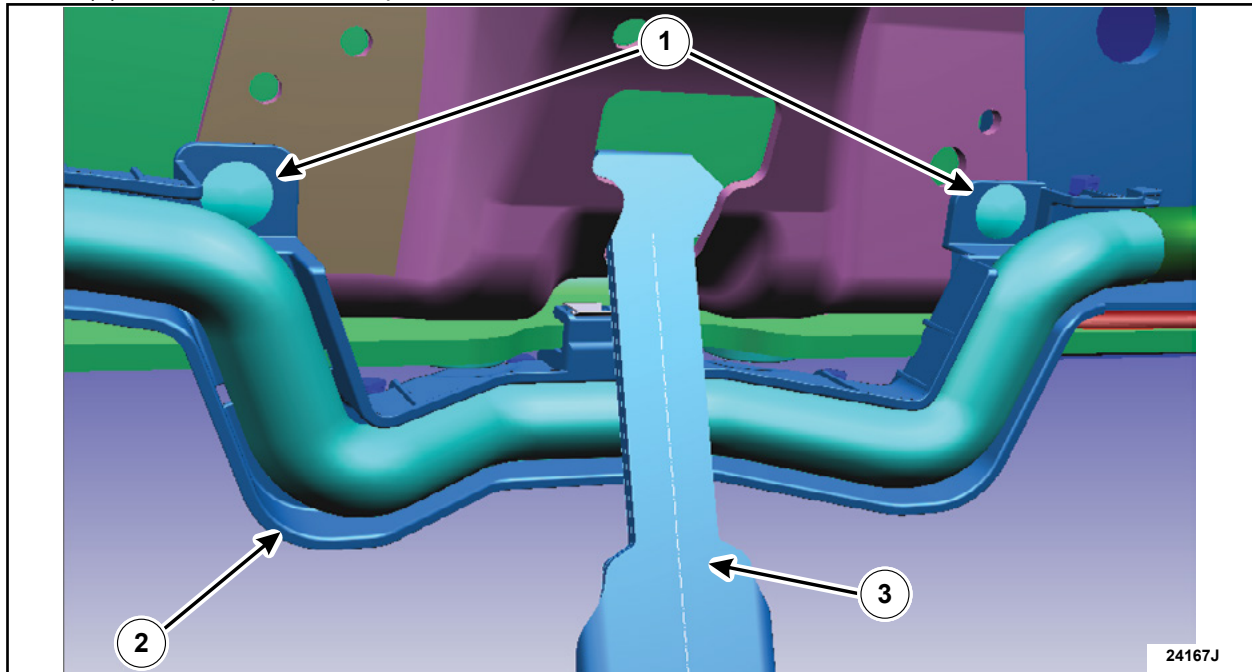
**FIGURE 24**

- (1) Harness shield push pins.
- (2) Wiring harness shield.
- (3) Mid ship fuel tank strap.

1. From the left hand side lower frame rail, remove the harness shield push pins as shown in Figure 24.

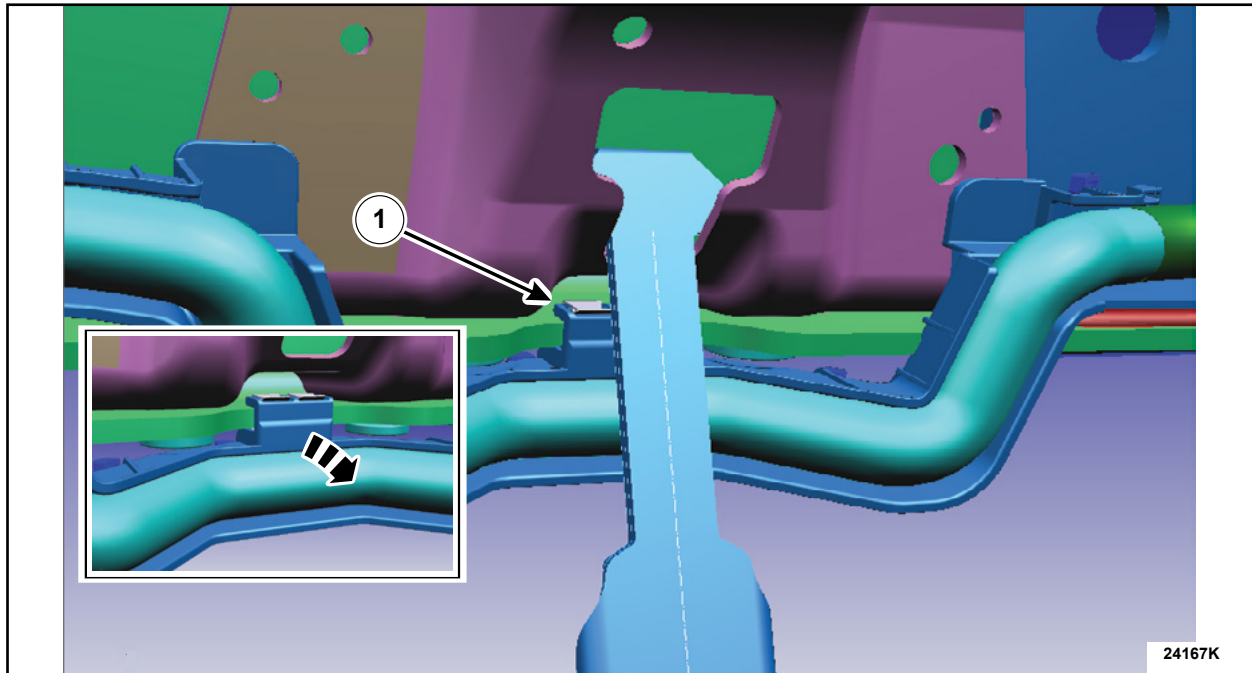
**FIGURE 25**

(1) Edge biter.

2. Detach the edge biter clip from the frames lower flange as shown in Figure 25.

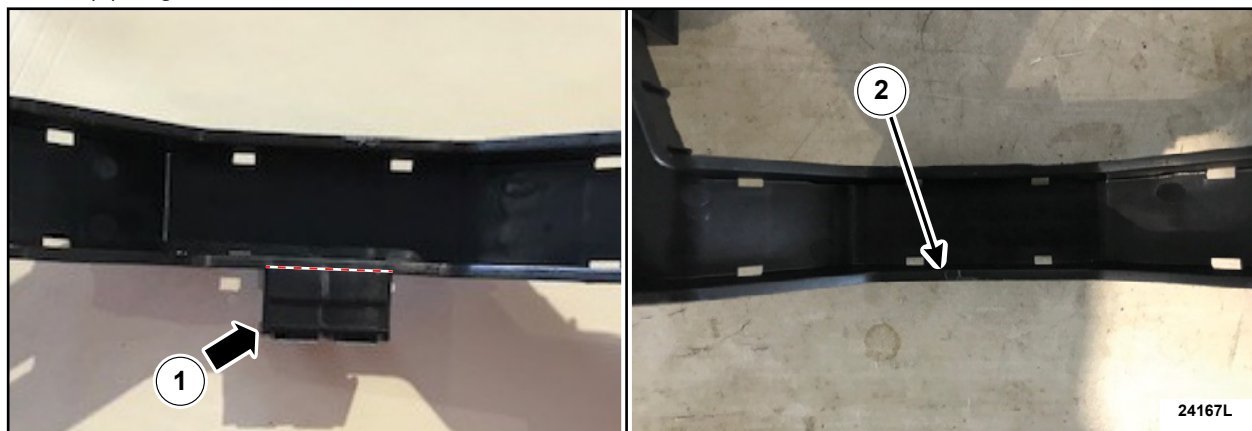
**FIGURE 26**

(1) Remove the edge biter.

(2) Edge biter removed.

4. Using a suitable cutting tool, remove the edge biter clip flush with the surface of the harness shield as shown in Figure 26.

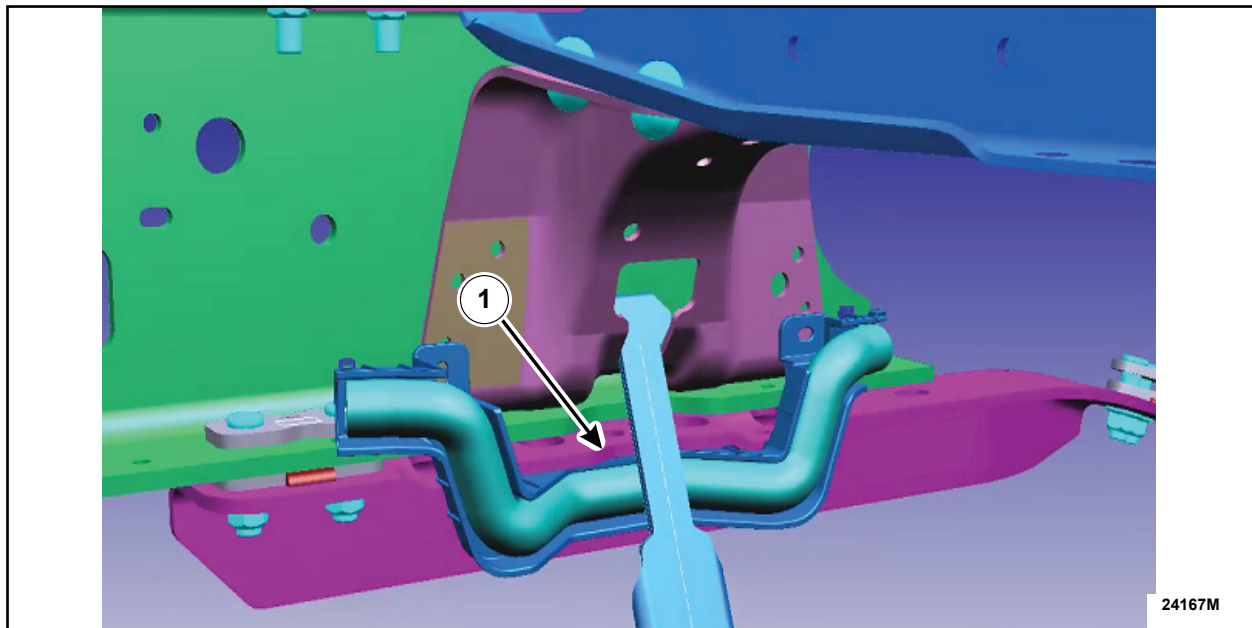
**FIGURE 27**

(1) Position the shield under the frame rail bracket.

5. Reattach the shield to the harness, in the same locations as they were removed from in Step 3, using seven (7) of the similar supplied tie straps.
6. Once the frame rail bracket has been installed, position the middle of the harness shield under the frame rail bracket as shown in Figure 27. Then, using two (2) of the supplied tie straps, secure the harness shield in the same location as the push pins were removed from in Step 1.

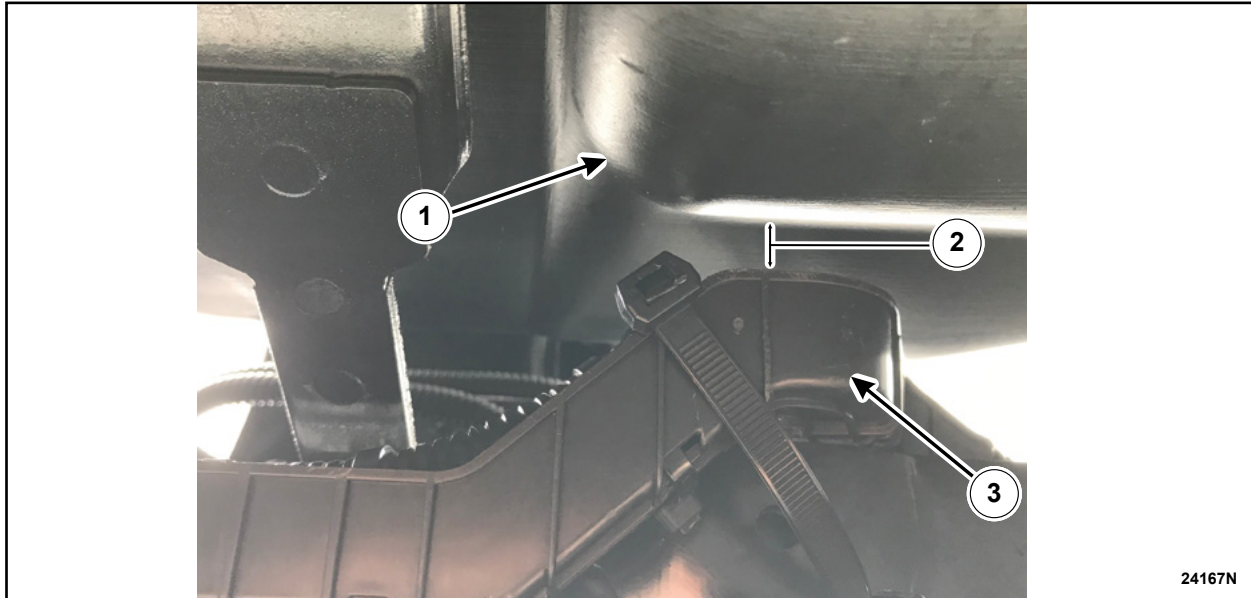
**FIGURE 28**

- (1) Mid ship fuel tank.
- (2) 9.5 mm (0.37 in).
- (3) Harness shield.

8. Ensure that the wiring harness shield has at least 9.5mm (0.37 in.) of clearance from any contact to the mid ship fuel tank. See Figure 28.

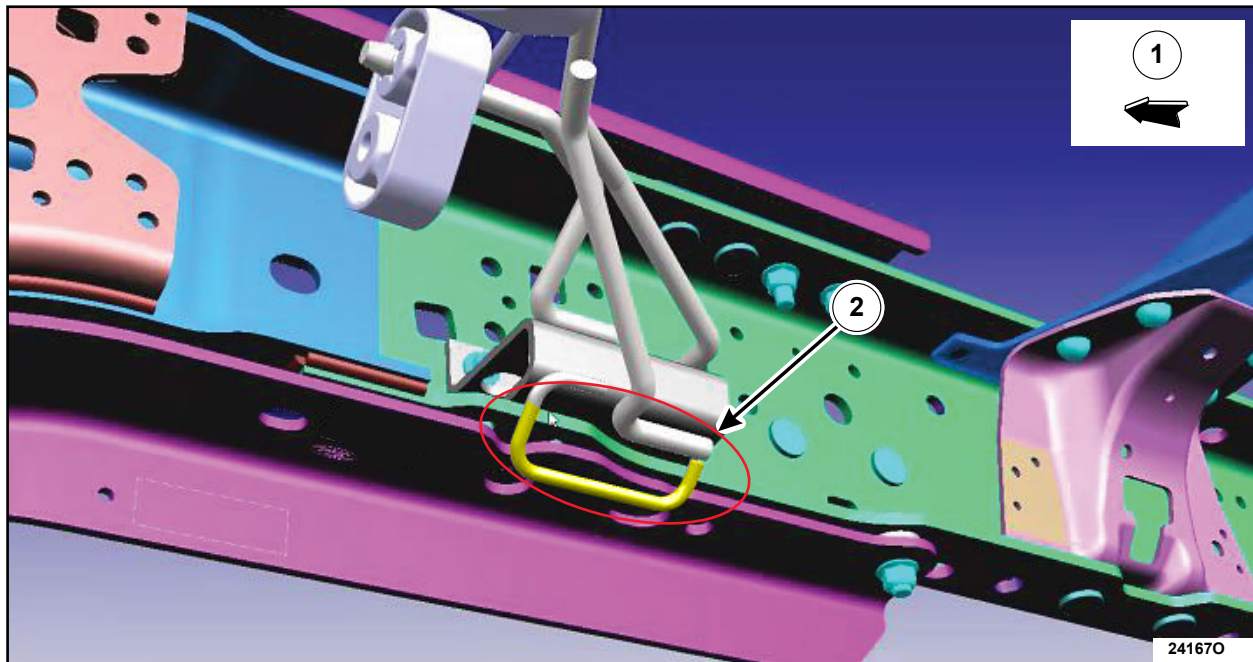
**FIGURE 29**

1. The right hand side exhaust hanger will interfere with right hand side lower reinforcement bracket.  
Figure 29 shows the portion of the exhaust hanger that will be removed in order to obtain the clearance needed.

- (1) Front of Vehicle.
- (2) The portion of exhaust hanger to be removed in yellow.

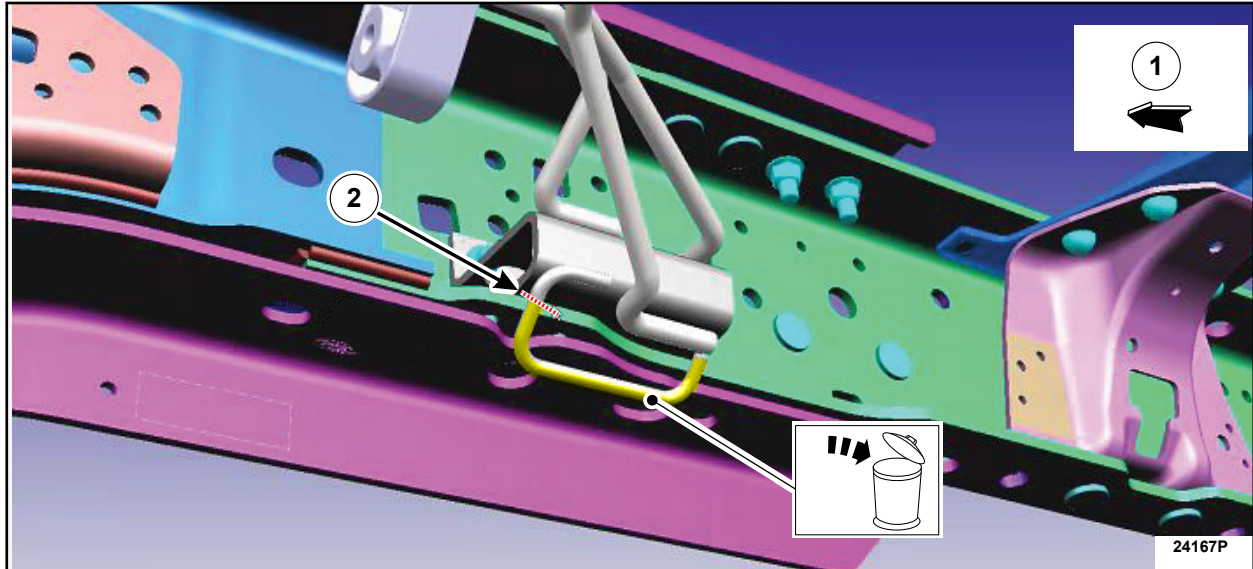
**FIGURE 30**

- (1) Front of Vehicle.
- (2) Cut and remove the portion of exhaust hanger here.

2. Using a suitable cutting tool, cut the exhaust hanger in the location shown in Figure 30. Remove and discard the cut off portion of exhaust hanger. See Figure 30.

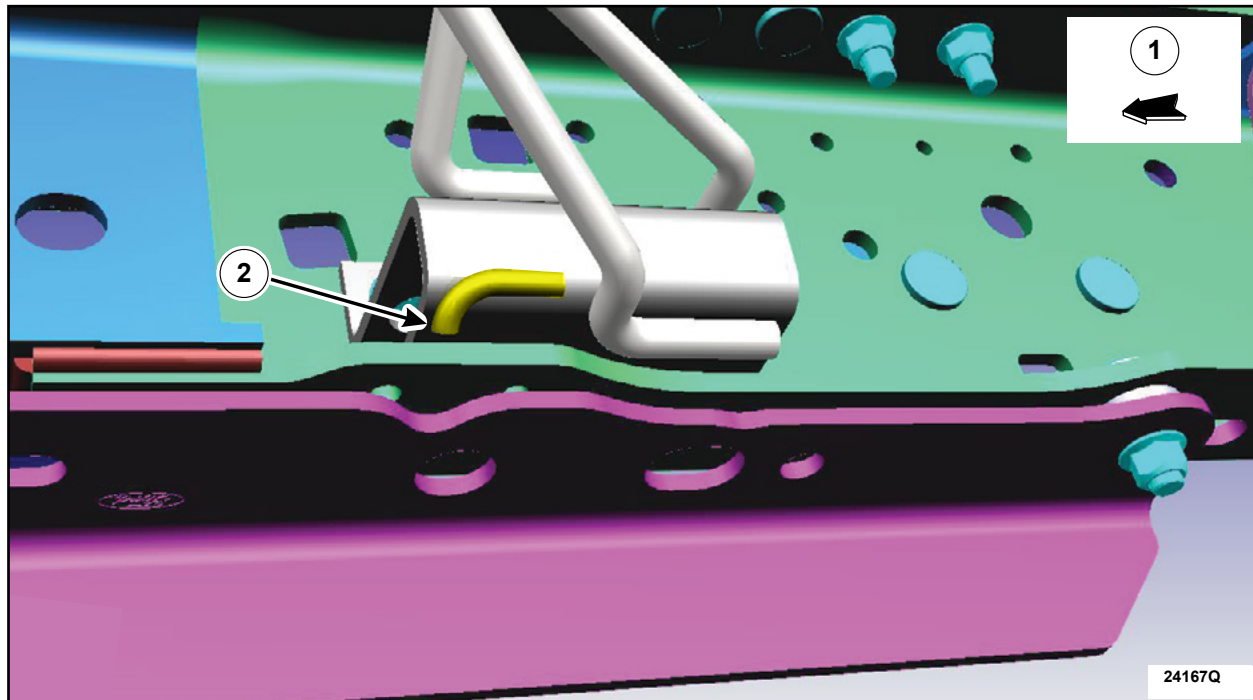
**FIGURE 31**

3. Figure 31 shows the final result once the exhaust hanger portion is removed.

- (1) Front of Vehicle.
- (2) Final result.
