## Technical Service Bulletin

**26-EM-007H**

**ELANTRA (CN7)**

**SUBJECT: STEERING WHEEL VIBRATION FROM COOLING FAN OPERATION**

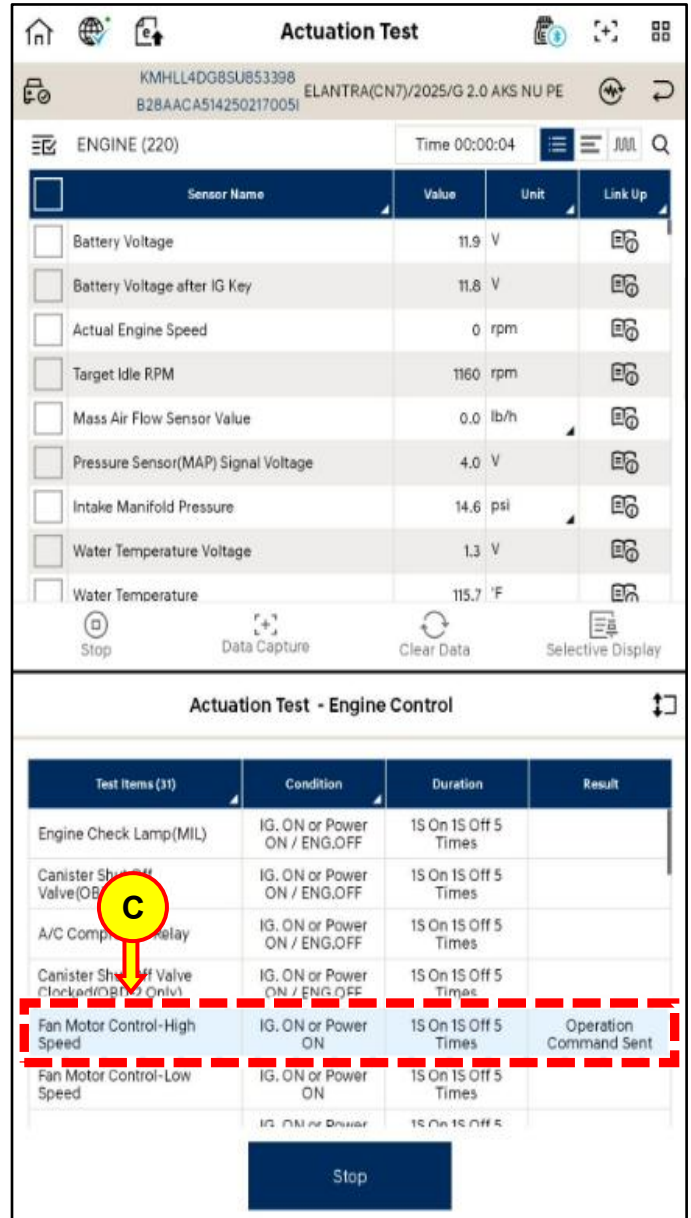
5. While cooling fan is operating at high speed, place your hand on the steering wheel in the location indicated (D) and inspect for excessive vibration.

- If **NO** excessive vibration is felt, this TSB does **NOT** apply. Service procedure is complete.
- If an excessive amount of vibration is felt, proceed to the [Engine Cooling Fan Replacement](#) procedure.
