**Diagnostic Sheet**

# Grecale - Engine Bay Wiring Harness Diagnosis

DATE: March 11, 2026

**MODELS AFFECTED:** (M182) Grecale – All MY**ANOMALY:**

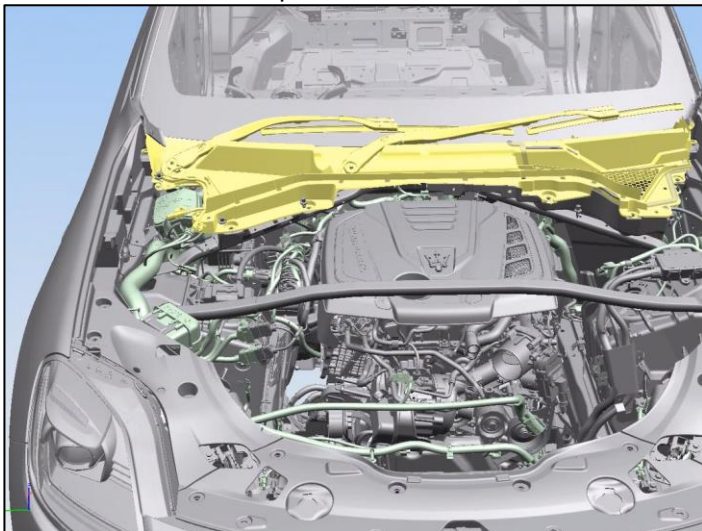
1. To reach the wiring section underneath the Front Distribution Unit (FDU), Follow procedure #9.15.016 to remove the cowl trim panel and water containment tray.
2. Remove the cowl trim panel

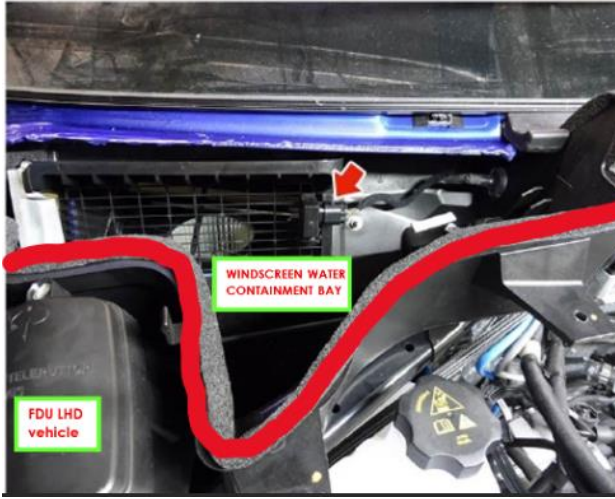
3. Remove the water containment tray

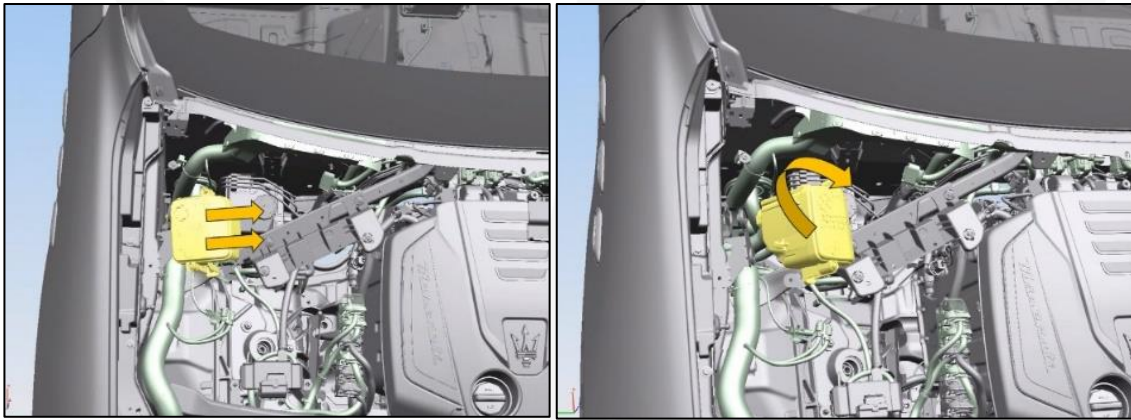
4. Loosen or partially remove the FDU mounting screws and move the FDU to the side to gain access to the part of the harness in question.
