GENERAL MOTORS
DCS7458
URGENT - DISTRIBUTE IMMEDIATELY

Subject: REVISION: N252528650-01– Service Update
Body Seal Water Leak
Revised Parts Table

Models: 2024-2025 Chevrolet Equinox EV

N252528650 Body Seal Water Leak

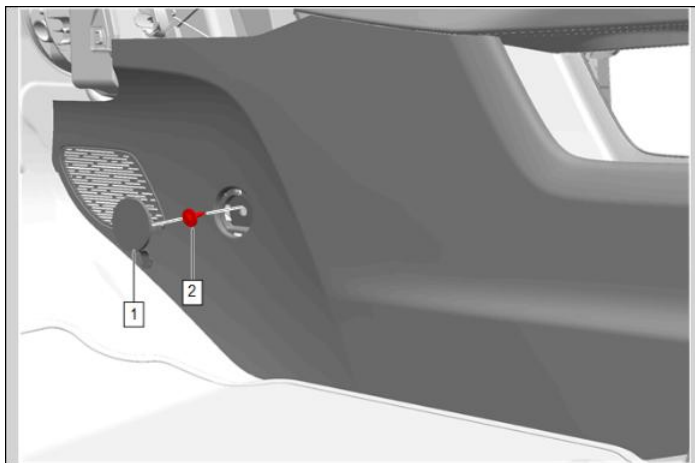
6497759

3. Remove the Left Side Front Floor Console Extension Panel Access Hole Cover (1) and Bolt (2).
4. Loosen the Left Side Front Floor Console Extension Panel. It does NOT need to be removed from the vehicle.
5. Remove the Left Side Door Sill Garnish Molding. Refer to *Front Side Door Sill Garnish Molding Replacement* in SI.

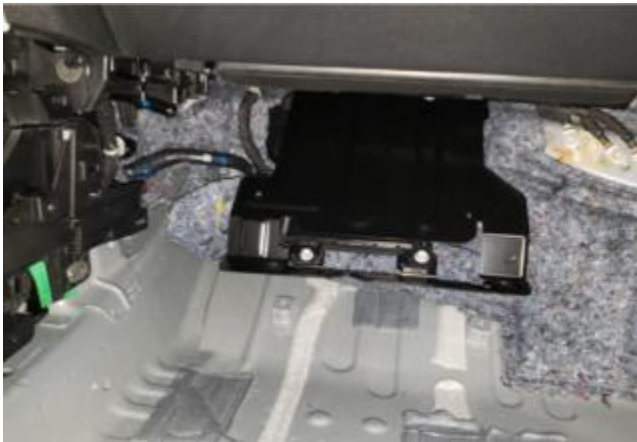
7002659

10. Remove all 10mm bolts securing the BECM bracket cover and gently lift the cover to provide room for inspection and BECM access.
11. Relocate the BECM aside, but do not disconnect the connectors.
12. Verify the HVAC drain tube is connected. If it is not connected, reseal the connector.

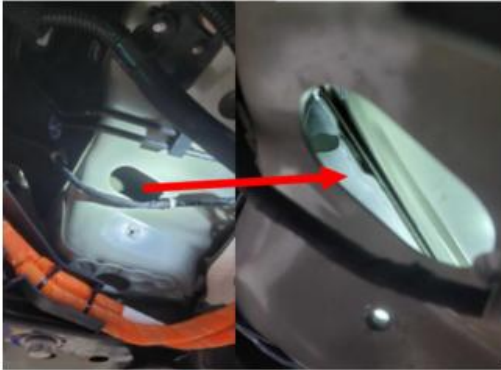
7002663

3. Confirm the leak by applying water to the seam shown above on the appropriate driver or passenger side. After spraying, lower the vehicle and check for water inside the appropriate footwell.
4. After confirming, raise the vehicle again and use compressed air to blow all the water out of the affected area. It must be DRY before applying seam sealer.

5. Attach a straw/hose to sealer nozzle tip to reach the seam as shown above.
6. Insert the tip of straw/hose between seam of sheet metal and dispense sealer along length of seam. It is recommended to use a small brush to push sealer into gap and smooth over.
