GROUP	MODEL
ELE	2022-2025MY Multiple Models
NUMBER	DATE
394	March 2026

## TECHNICAL SERVICE BULLETIN

### AVN5.0W DTC P17A000 DAIGNOSTIC PROCEDURE

This bulletin provides information regarding a potential illuminated Malfunction Indicator Lamp (MIL) accompanied by DTC P17A000 on some 2022-2025MY Hybrid Electric Vehicles (HEV) and Plug-In Hybrid Electric Vehicles (PHEV) equipped with AVN5.0Wide head units listed below. This condition occurs when the Global Positioning System (GPS) module within the Audio Video Navigation (AVN) head unit, sends an inaccurate signal to the Hybrid Power Control Unit (HPCU), causing the DTC to set. **There are no drivability symptoms associated with this condition.** Follow the procedures outlined in this TSB to inspect and if necessary, install the AVN5.0W software and inspect and if necessary, replace the antenna and/or the AVN5.0W head unit.

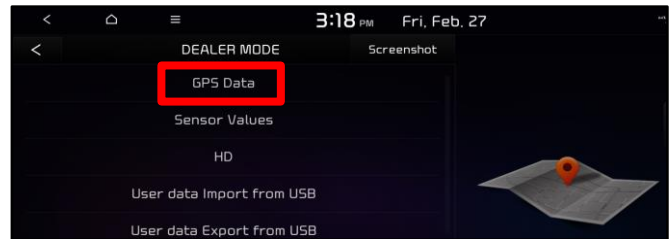
8d. Select 'GPS Data'.

9. Confirm the 'Satellite visible', 'Satellite received', and 'Satellite available' are within specification.

- Satellite visible, received AND available **ARE ALL** within specification (OK), then proceed to step 10.
- Satellite visible, received AND available are **NOT** within specification (NG), then proceed to the 'Antenna Replacement Procedure' on page 10. Using KDS Tablet [Warranty Claim Attachment](#) Tab, take a photo of the 'Satellite visible', 'Satellite received', and 'Satellite available' values.
