PRODUCT CAMPAIGN BULLETIN

APPLICABILITY: 2020-2022 MY Legacy
2020-2022 MY Outback

NUMBER: WRA-24R

SUBJECT: Safety Recall – ODS Sensor Replacement

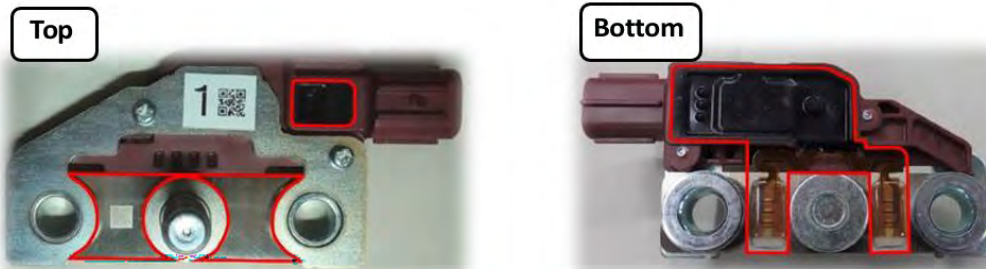
USE CAUTION WHEN HANDLING THE OCS SENSORS:

- **DO NOT** use any sensor if dropped or experienced any type of impact.
- **DO NOT** allow water, oil, etc. to adhere to the sensors.
- **DO NOT** touch the portions of the sensor outlined in **RED** below.

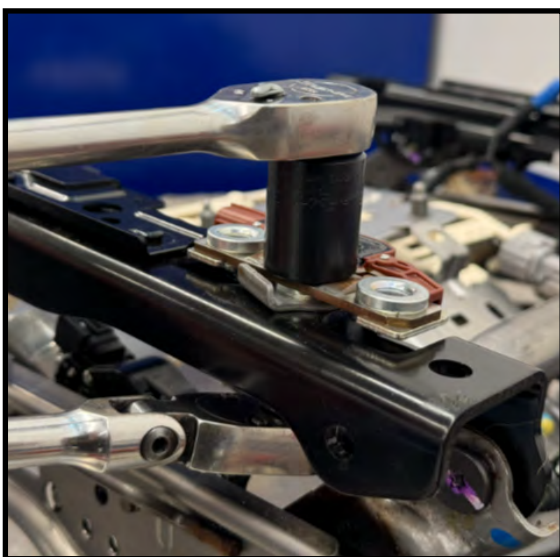
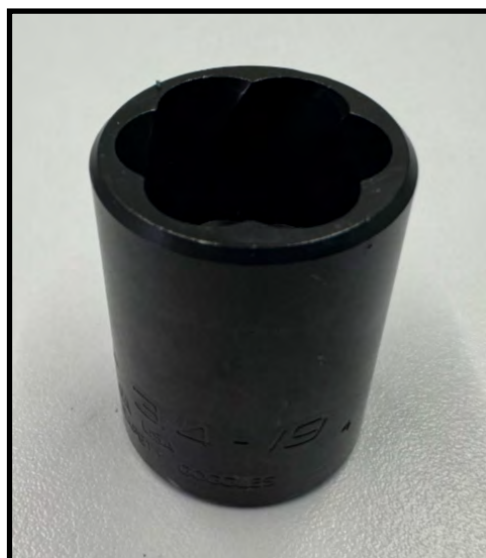
NOTE: In rare instances, the stud attached to the ODS sensor may spin when attempting to remove the nut. If this occurs, remove the 8mm nuts (shown in red in the image below) securing the ODS sensors to the seat frame.

Attach a 19mm twist socket and ratchet to the bottom portion of the stud to prevent it from spinning, then remove the nut securing the ODS sensor to the seat bottom.

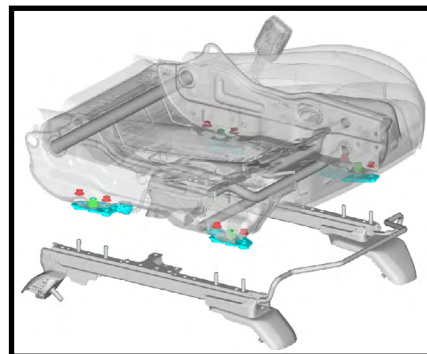
NOTE: In rare instances, the stud attached to the ODS sensor may spin when attempting to remove the nut. If this occurs, remove the 8mm nuts (shown in red in the image below) securing the ODS sensors to the seat frame.

Attach a 19mm twist socket and ratchet to the bottom portion of the stud to prevent it from spinning, then remove the nut securing the ODS sensor to the seat bottom.

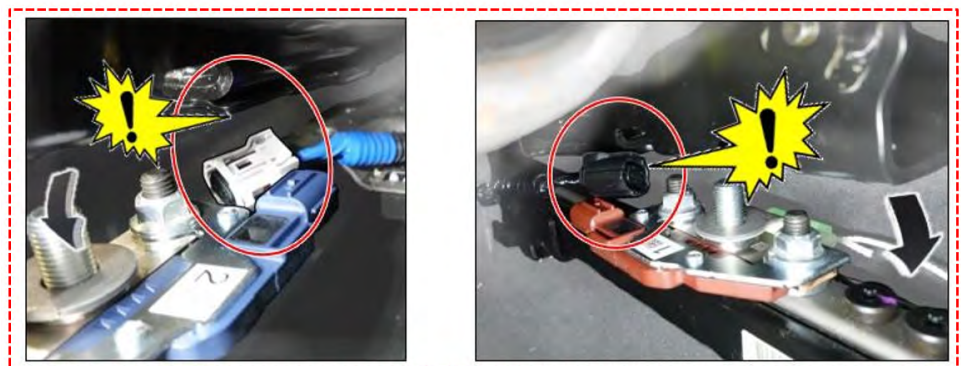
CAUTION: It is possible for the connector to be caught between the cushion frame and the rail/sensor. Confirm the connector is not pinched in any way.

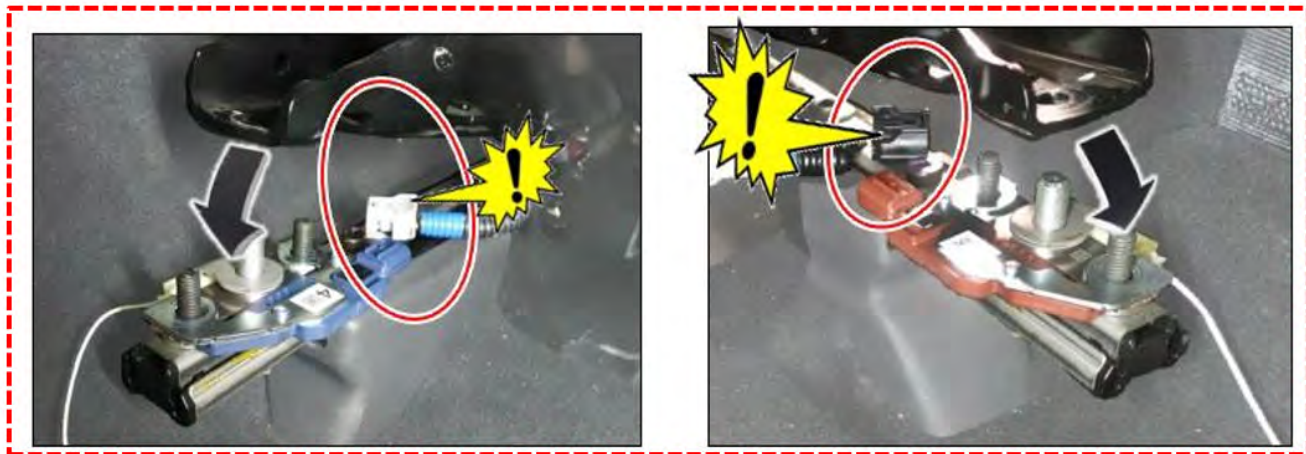
CAUTION: It is possible for the connector to be caught between the cushion frame and the rail/sensor. Confirm the connector is not pinched in any way.
