Technical Service Bulletin

Mazda North American Operations
Irvine, CA 92618-2922

Subject: DOOR OUTER HANDLE TOUCH SENSOR DOES NOT WORK (LOCK AND/OR UNLOCK)	Bulletin No.: 09-013/26
	Last Issued : 03/31/2026

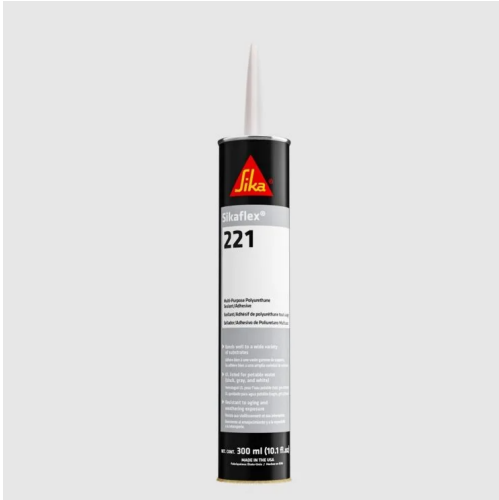
1. **Adhesive:** [Sikaflex-221](#)

- **Locally sourced adhesive.**
- **(1) 10.1 oz. (300 ml) tube or cartridge recommended.**
- **(1) tube or cartridge repairs multiple door handles.**
- **Adhesive comes in several colors. Specify color when ordering: primarily white, black, aluminum gray, and colonial white.**
- **Adhesive becomes tack-free in approx. 60 minutes at 23°C (73°F) and 50% relative humidity.**

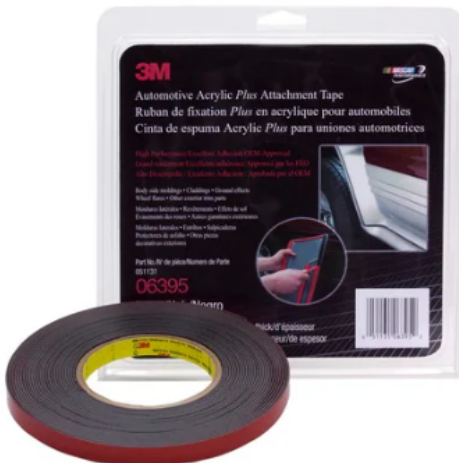
2. **3M Butyl Tape, Part # 06395:**

- **Locally sourced.**
- **Thickness: 1/16 in. (1.5mm) x 2 in. wide.**
- **Repairs approximately 176 door handles.**

NOTE: If you cannot find the appropriate size butyl tape, layer strips of waterproof tape to 1/16 in. (1.5mm).

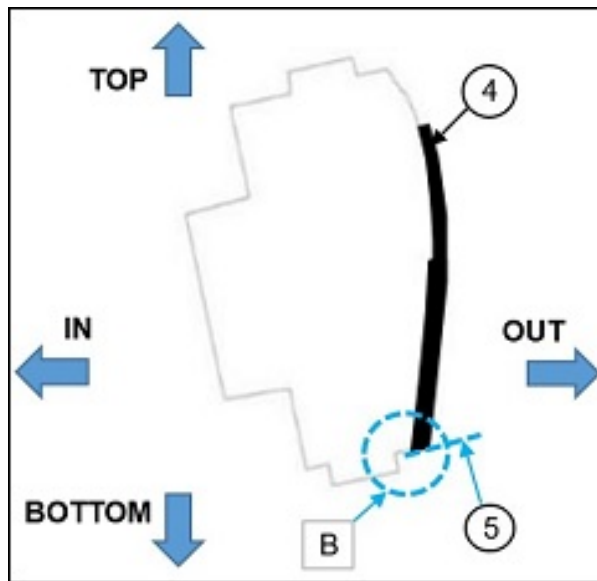
Section A-A

- (2) 2 in. (55mm)
- (3) 0.63 in. (16mm)
- (4) Butyl tape: 1/16 in. (1.5mm) thickness
