Subject: REPLACEMENT OF WATER PUMP FOR COOLANT LEAK	Service Alert No.: SA-014/26
	Last Issued : 03/11/2026

APPLICABLE MODEL(S)/VINS

2018-2026 Mazda3	2018-2026 CX-5	2020-2026 CX-30	2025-2026 CX-70 (All)
2018-2021 Mazda6	2018-2023 CX-9	2023-2026 CX-50 (All)	
2018-2021 CX-3	2018-2024 MX-5	2024-2026 CX-90 (All)

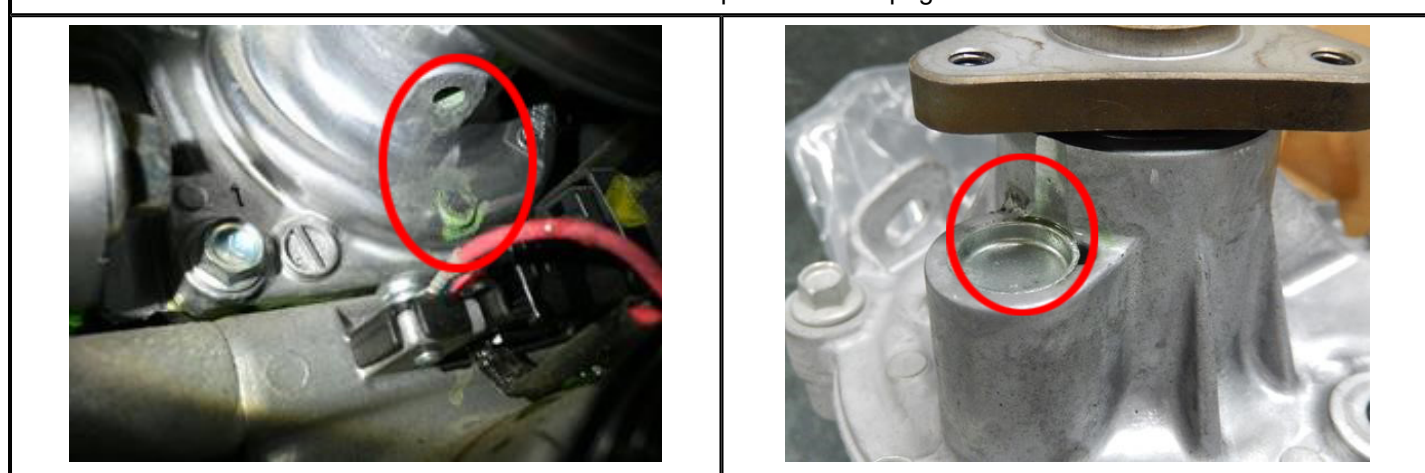
Normal Water Pump Coolant Seepage

A mechanical seal (A) is used for the water pump. This mechanical seal can seal coolant (B) by sliding a mating ring (C) against a seal ring (D). When the sliding surface temperature of the mechanical seal is more than 248 °F (120 °C) while driving, a small amount of steam (E) is leaked and bleeds through the bleeding hole (F). After drying, the steam leaves a green coolant deposit near the water pump bleed hole (F). This is a normal condition and does not require water pump replacement. The water pump should only be replaced if there is an accumulation of crystallized coolant near the bleed hole.
