## Technical Service Bulletin

GROUP	NUMBER
<b>CAMPAIGN</b>	<b>26-01-034H</b>
DATE	MODEL(S)
<b>APRIL 2026</b>	<b>PALISADE (LX3)</b>

**SUBJECT:** CCU SOFTWARE UPDATE FOR OTA INITIALIZATION  
(LIMITED COVERAGE CAMPAIGN LA20)

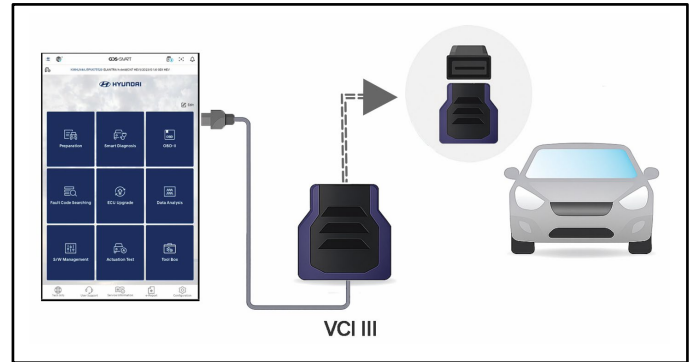
1. Connect the Ethernet Communication Interface (ECI) DLC cable to the OBD connector of the vehicle.
2. Connect the VCI DLC cable to the ECI.
3. Select the appropriate tablet cable (type C, 5-pin) to the ECI.
4. Connect the cable to the tablet PC.

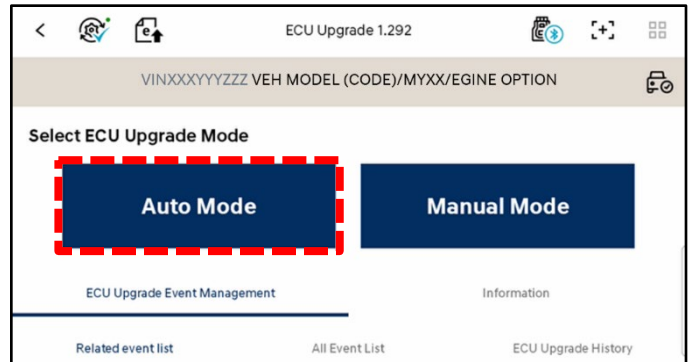
1. Perform the ECU update in **Auto Mode**.

Refer to **TSB # 25-GI-011H**, “**ECU Update Procedure for Tablet-Based GDS-Smart**”, for additional information.

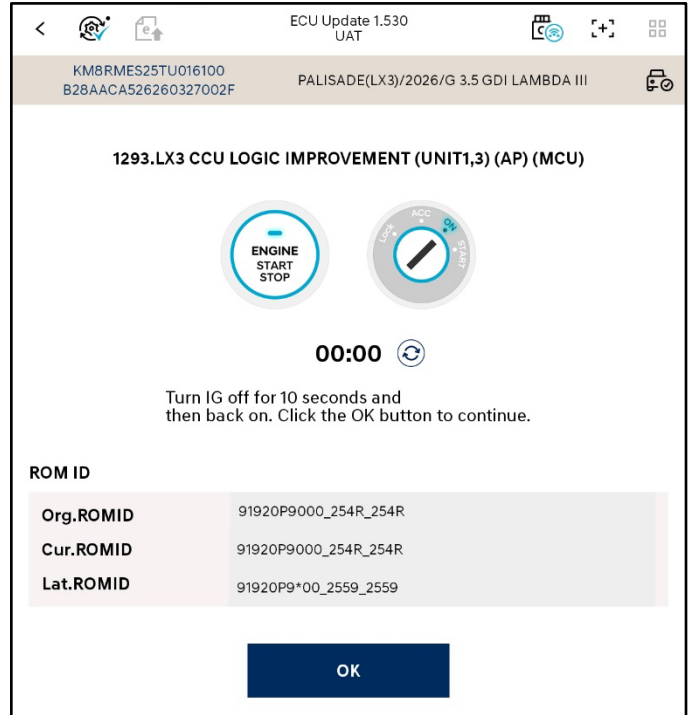
- After the ECU update process shows 100% complete, follow the prompts on the screen to cycle the ignition **OFF** for at least **10 seconds** to reset the control unit (certain models may take up to **30 seconds**).

Use the **Refresh** button to reset the timer.

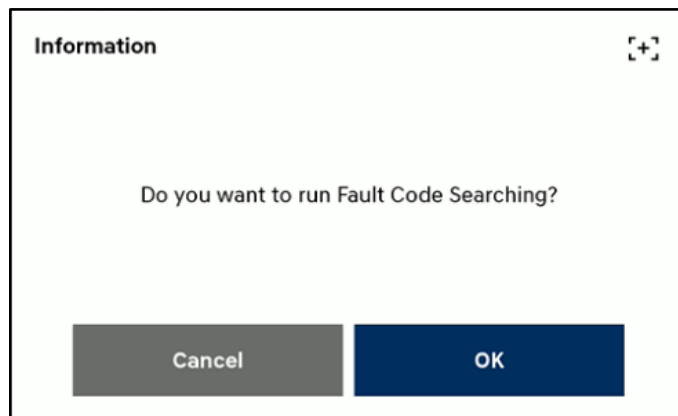
5. Perform an **All Systems Fault Code** search and erase DTC history that had incidentally occurred from the ECU update.
