HYUNDAI Technical Service Bulletin

GROUP BODY ELECTRICAL	NUMBER 26-BE-010H
DATE APRIL 2026	MODEL(S) SEE BELOW

SUBJECT: INOPERATIVE HORN ASSEMBLY REPLACEMENT
(WARRANTY EXTENSION Z07)

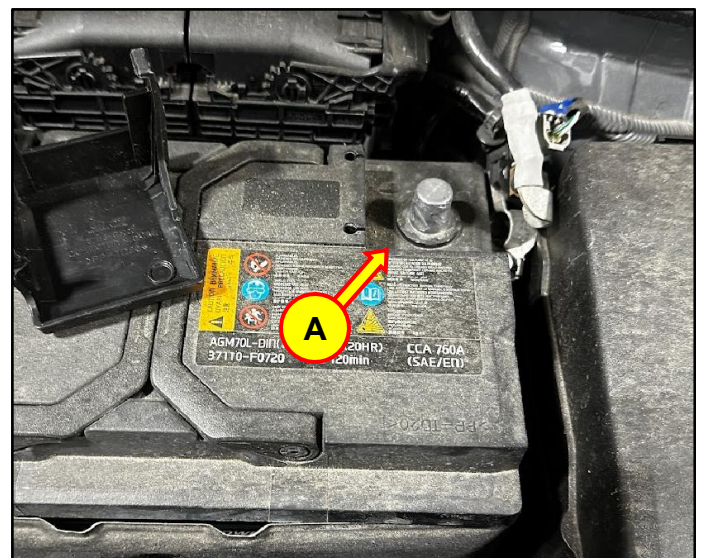
1. Disconnect the negative (-) battery terminal (A).

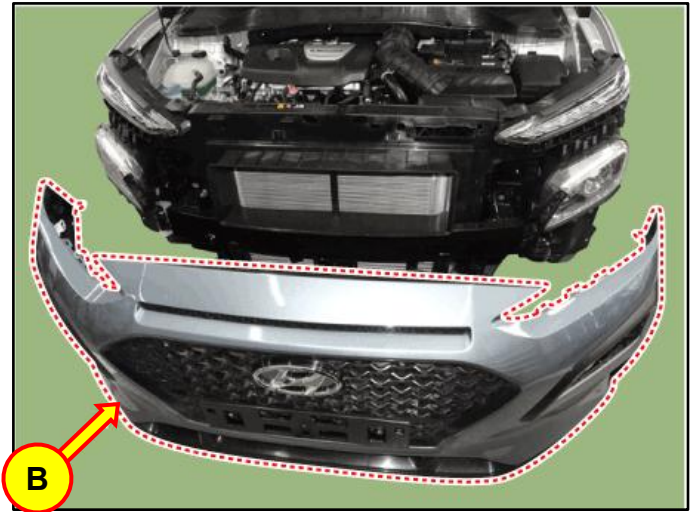
2. Remove the front bumper assembly (B) by referring to the shop manual:
 - **Body (Interior and Exterior) > Front Bumper > Front Bumper Assembly > Repair procedures**
