STAR ONLINE PUBLICATION

Case Number: S2308000034 Rev. B

Symptom/Vehicle Issue: No Wireless Charging Or Slow Wireless Charging

Models Affected:

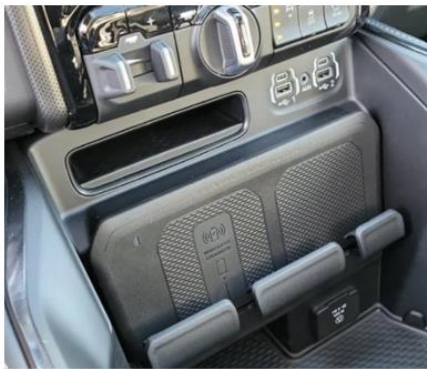
RU

3. Verify the device does not have a case that may reduce the charging signal (case too thick, not Qi certified, other accessories that may block wireless charging such as have a pop socket 📱 or metal plate/ring).
4. Inspect the charge pad location for any liquid contaminates that may have spilled creating interference (clean as needed).
5. Vehicles equipped with FAN integrated charger ONLY (identified by ventilation holes in charging base (see image below)): Check that the Welcome Green LED turns on for 1 second after a sleep cycle. Green LED On means the WCP has no issues and ready to charge the phone.
