Condition

Model(s)	Year(s)	VIN Range	Vehicle Specific Equipment
A8	2019 – 2021	All	4.0 ltr. V8 TFSI
S8, SQ7, SQ8, and RS Q8	2020 – 2025		
RS6 Avant, and RS 7	2021 - 2025

Technical Background

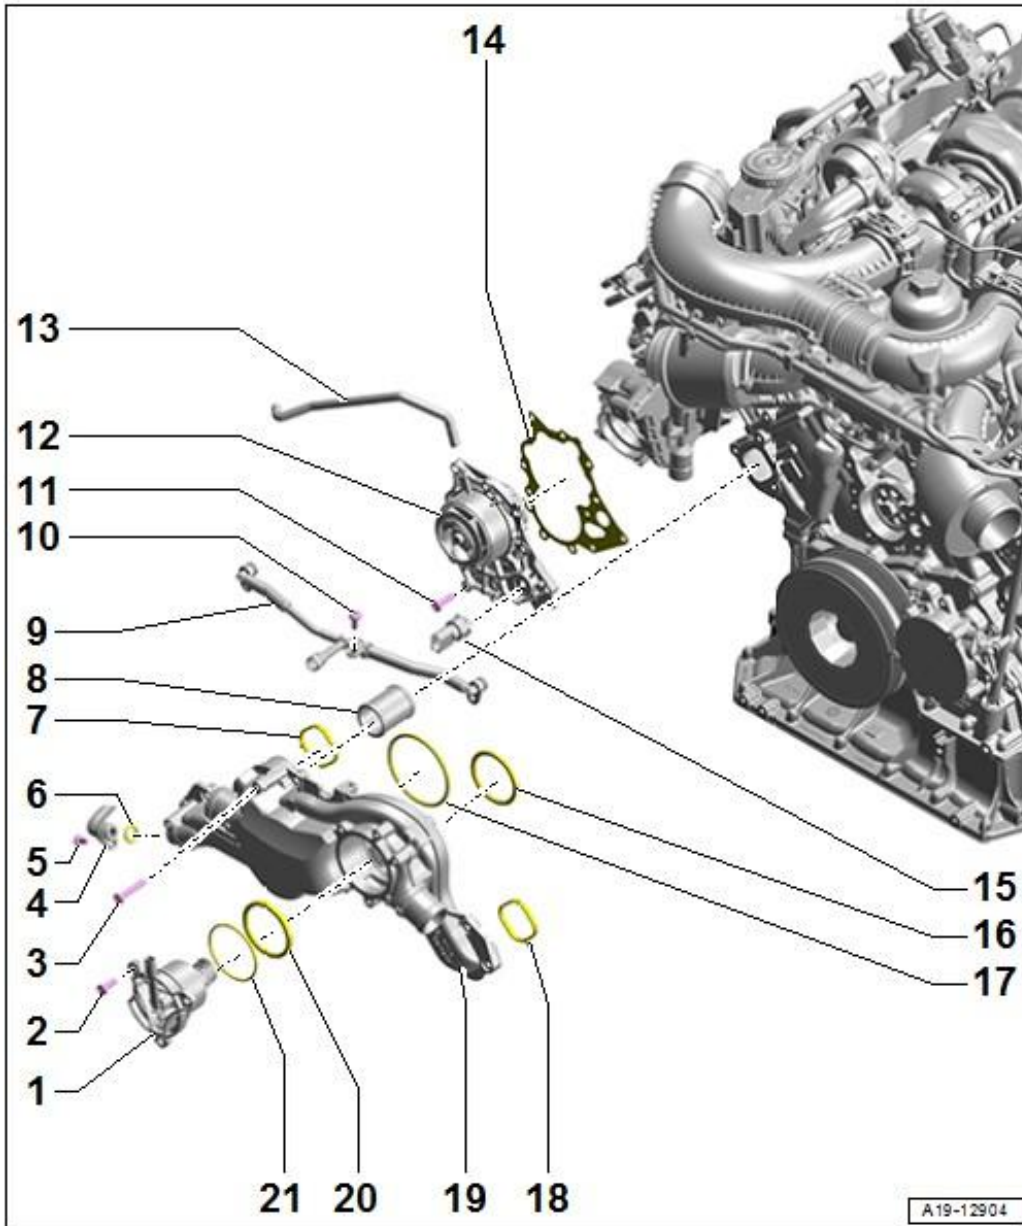
Figure 5. Assembly overview – coolant pump/thermostat incl. switchable mechanical coolant pump, number 12.

If the end positions are not reached correctly, replace the mechanical coolant pump.
