Water enters the vehicle interior. The headliner and/or footwell is wet.

Water enters the dry area of the wind deflector storage compartment.

Modification(s) on panoramic sliding sunroof.

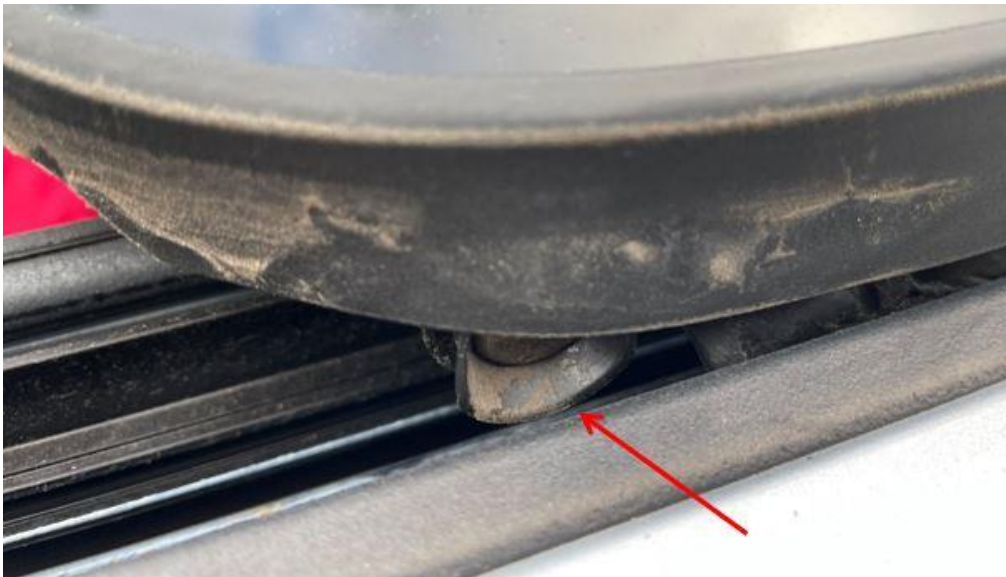
**Figure 32.**

Frame with flapper valve (see Figure 32)

Remove flapper valve from mechanism.

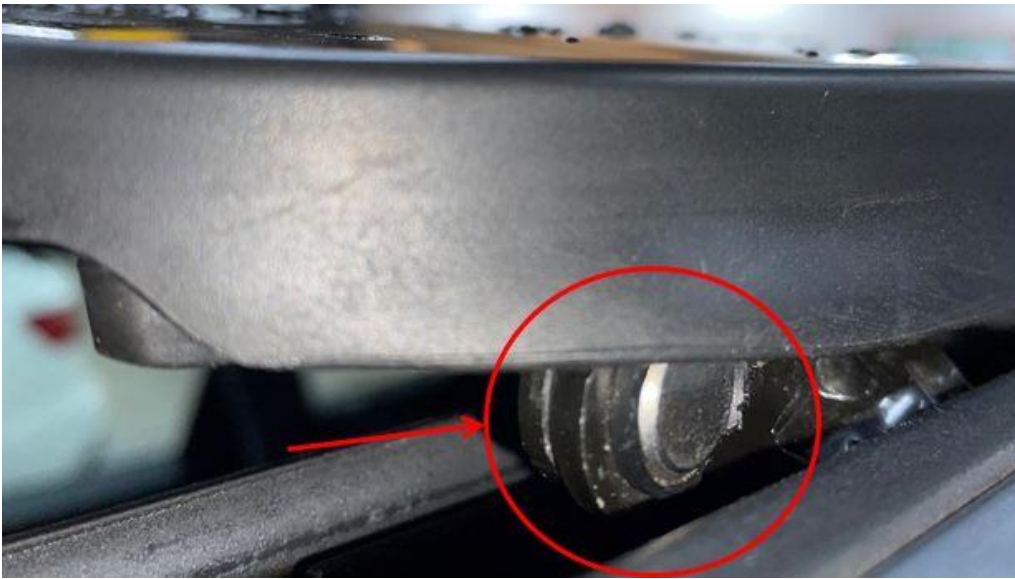
**Figure 33.**

Frame without flapper valve (see Figure 33).

Remove the water guiding washer using a diagonal cutter or cutter knife.

The plastic must be cut back so that it does not protrude from the silver pivot pin; it should be flush with the pivot pin.
