**Windshield Water Ingress in the Area of the Front Overhead Console (34/26)**

Model Line: **Macan (XAB)**

Model Year: **As of 2024 up to 2026**

Concerns: **Windshield**

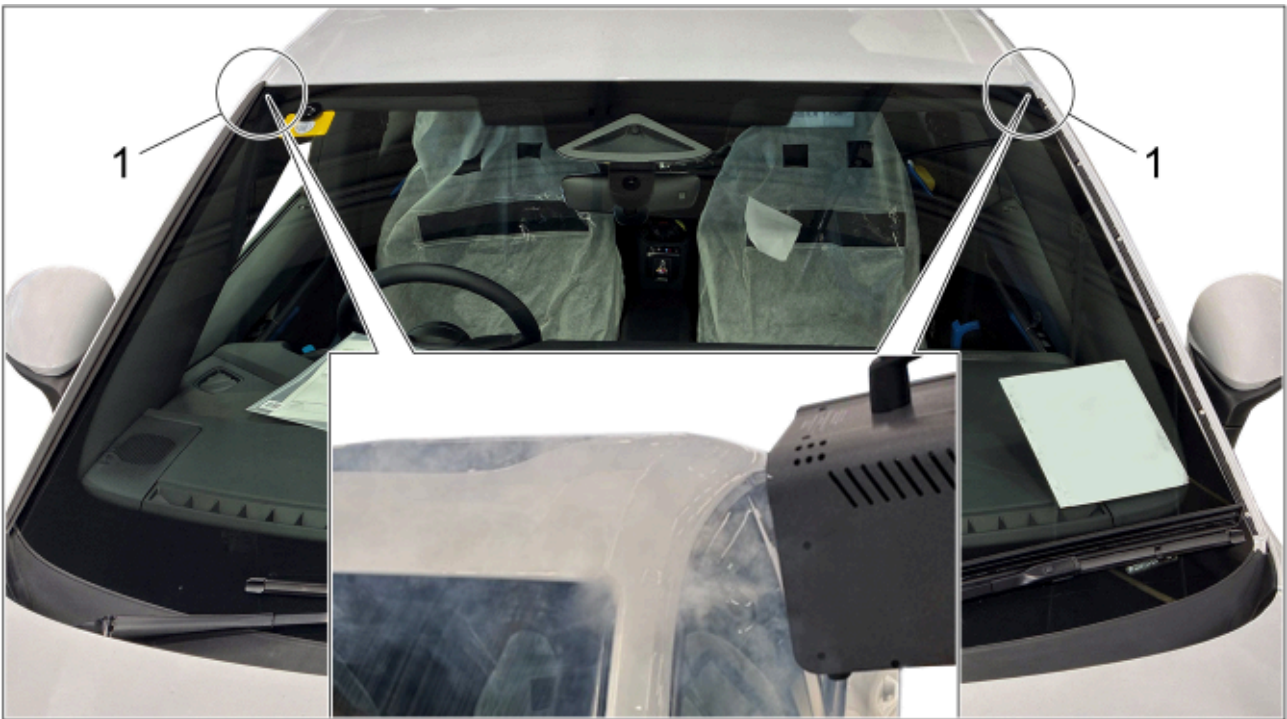
*Test with fog*

2 **Test with fog machine:** Blow in fog sideways via the upper corners of the windshield ⇒ *Test with fog -1-*.

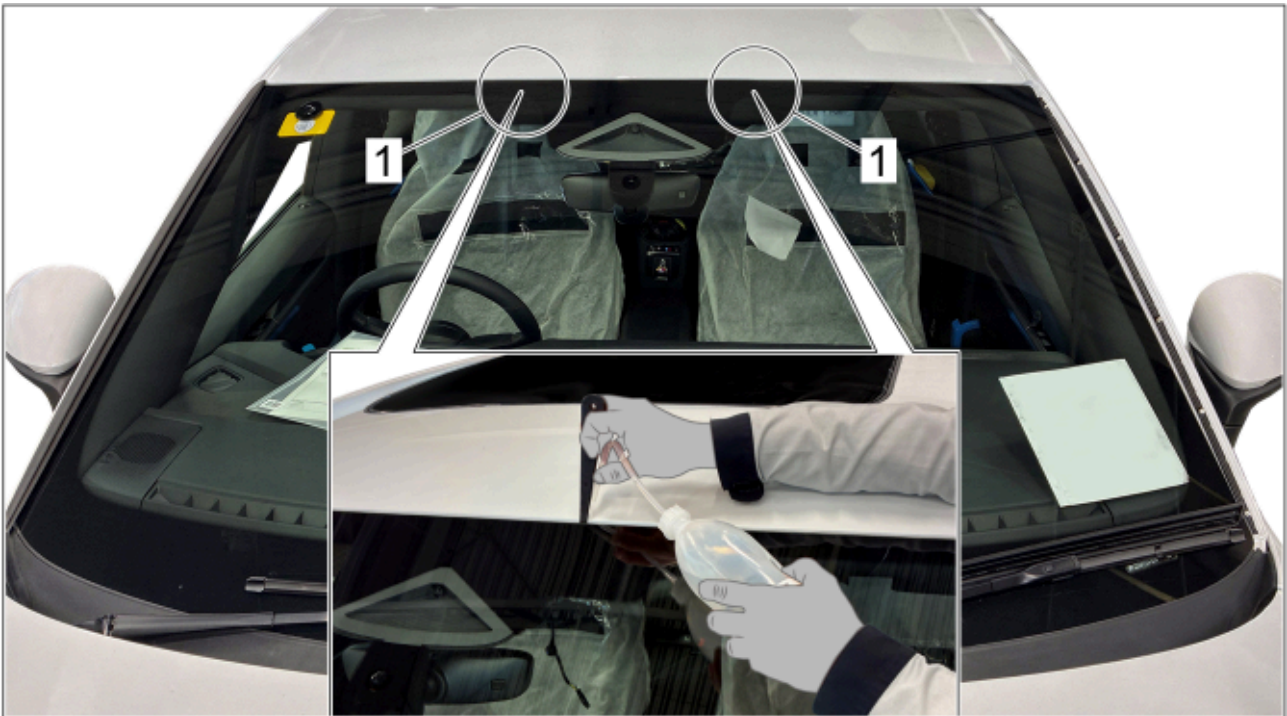
*Test with water*

3 **Test with water:** Fill water in the area ⇒ *Test with water -1-* behind the dust seal.

To do this, lift the dust seal slightly off the body using a plastic wedge and insert the water between the dust seal and the body.
